Troy Bridge Inspection

Troy Bridge over NE Stadium Way

Inspection Date: August 6, 2021

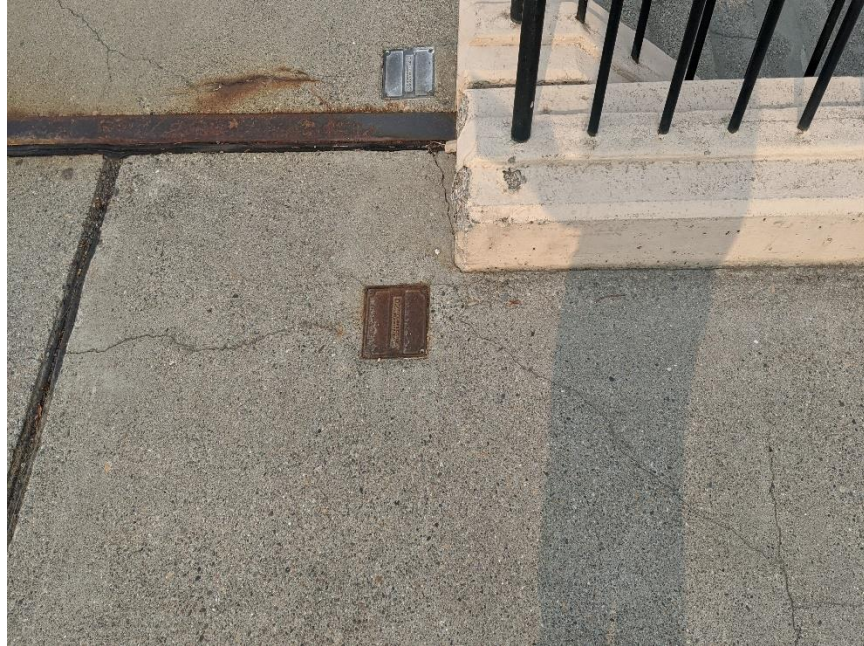
- The top of deck exhibited minor scaling up to 1/16 to 1/8-in. deep throughout. (See Photo 12)
- The top of deck around the snow melt junction boxes exhibited hairline to 1/16-in.-wide cracks. Some areas had minor corrosion staining through the cracks. (See Photo 13)

Photo 13: Typical Cracking Around Snow Melt Junction Boxes, Looking West

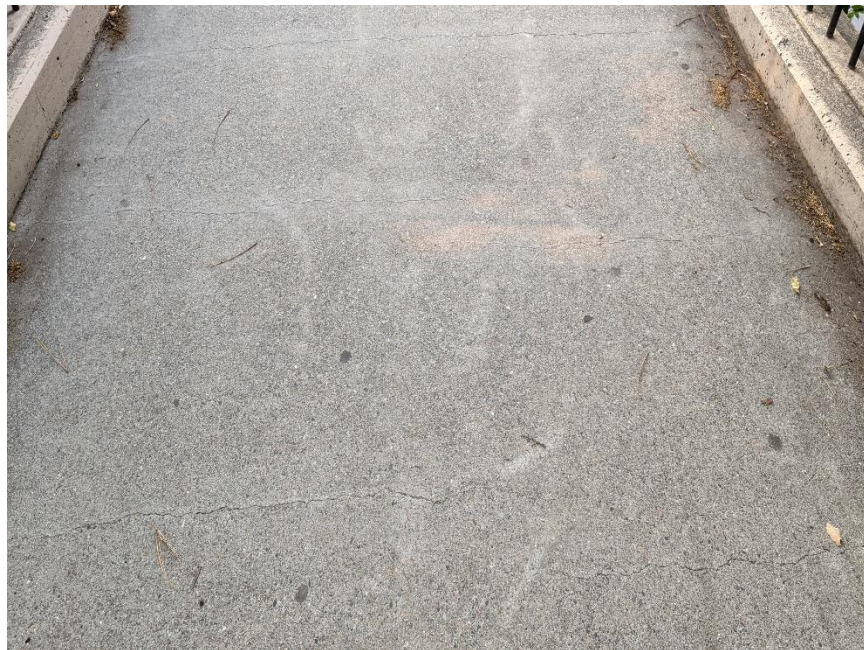
- The top of deck exhibited transverse hairline to 1/16-in.-wide cracking with up to 1/8-in. edge spalling approximately every 3-5 ft throughout each span. Longitudinal hairline to 1/16-in.-wide cracks with minor edge spalling was present near deck joints and throughout top of deck for all spans. (See Photos 14-16)

Photo 14: Typical Transverse Cracking in Top of Deck, Looking South

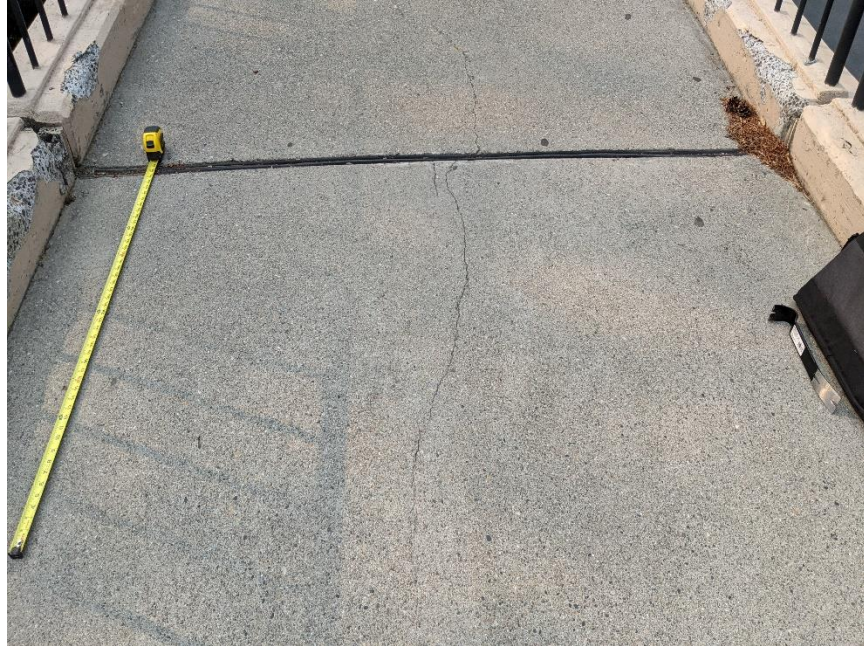
Photo 15: Typical Longitudinal Cracking from Deck Joints in Top of Deck, Looking North

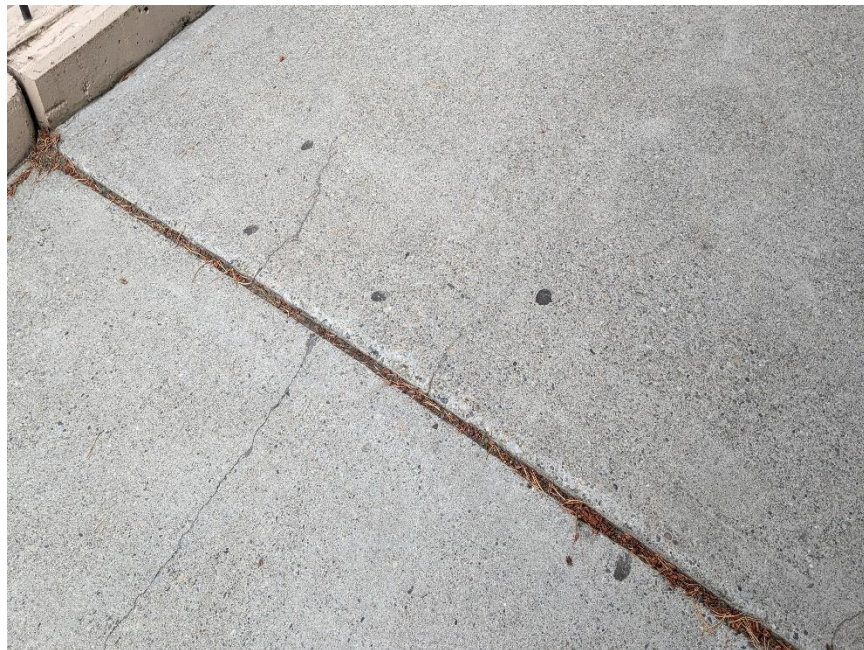
Photo 16: Typical Longitudinal Cracking from Deck Joints in Top of Deck, Looking Southeast

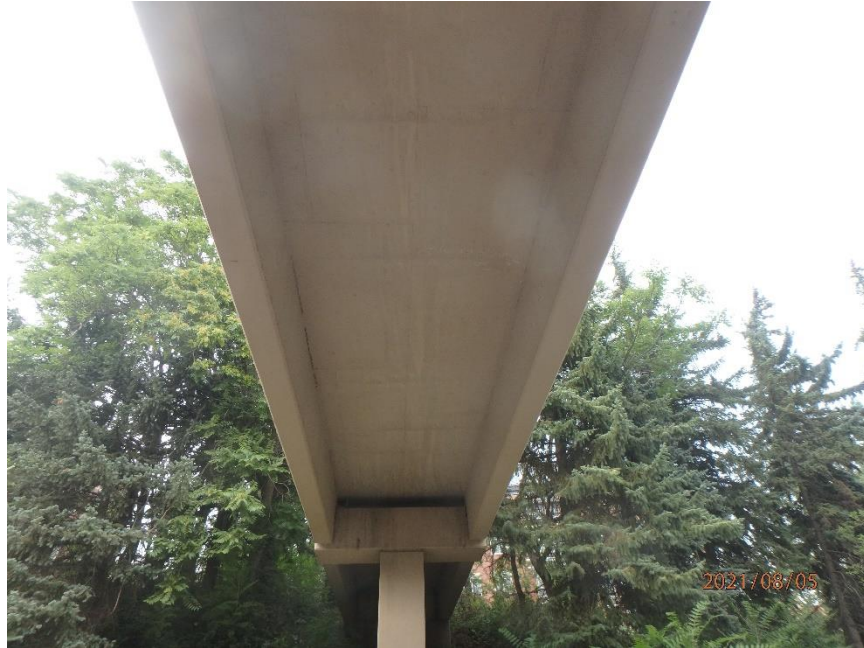
- The underdeck exhibited transverse hairline to 1/16-in.-wide cracks with light to moderate efflorescence approximately every 2-4ft throughout each span. Longitudinal 1/16-in.-wide cracks were present at the deck joints with moderate to heavy efflorescence and corrosion staining. (See Photos 17-20)

Photo 17: Typical Transverse Cracking in the Underdeck, Looking North

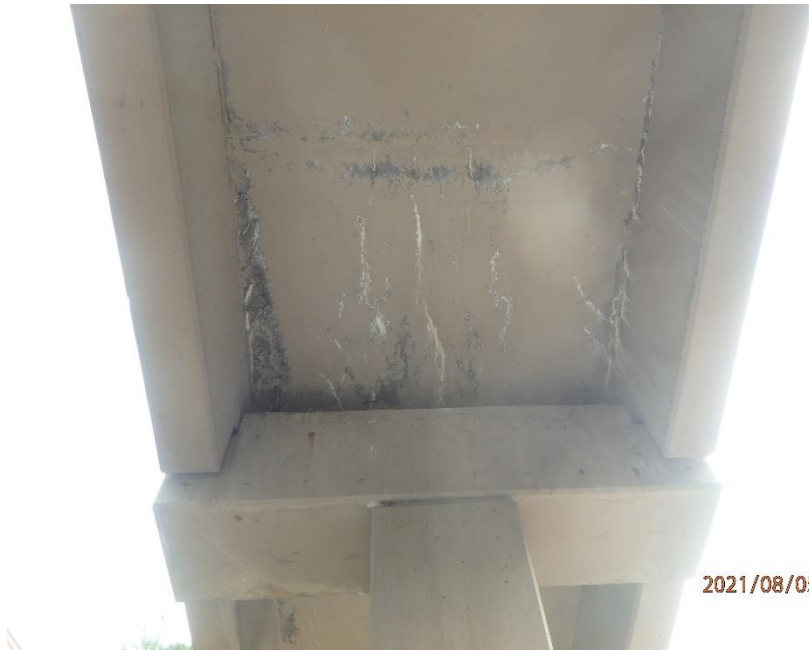
Photo 18: Typical Longitudinal Cracking in the Underdeck, Looking South

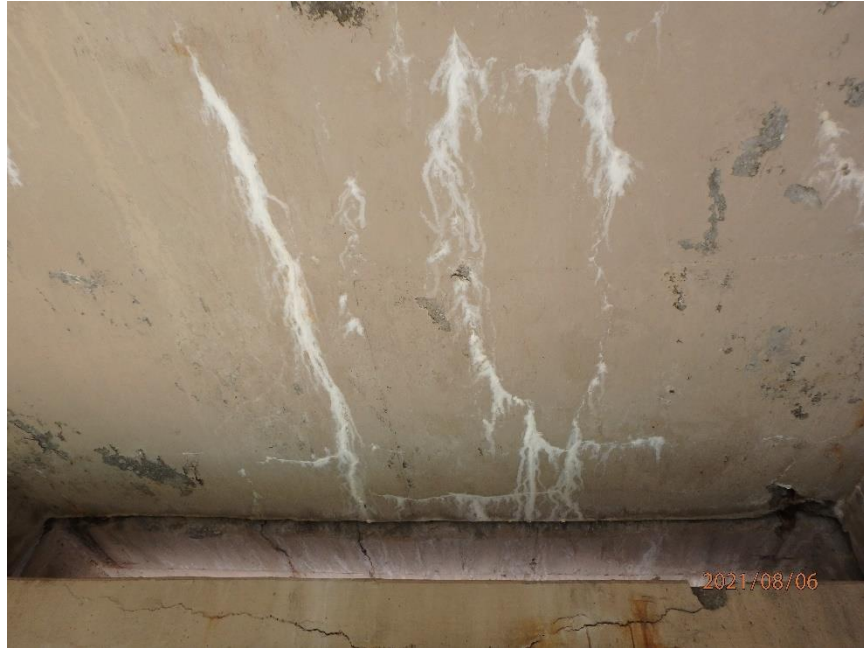
Photo 19: Typical Longitudinal Cracking in the Underdeck, Looking South

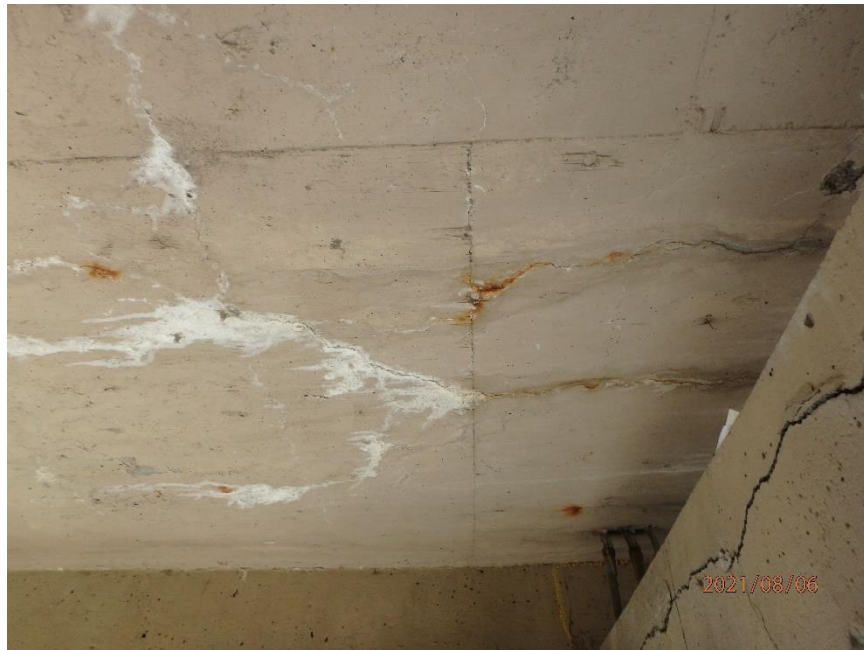
Photo 20: Typical Longitudinal Cracking in the Underdeck, Looking East

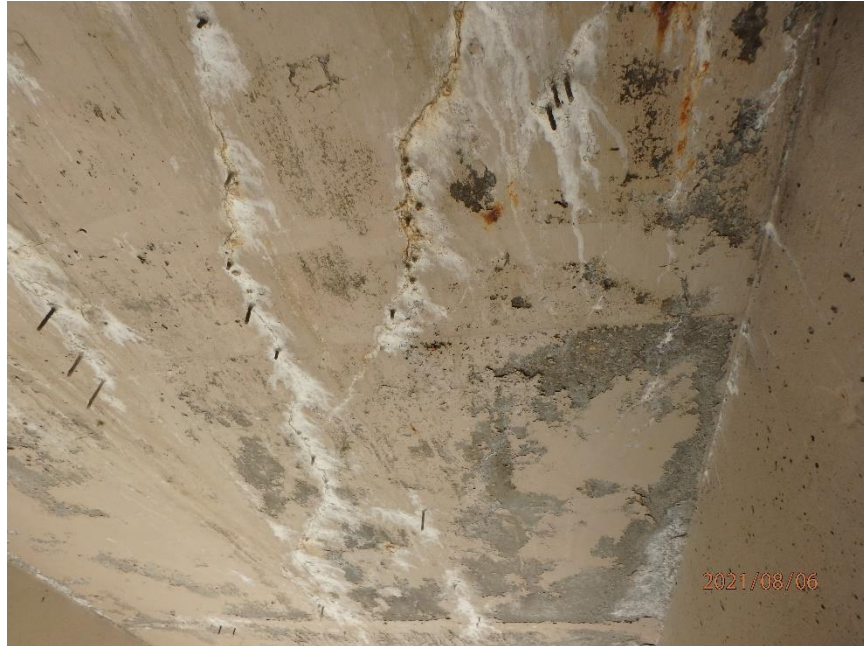
- The underdeck at pier 2 had longitudinal 1/16-in.-wide cracking propagating from the bridge joint up to 20 ft in length with moderate to heavy efflorescence and areas of delamination at the north end of span 2. The south end of span 3 underdeck had a spall near the southwest corner measuring 8-in. wide by 10-in. long by 1-in. deep with exposed reinforcing. (See Photos 21-23)

Photo 21: Longitudinal Cracking at Pier 2 Underdeck, Looking South

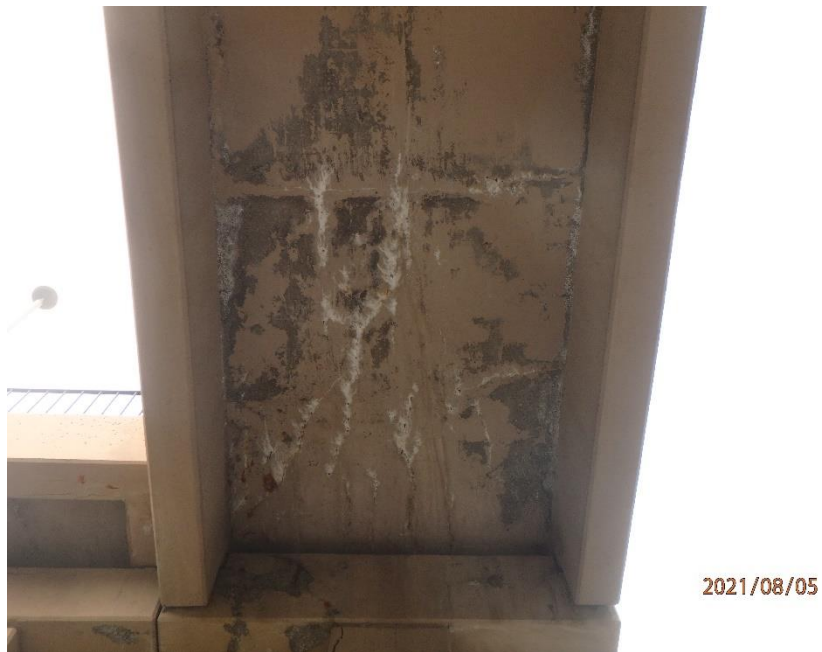
Photo 22: Span 2 North End Underdeck, Looking North

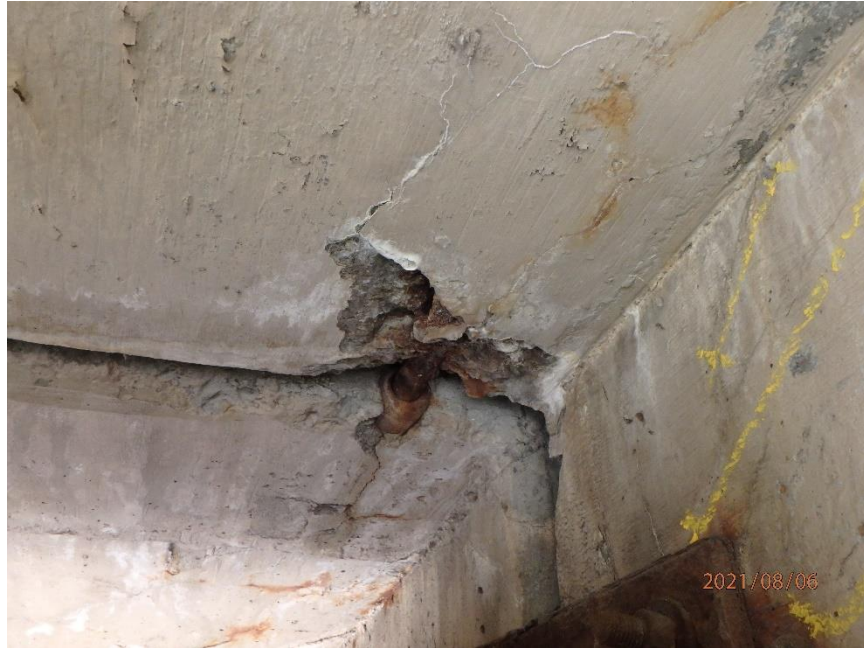
Photo 23: Spall in Southwest Corner of Span 3 Underdeck Above Pier 2, Looking Southwest

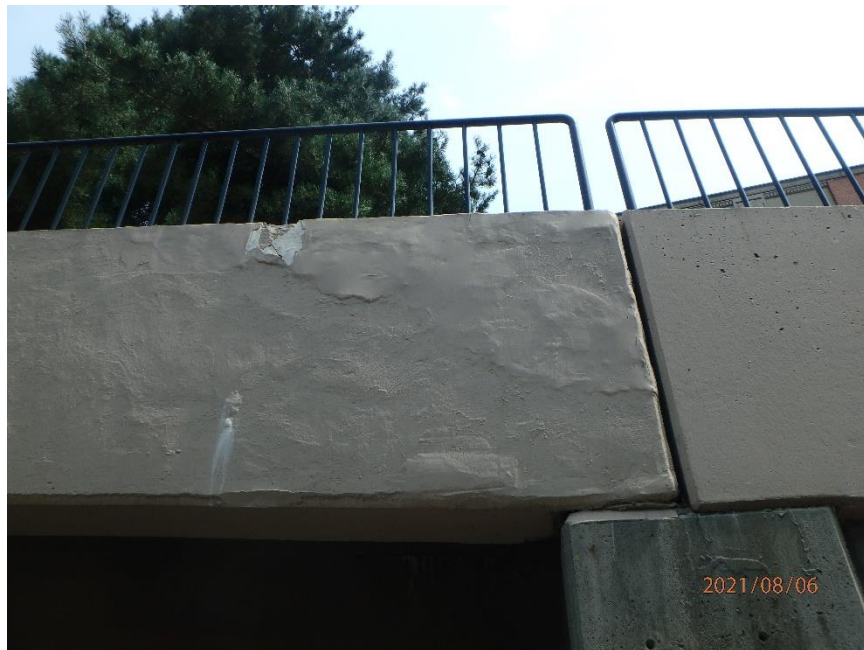
Photo 24: Typical Unsound Patches in West Face of West Girder, Looking East

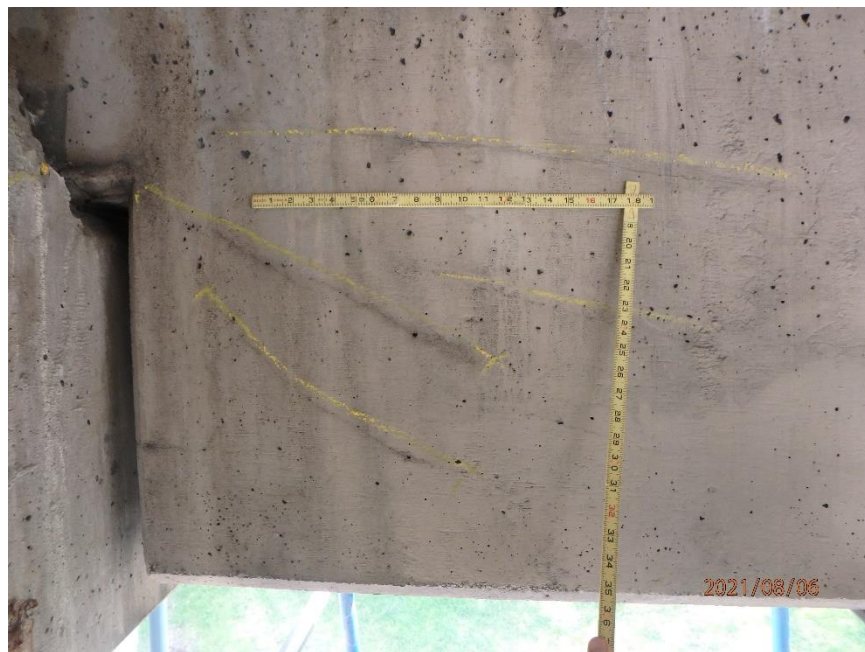
- Span 1:
 - South End
 - Girders in good condition.
 - North End
 - Both interior faces exhibited multiple hairline diagonal cracks extending from the dapped girder end up to 30-in. long on the east girder and 28-in. long on the west girder. Areas of delamination exist around the interior girder-to-pier cap hardware connection measuring up to 12-in. high by 14-in. long. (See Photos 26 and 27)

Photo 26: Diagonal Cracks in West Face of Span 1 East Girder at North End, Looking East

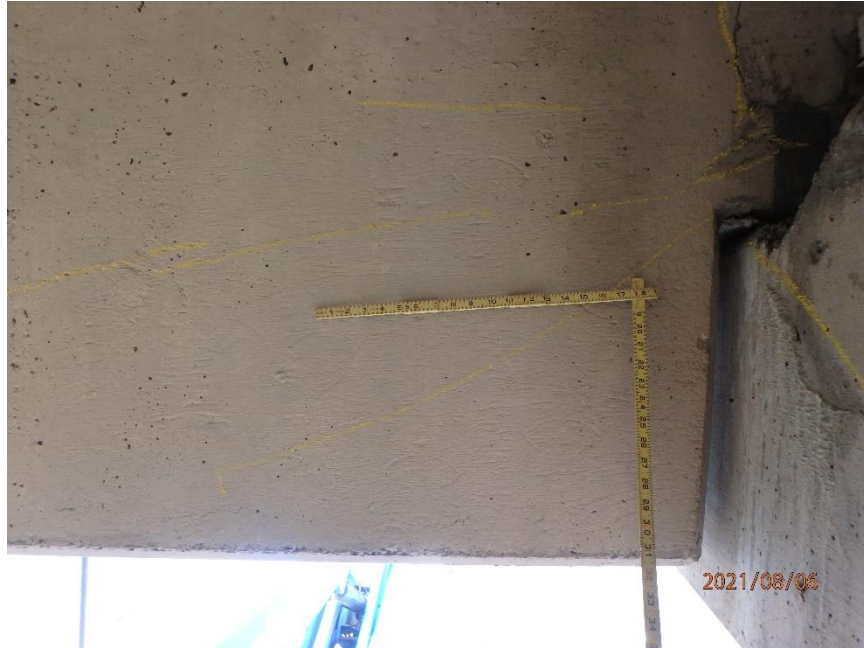
Photo 27: Diagonal Cracks in East Face of Span 1 West Girder at North End, Looking West

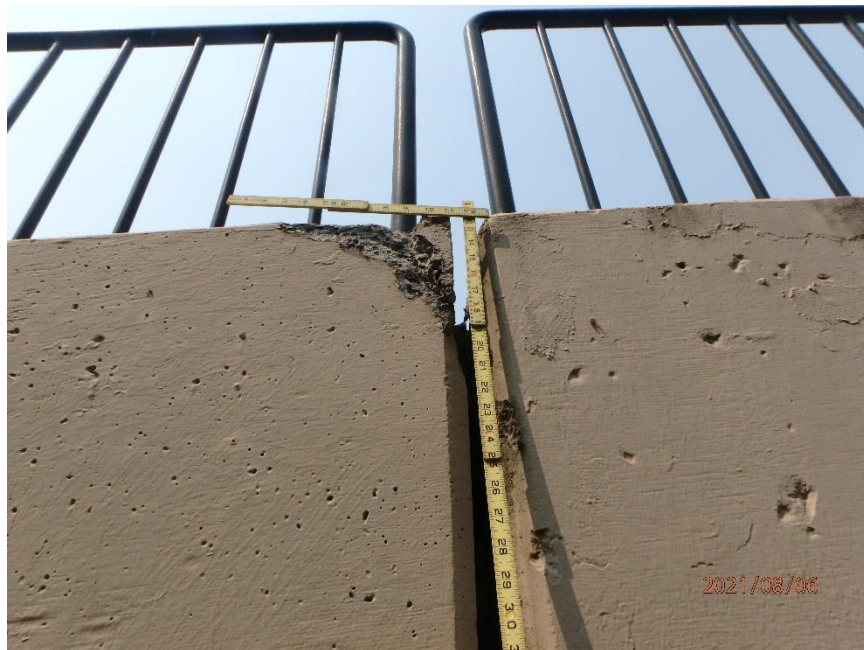
- East face of the east girder had a spall in the top corner measuring 8-in. high by 8-in. long by 1-in. deep with no exposed bar. The bottom

Photo 28: Spall in East Face of Span 1 East Girder at Top Corner at North End, Looking West

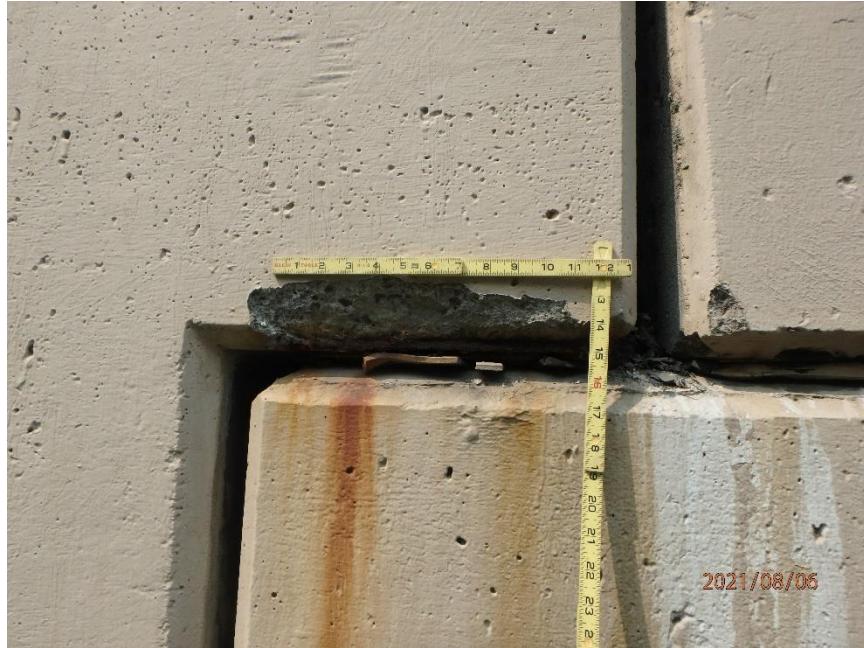
edge just above the bearing pad exhibited a spall 3-in. high by 14-in. long by 1-in. deep with no exposed bar. (See Photos 28 and 29)

Photo 29: Spall in East Face of Span 1 East Girder at bottom edge at North End. Looking West

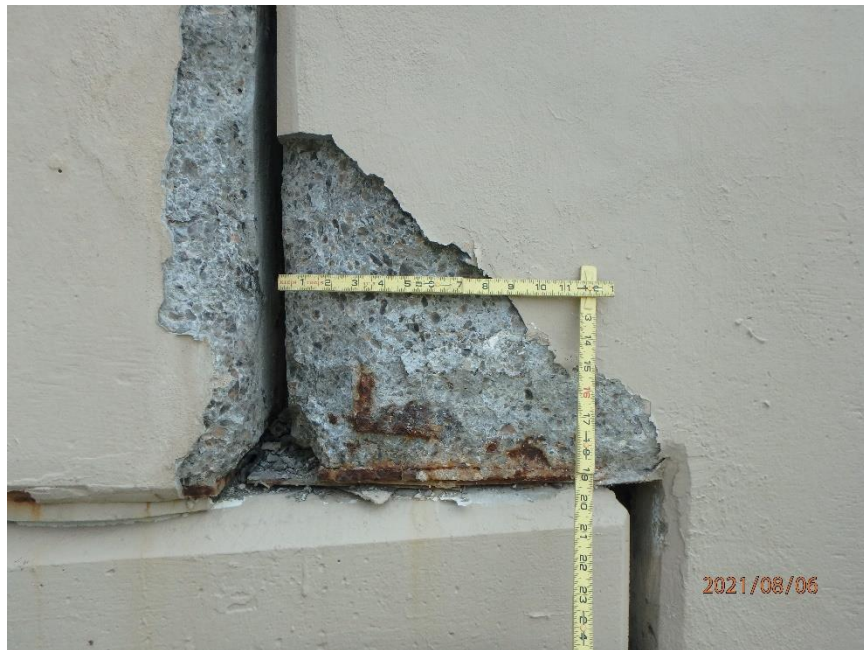
- West face of the west girder had a spall above the bearing plate measuring 14-in. high by 15-in. long by 1-in. deep with 3 exposed bars. (See Photo 30)

Photo 30: Spall in West Face of Span 1 West Girder at bottom edge at North End. Looking East

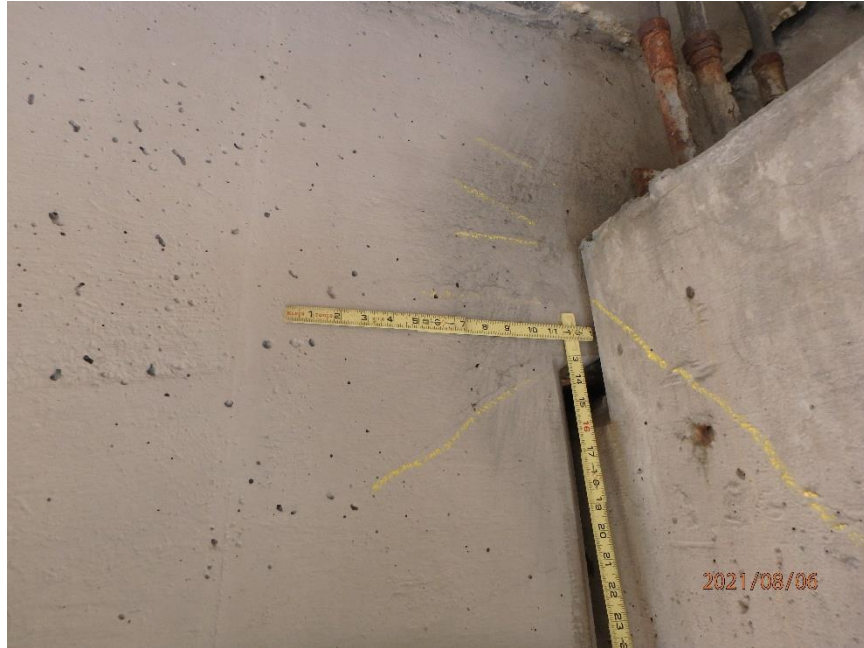
- Both interior faces exhibited multiple hairline diagonal cracks extending from the dapped girder end up to 8-in. long on the east girder and 19-in. long on the west girder. (See Photos 31 and 32)
 - The west face of the west girder had a full height spall up to 4-in. wide by 1-in. deep with no exposed bar. (See Photo 33)

Photo 31: Diagonal Cracks in West Face of Span 2 East Girder at South End, Looking East

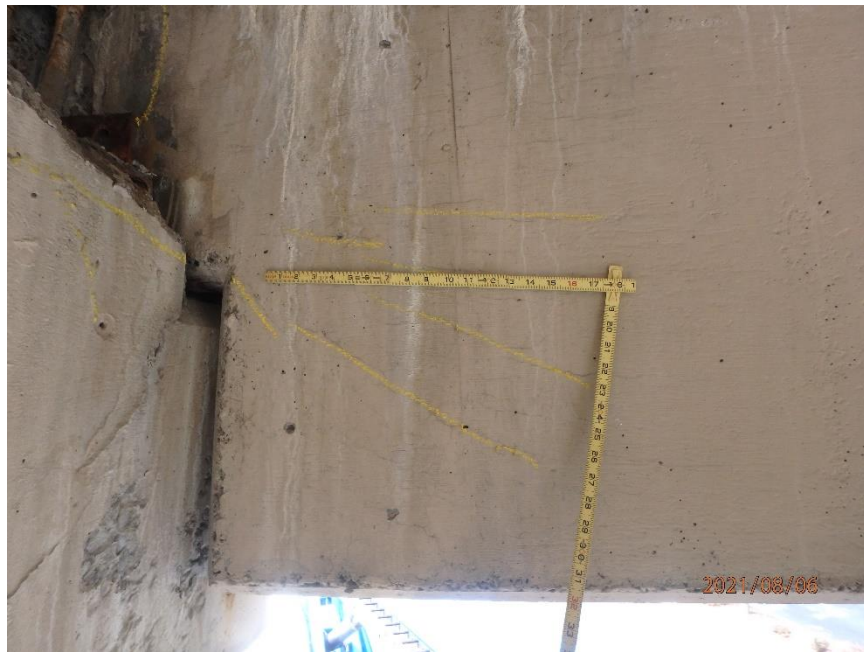
Photo 32: Diagonal Cracks in East Face of Span 2 West Girder at South End, Looking West

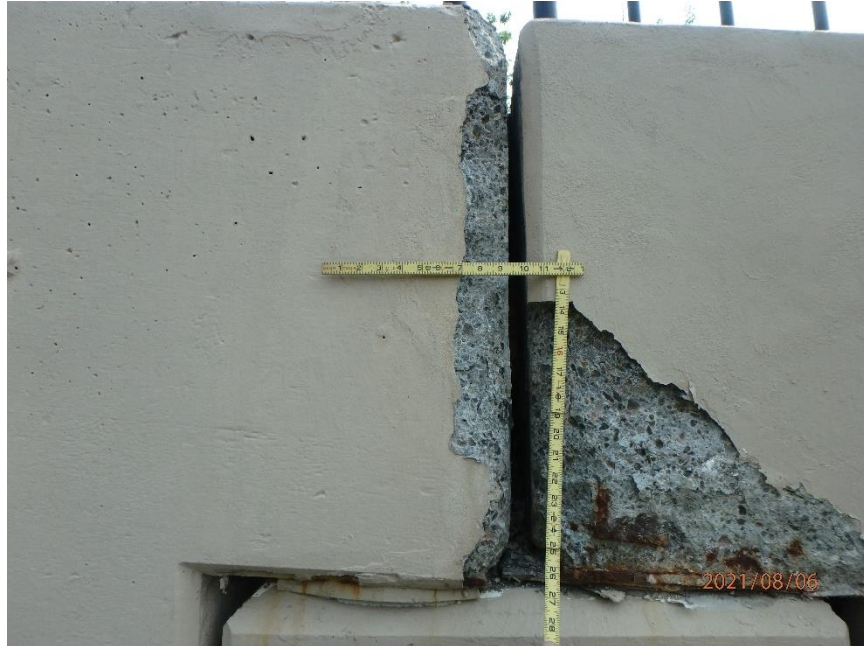
Photo 33: Spall in West Face of Span 2 West Girder at bottom edge at South End. Looking East

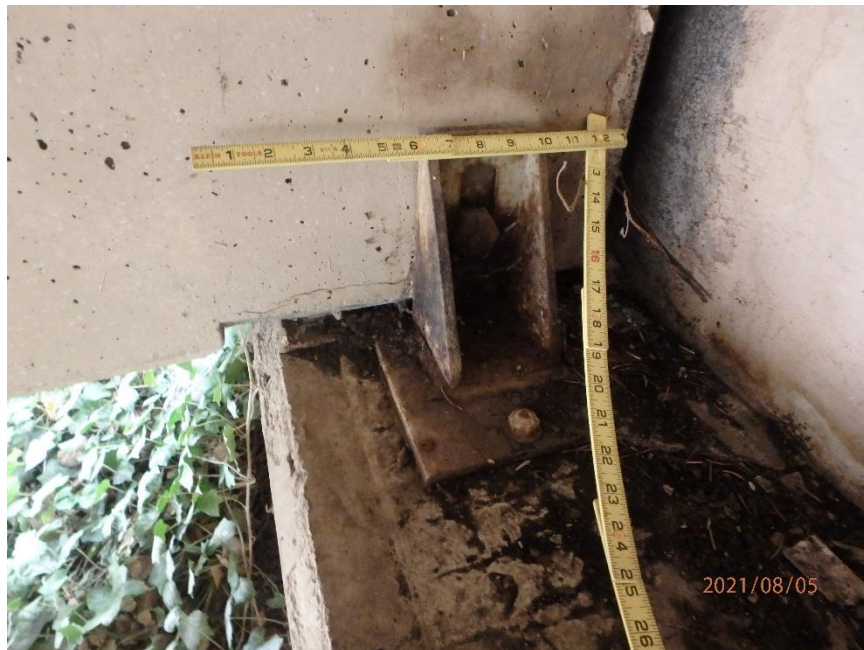
- All girders were connected to the pier cap or abutments with steel brackets and embedded bolts. Over the pier caps the steel brackets were continuous on both interior faces with slotted holes on one side of the bracket to allow movement. Over the abutments the steel brackets were on both interior faces. The north abutment steel brackets slotted holes were vertical and not horizontal. The south abutment steel brackets did not have slotted holes. The connection hardware had moderate to heavy corrosion in all locations. See span 2, north end for more connection hard wear defects. (See Photos 34-36)

Photo 34: Typical North Abutment Steel Connection Bracket, Looking West

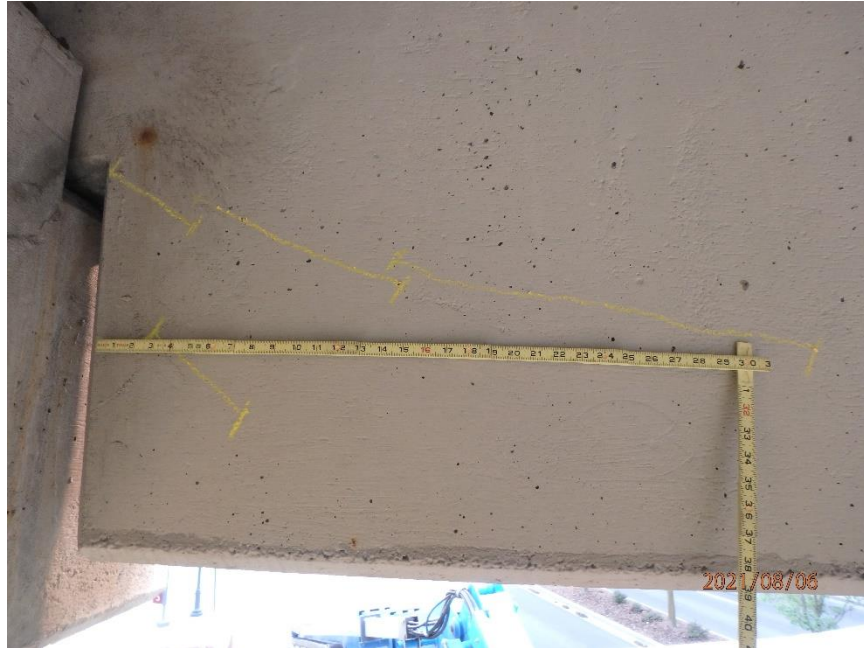
- Both interior faces exhibited multiple hairline diagonal cracks extending from the dapped girder end up to 36-in. long on the east girder and 16-in. long on the west girder. (See Photos 37 and 38)
 - The east girder had a spall at the northeast corner and above the bearing plate measuring 21-in. high by 16-in. long by 1.5 in. deep with 4 exposed bars having approximately 20% loss of section. (See Photos 39 and 40)
 - The west face of the west girder had a spall measuring 16-in. high by 15-in. wide by 1.5-in. deep with 2 exposed bars. (See Photo 41)
 - The steel connection hardware on top of Pier 2 for span 2 to span 3 girders had 2 sheared off bolts at the span 2 connection. (See Photos 42 and 43)

Photo 37: Diagonal Cracks in West Face of Span 2 East Girder at North End, Looking East

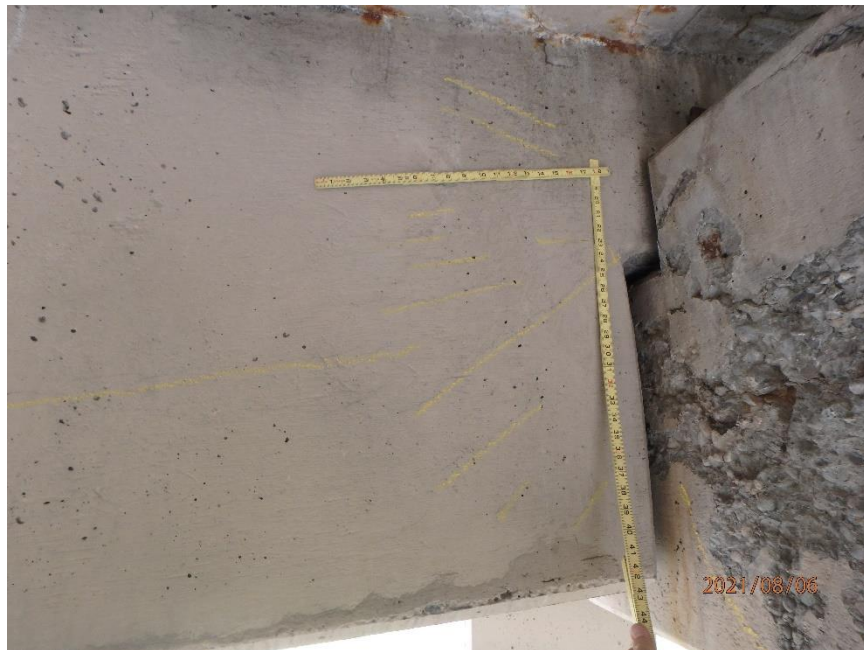
Photo 38: Diagonal Cracks in East Face of Span 2 West Girder at North End, Looking West

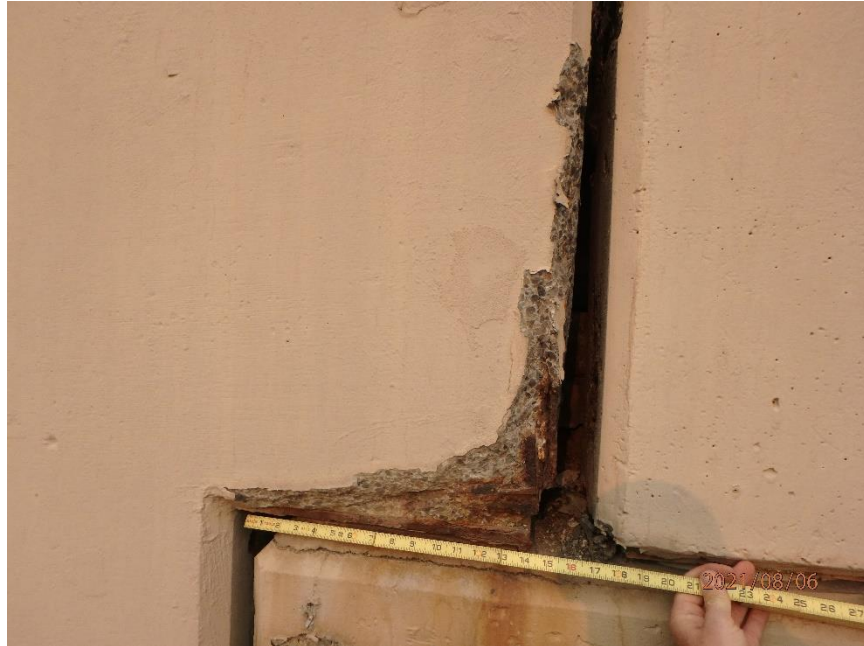
Photo 39: Spall in Span 2 East Girder at Northeast corner, Looking West

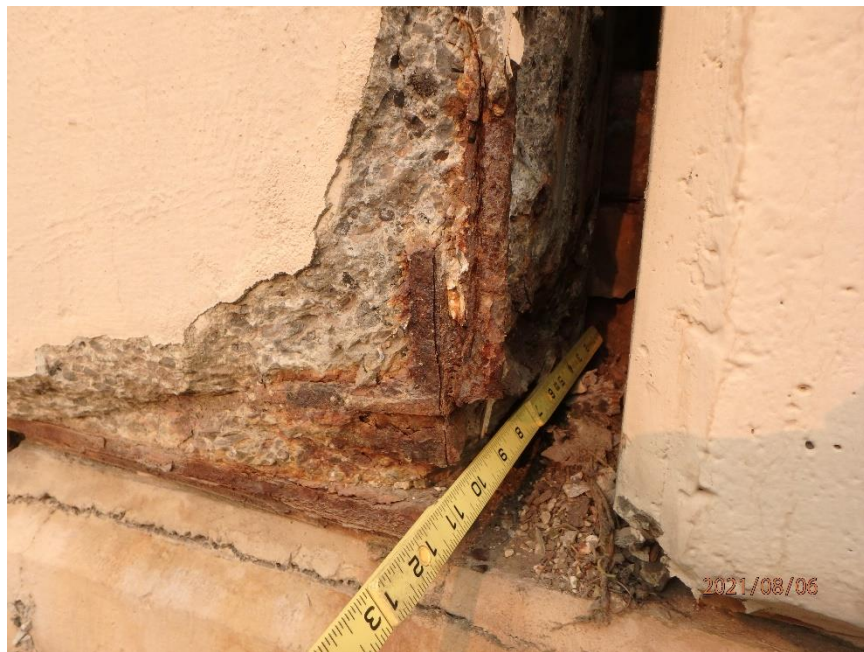
Photo 40: Spall in Span 2 East Girder at Northeast corner, Looking Southwest

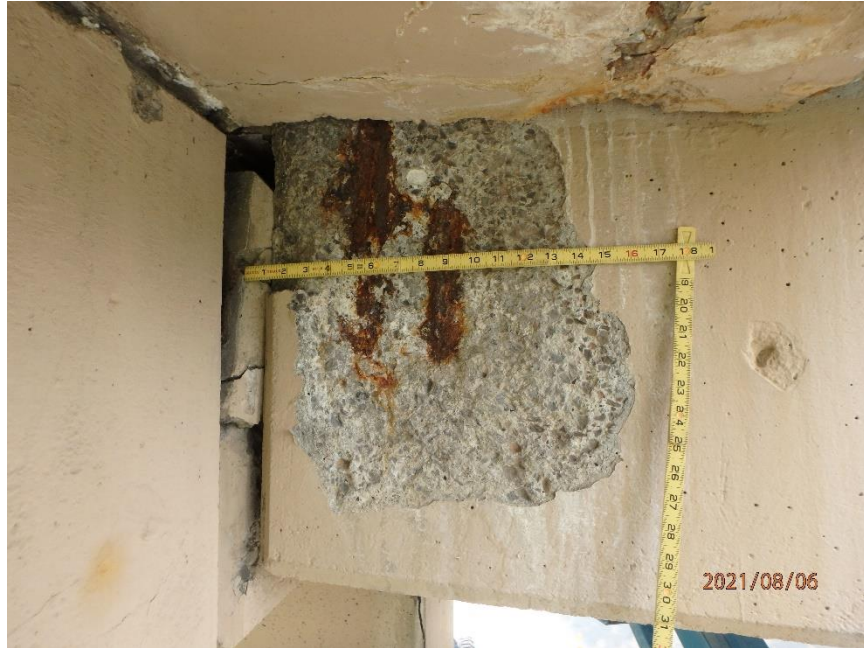
Photo 41: Spall in Span 2 West Girder on the West Face at the North End, Looking East

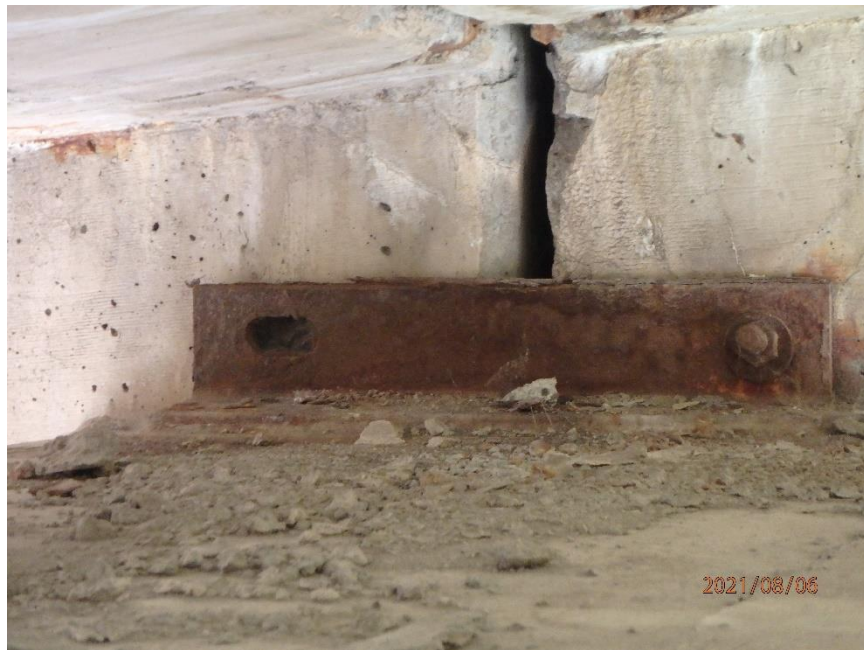
Photo 42: Sheared off Bolt at Pier 2 Connection Hardware, Looking West

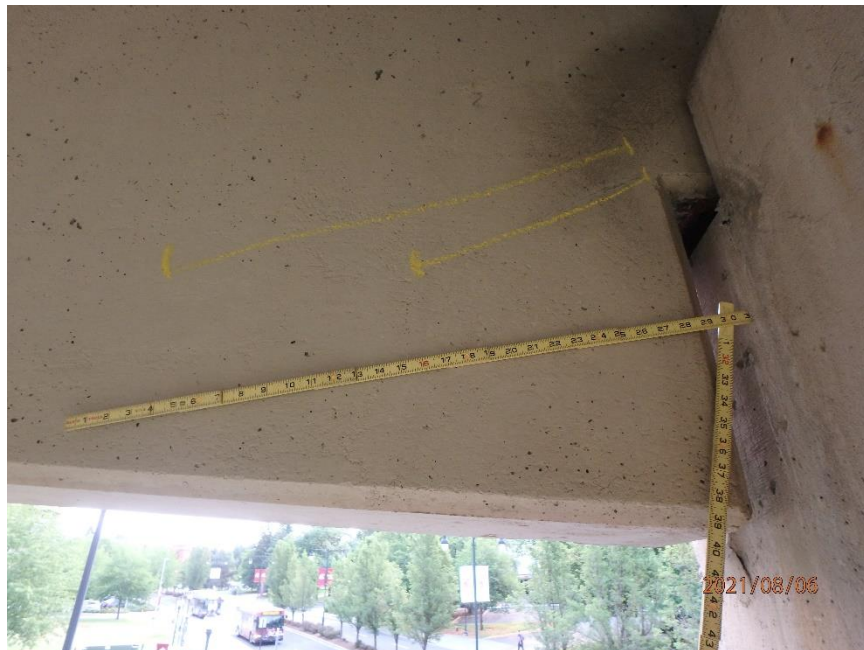
- Both interior faces exhibited multiple hairline diagonal cracks extending from the dapped girder end up to 25-in. long on the east girder and 24-in. long on the west girder with rust staining. (See Photos 44 and 45)

Photo 44: Diagonal Cracks in West Face of Span 3 East Girder at South End, Looking East

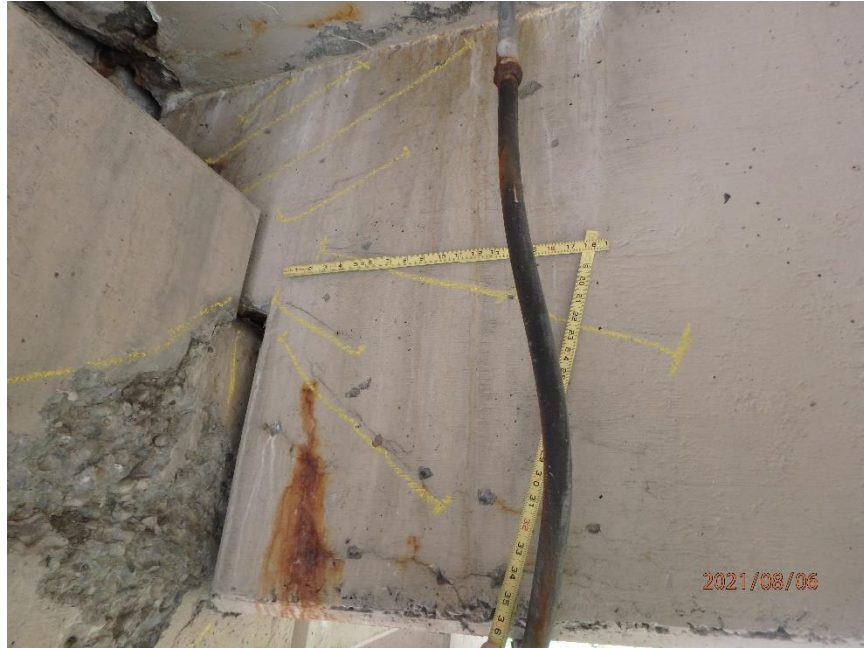
Photo 45: Diagonal Cracks in East Face of Span 3 West Girder at South End, Looking West

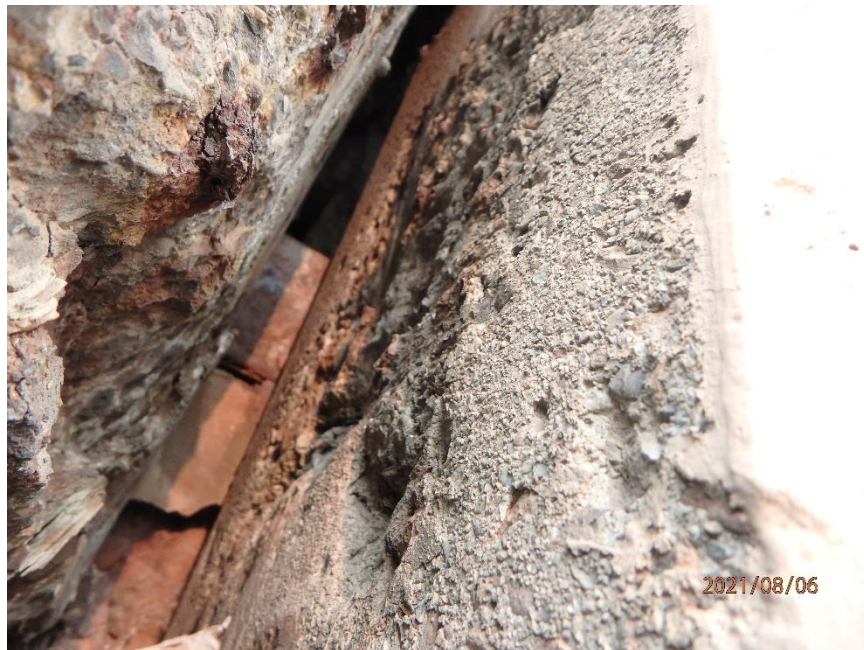
- The east girder had spalls along the south face measuring 10-in. high by 6-in. wide by 1-in. deep with multiple reinforcing bar ends exposed. (See Photo 46)
- North End
 - The interior face of the east girder exhibited one hairline diagonal cracks extending from the dapped girder end up to 34-in. long. (See Photo 47)
- Span 4:
 - South End
 - The east girder had a spall on the east face above the bearing plate measuring 2-in. high by 12-in. long by 1-in. deep with no bar exposed. (See Photo 48)
 - The west girder had a spall on the west face at the bottom corner measuring 4-in. high by 10-in. long by 1-in. deep with no exposed bar. (See Photo 49)
 - North End
 - Both exterior faces on east and west girders had spalls above the bearing plates measuring up to 2-in. high by 14-in. long by 1-in. deep with no bar exposed. (See Photo 50)

Photo 46: Spall in South Face of East Girder at South End, Looking Northwest

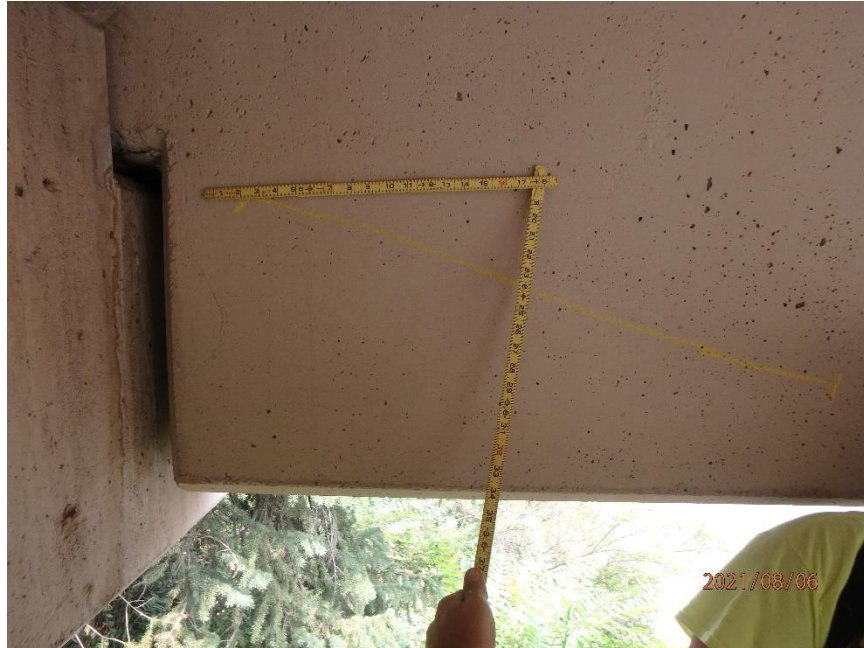
Photo 47: Diagonal Cracks in West Face of Span 3 East Girder at North End, Looking East

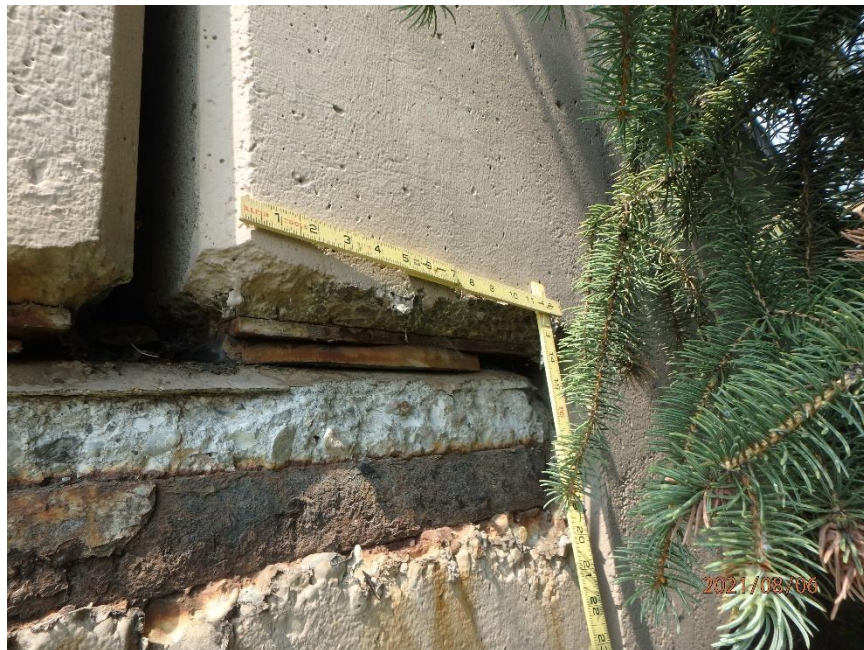
Photo 48: Spall in Span 4 East Girder on the East Face at the South End, Looking Northwest

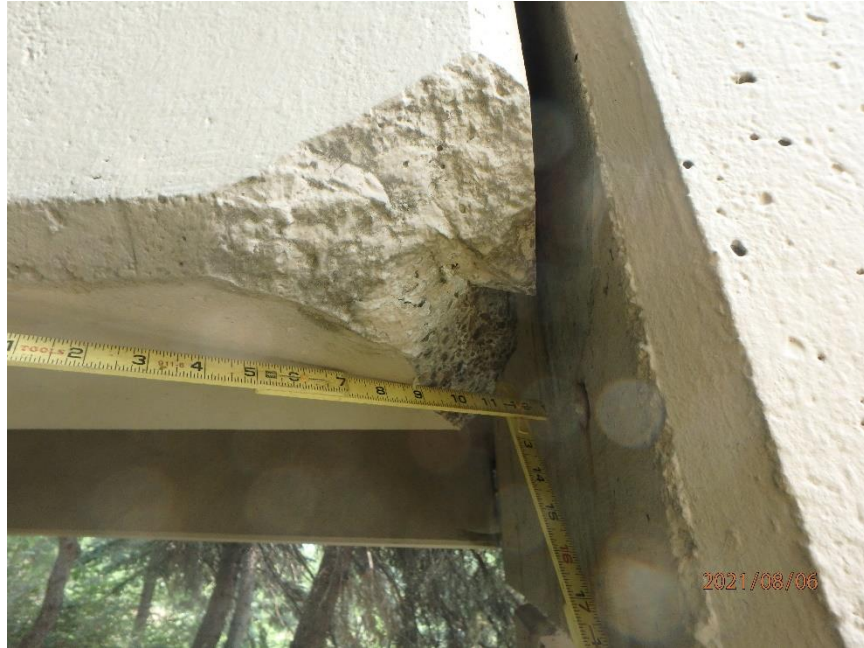
Photo 49: Spall in Span 4 West Girder on the West Face at the South End, Looking East

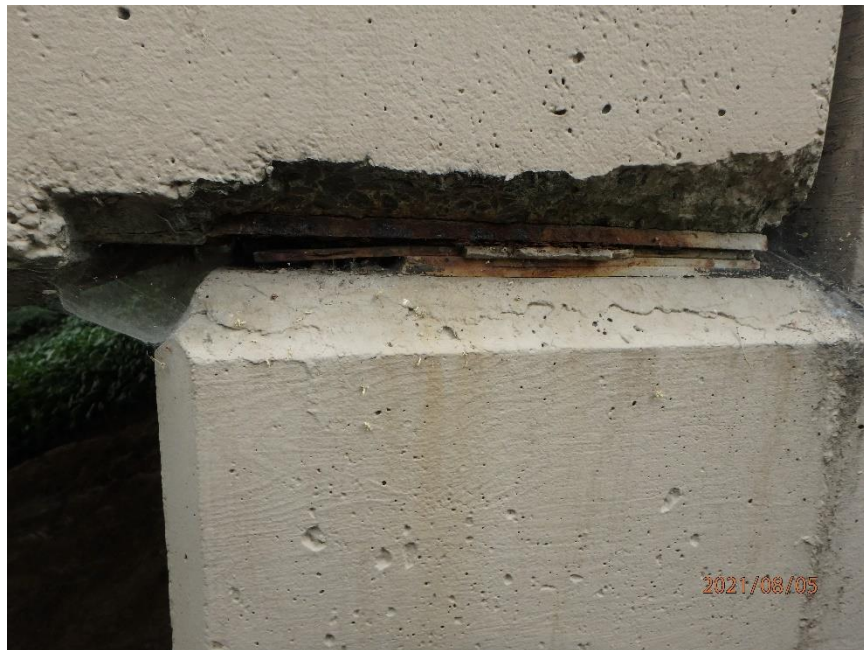
Photo 50: Spall in Span 4 East Girder on the East Face at the North End above the bearing plate, Looking West

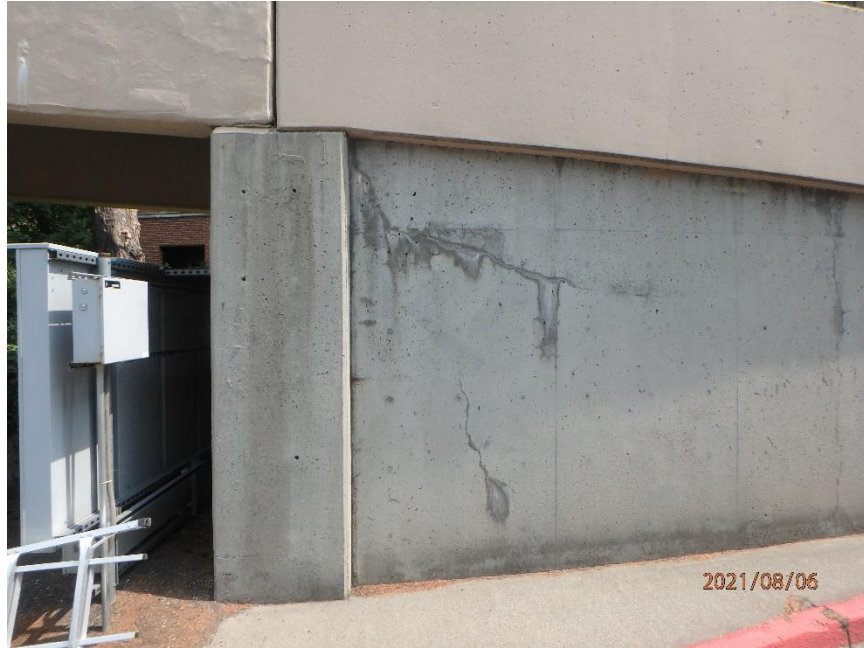
- South Abutment:
 - The west face exhibits minor hairline cracks with light efflorescence up to 5 ft long. (See Photo 51)
 - The abutment back wall exhibited random vertical hairline cracks.

Photo 51: Hairline Cracks with Light Efflorescence in South Abutment West Side, Looking East

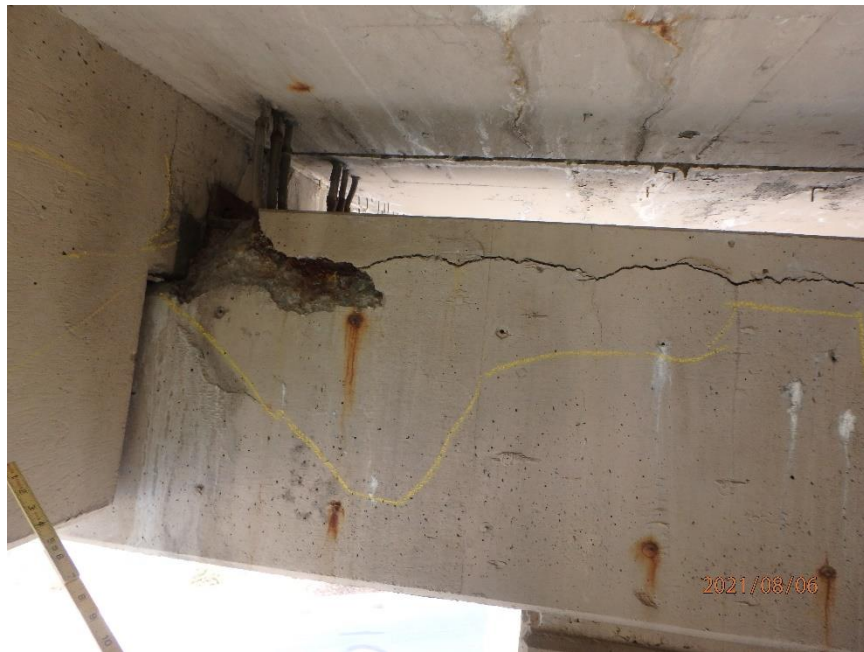
- Pier 1:
 - Pier
 - The base of the pier had random minor areas of impact damage consisting of 2-in. diameter spalls in the corners.
 - Pier Cap
 - The top half of both south and north faces were delaminated and cracking for the whole length by up to 22-in. high on the vertical face and up to 8-in. on the top surface. (See Photos 52-54)

Photo 52: Delamination of the South Face of Pier 1 Cap, Looking Northwest (Yellow Lines Show Delamination)

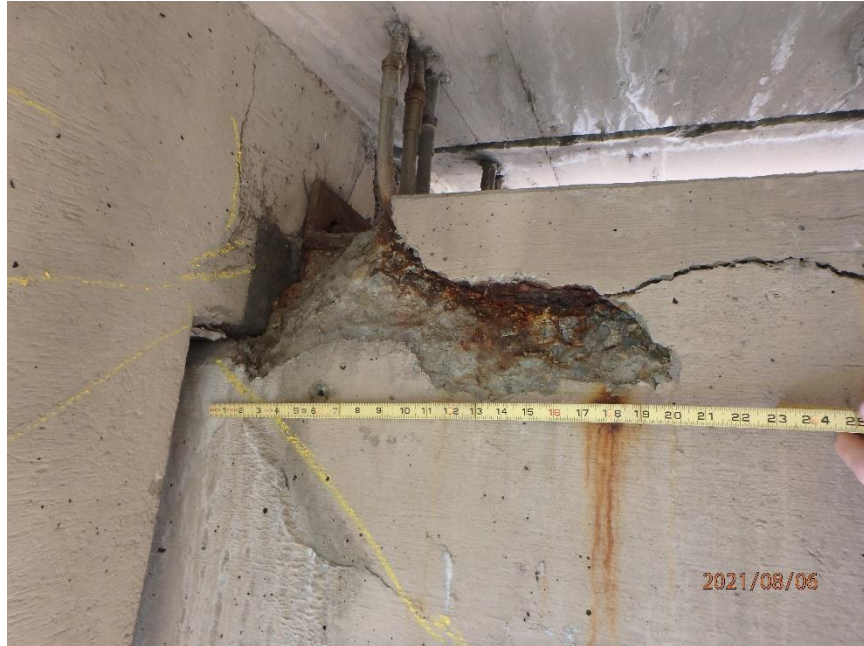
- The south face had spalls at each top corner measuring 9-in. high by 20-in. long by 5-in. deep on the west corner and 15-in. high by 24-in. long by 4-in. deep on the east corner. The spalls appear to be caused by heavily corroded steel conduit from the electric snow melt system with areas of 100% section loss exposing wires. (See Photos 55-57)

Photo 55: Spall in West Top Corner of Pier 1 Cap South Face, Looking North
