Troy Bridge Inspection

Troy Bridge over NE Stadium Way

Inspection Date: August 6, 2021

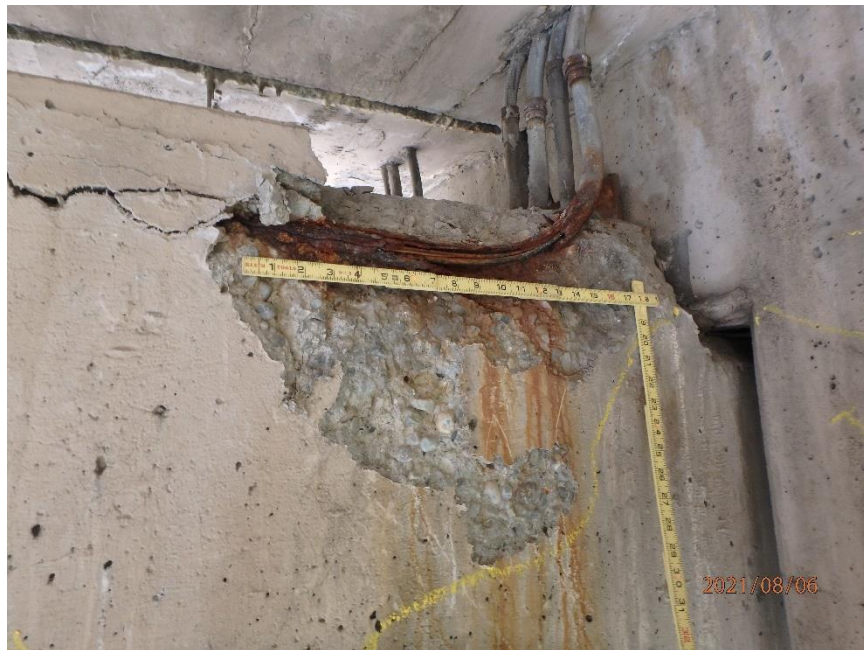
- The south face had spalls at each top corner measuring 9-in. high by 20-in. long by 5-in. deep on the west corner and 15-in. high by 24-in. long by 4-in. deep on the east corner. The spalls appear to be caused by heavily corroded steel conduit from the electric snow melt system with areas of 100% section loss exposing wires. (See Photos 55-57)

Photo 56: Spall in East Top Corner of Pier 1 Cap South Face, Looking North

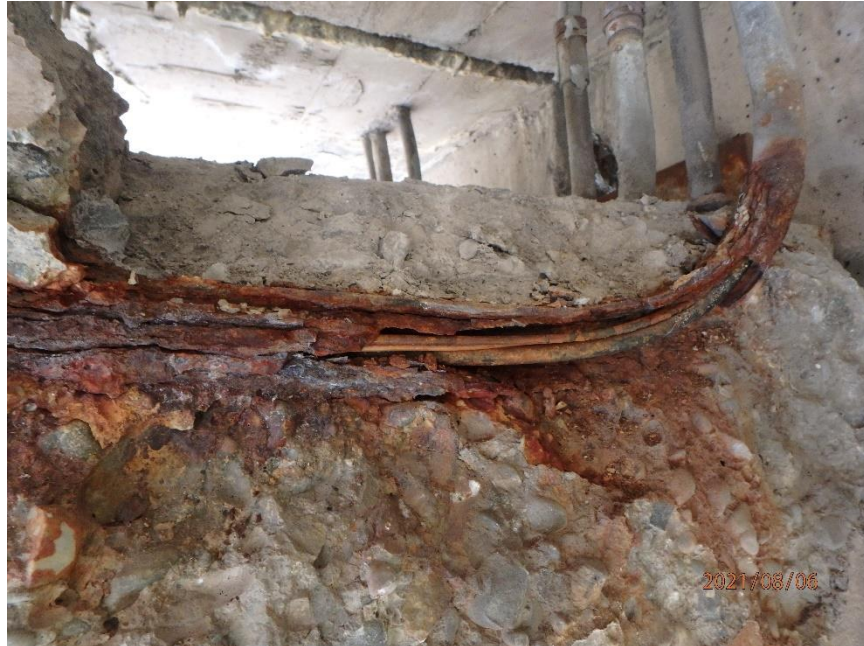
Photo 57: Exposed Wire and Corroded Steel Conduit at Pier 1 Cap, Looking North

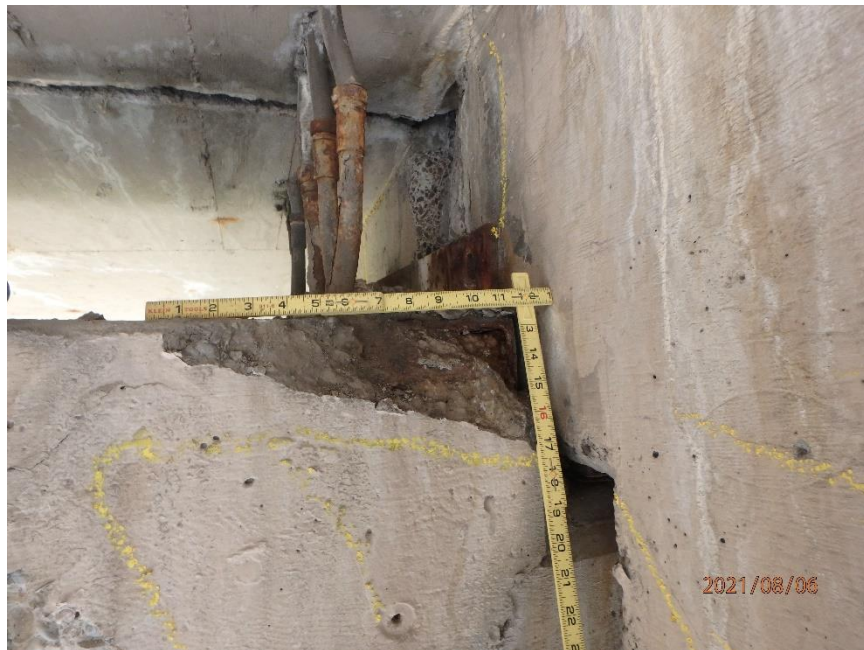
- The north face had a spall at the top west corner measuring 5-in. high by 12-in. long by 3-in. deep. (See Photo 58)
- Pier 2:
 - Pier
 - The top of the pier was delaminated on each face. Measurements of the crack height were taken at each corner: 60-in. at the southwest corner, 32-in. at the northwest corner, 16-in. at the northeast corner and 48-in. at the southeast corner. Cracks propagated down each corner for the length of the delamination up to 1/2-in. wide at the southwest corner. (See Photos 59 and 60)

Photo 58: Spall in West Top Corner of Pier 1 Cap North Face, Looking South

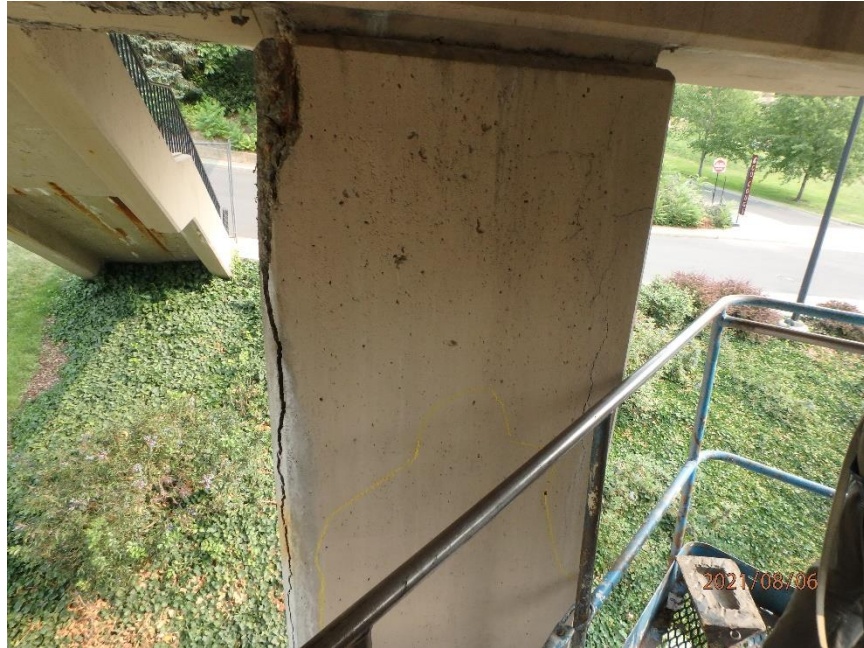
Photo 59: Delamination in Pier 2, Looking North

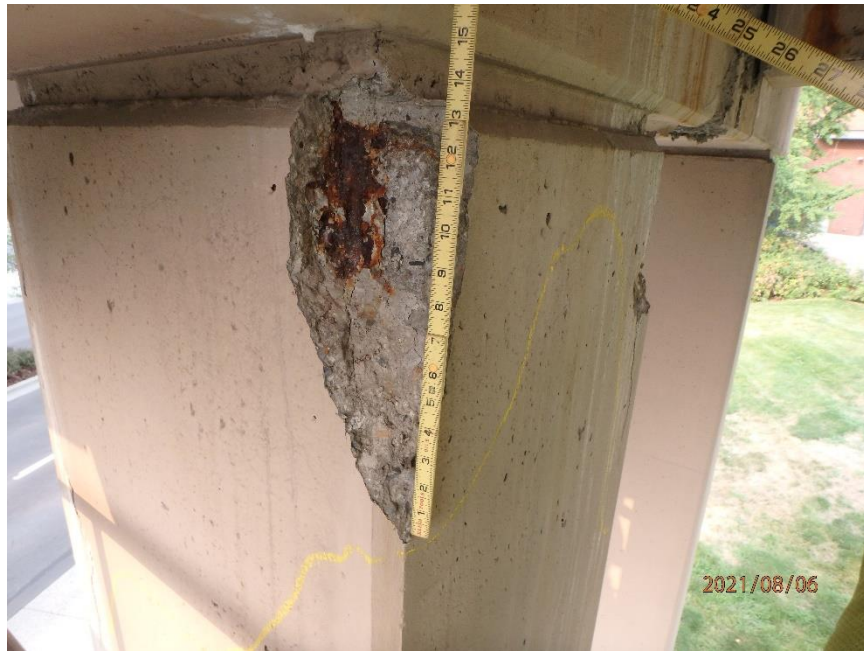
- The southwest, northwest, and northeast top corners all had spalls with exposed corroded steel measuring up to 15-in. high by 8-in. wide by 2.5-in. deep at the southwest, 13-in. high by 8-in. wide by 2.5-in.

Photo 61: Spall in Northeast Corner of Pier 2, Looking Southwest

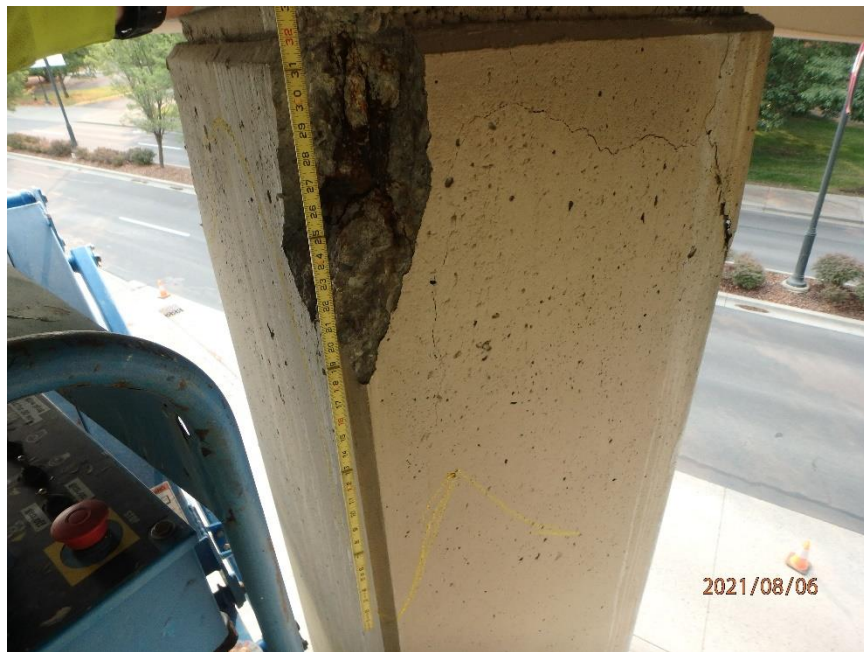
Photo 62: Spall in Northwest Corner of Pier 2, Looking Southeast

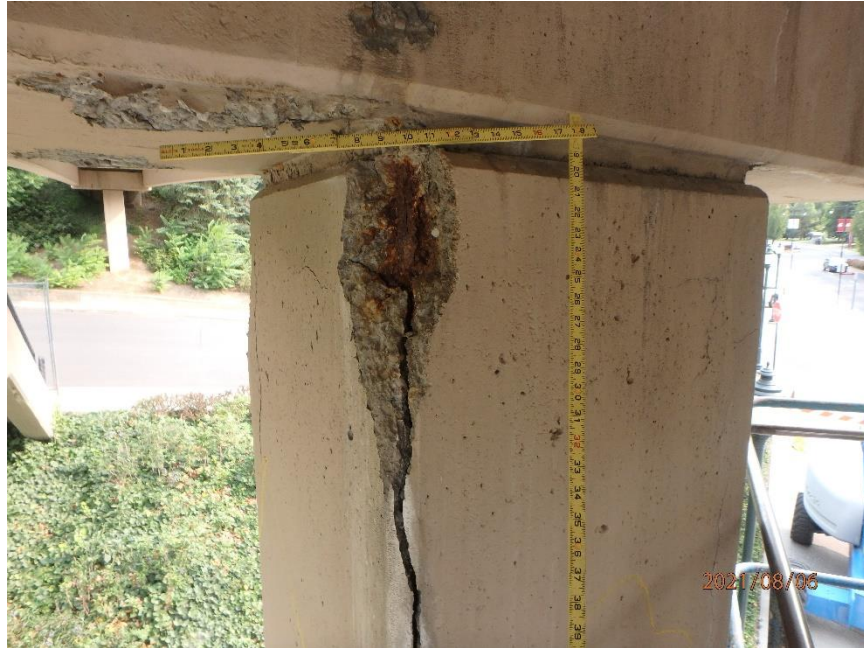
Photo 63: Spall in Southwest Corner of Pier 2, Looking Northeast

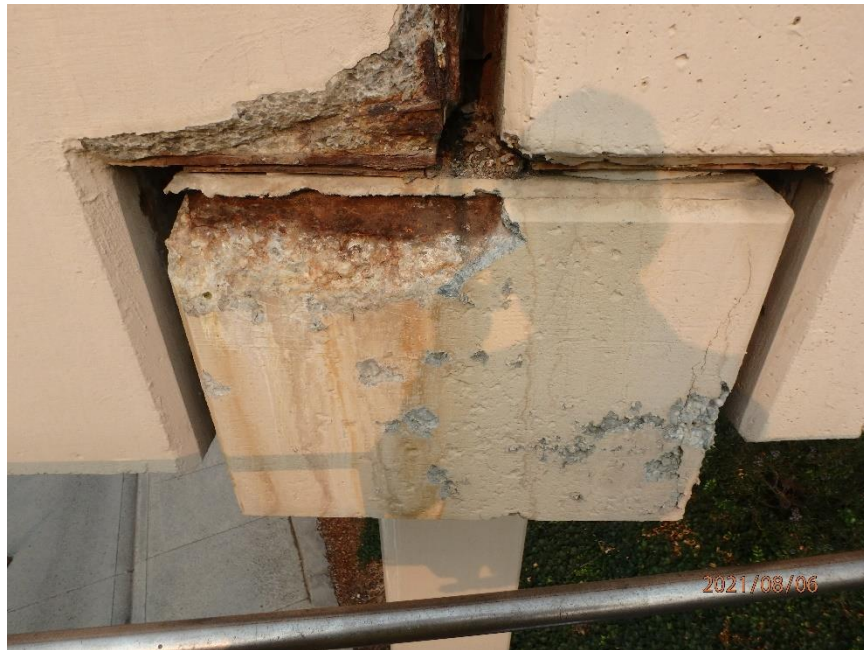
- Pier Cap
 - The east face of exhibits spalls and scaling throughout up to 1-in. deep with one large spall below the bearing measuring 7-in. high by 17-in. wide by 1.5-in. deep with the steel bearing pad exposed. (See Photo 64)

Photo 64: Spall and Scaling in East Face of the Pier 2 Cap, Looking West

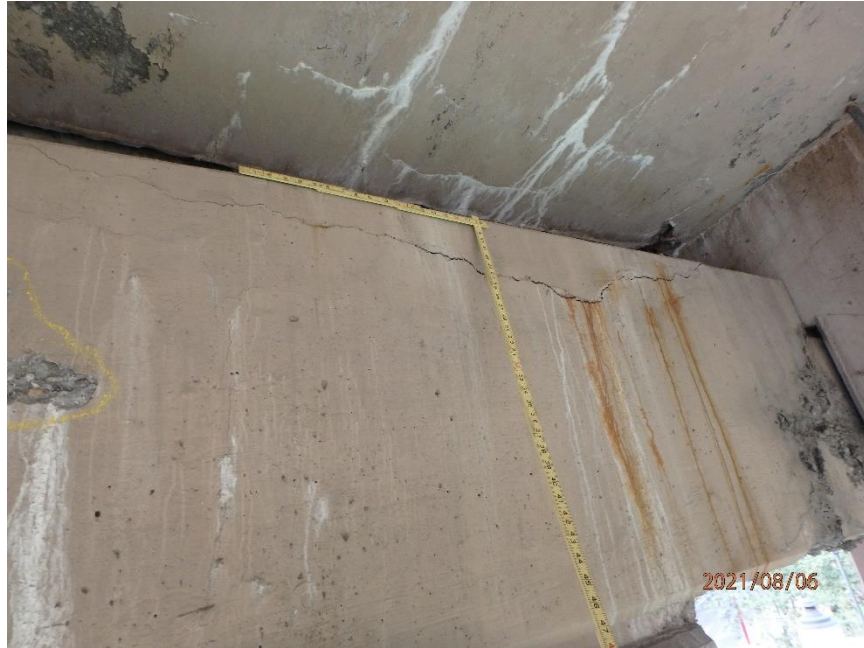
- The top half of the north face had an area of delamination with cracking up to 5 ft long by 8-in. high with rust staining. (See Photo 65)
 - The north, south and bottom faces had large areas of spall, delamination, and scaling throughout up to 1.5-in. deep with exposed bar. (See Photos 66-68)

Photo 65: Delamination of the North Face of Pier 2 Cap, Looking Southwest

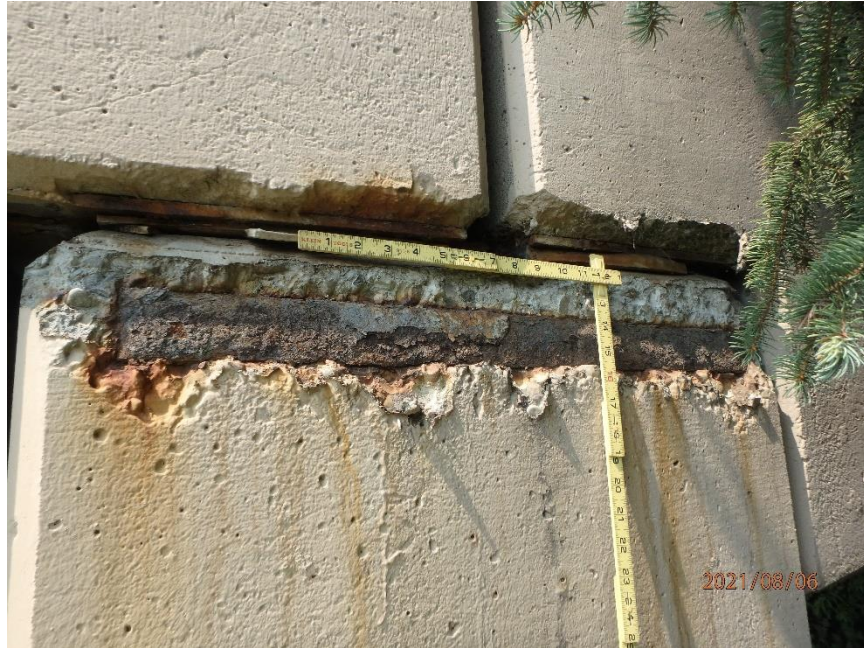
- The east face had a spall at the bearing plate measuring 6-in. high by full width of the cap by 1/2-in. deep with exposed steel bearing plate having moderate surface corrosion. (See Photo 71)

Photo 71: Spall in East Face of Pier 3 Cap, Looking West

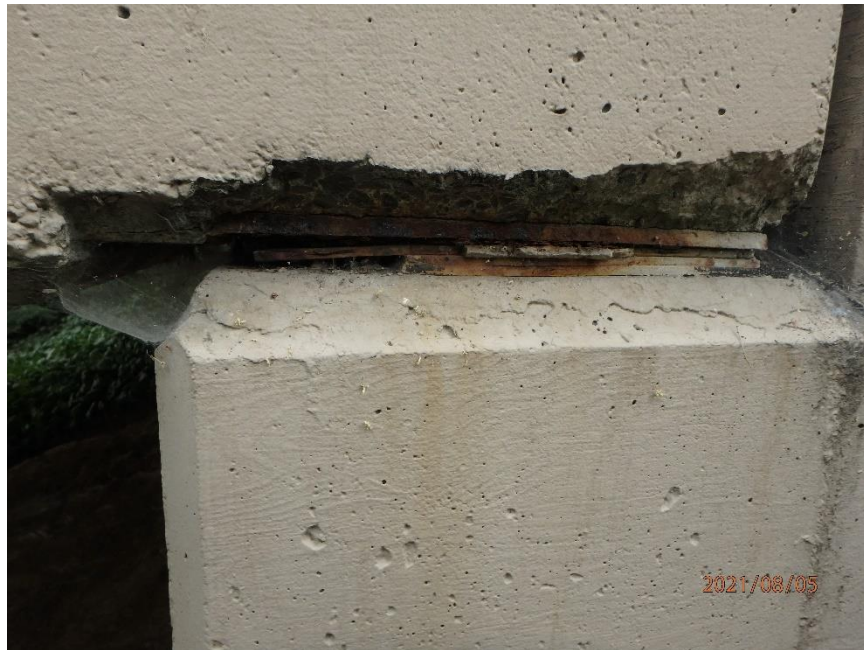
- All visible neoprene pads were cracked, bulging, and dried out. (See Photos 72-76)
- All steel plates had light to heavy surface corrosion with areas of 1/8-in. pack rust and 1/16-in. flaking mainly at Pier 1 and Pier 2. (See Photos 72-76)
- It is evident that the bearings are not fully working as intended due to the concrete spalls around the bearings shown in the Superstructure and Substructure sections.

Photo 72: Typical Bearing at North Abutment, Looking West

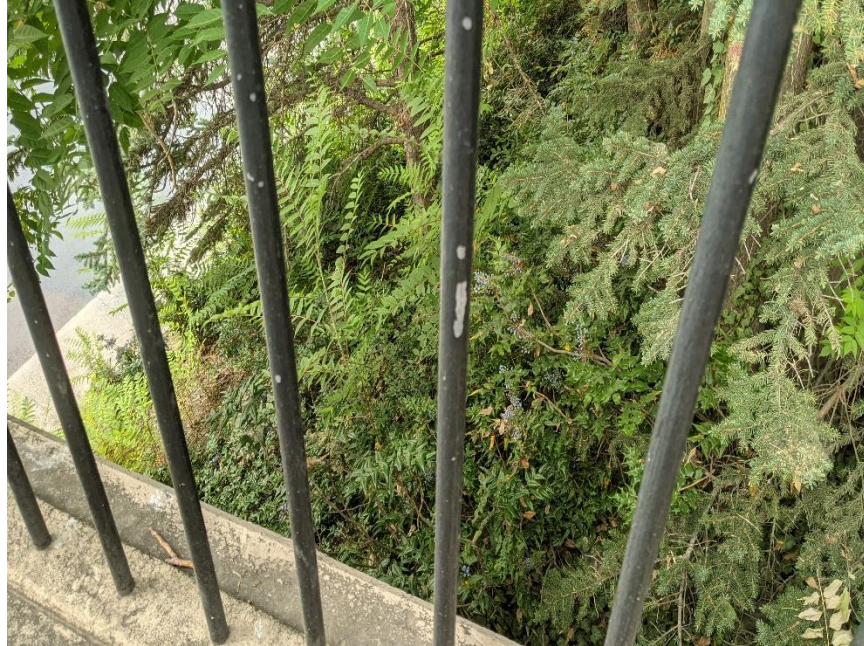
- Both bridge rails exhibit minor surface corrosion at the connection point to the tops of the curbs and minor areas of impact damage resulting in areas of chipped paint. (See Photos 77-79)
- The curbs exhibited random areas of spalling along the top interior edges throughout up to 1/2-in. deep and areas up to 4 ft long. (See Photos 80-82)

Photo 77: Typical Minor Impact Damage and Chipped Paint in Metal Rail

- If desired, replace the electric snow melt system for all areas above and below deck.
 - Clean and paint metal rails to prevent further corrosion.

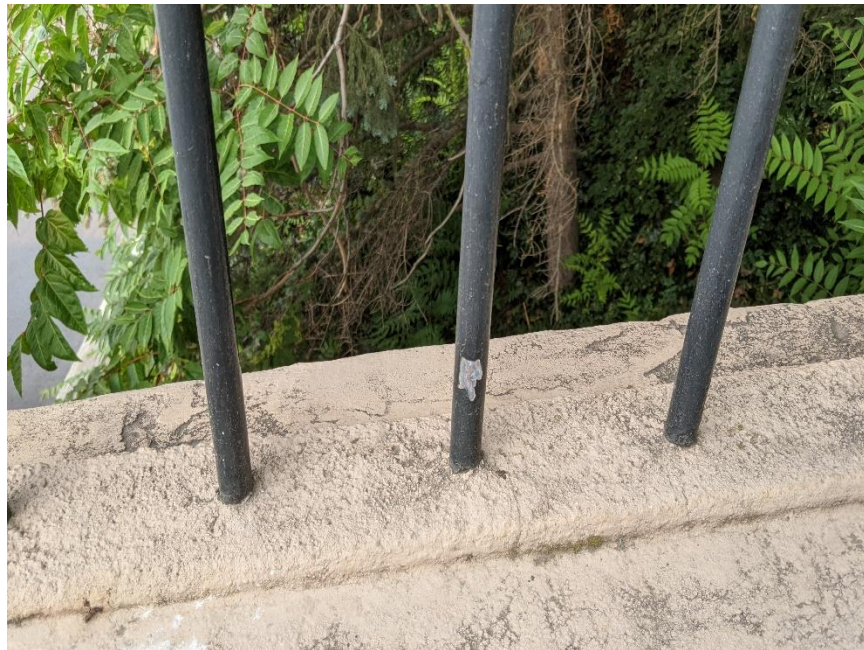
Photo 78: Typical Minor Impact Damage and Chipped Paint in Metal Rail

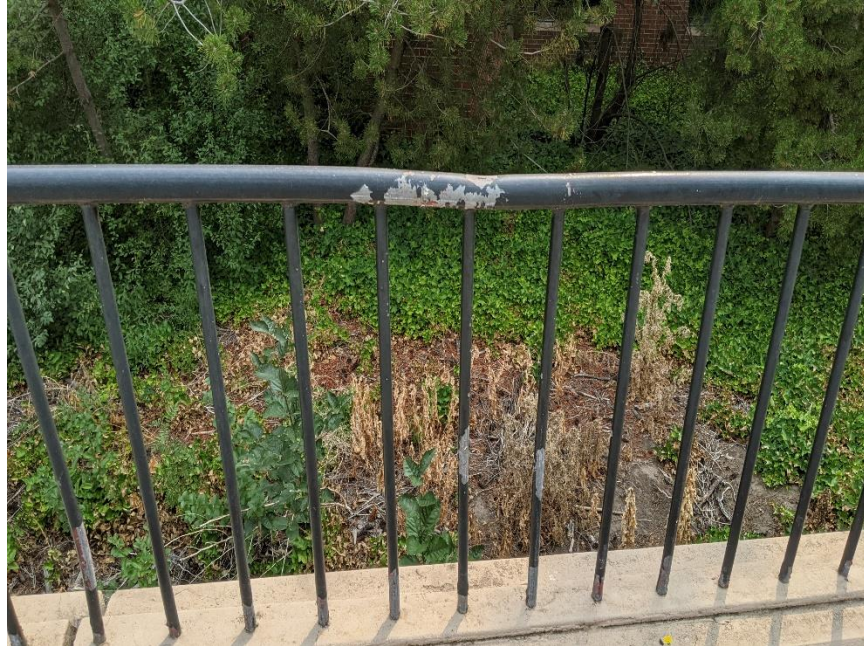
Photo 79: Typical Minor Impact Damage and Chipped Paint in Metal Rail with Typical Rust at Base.

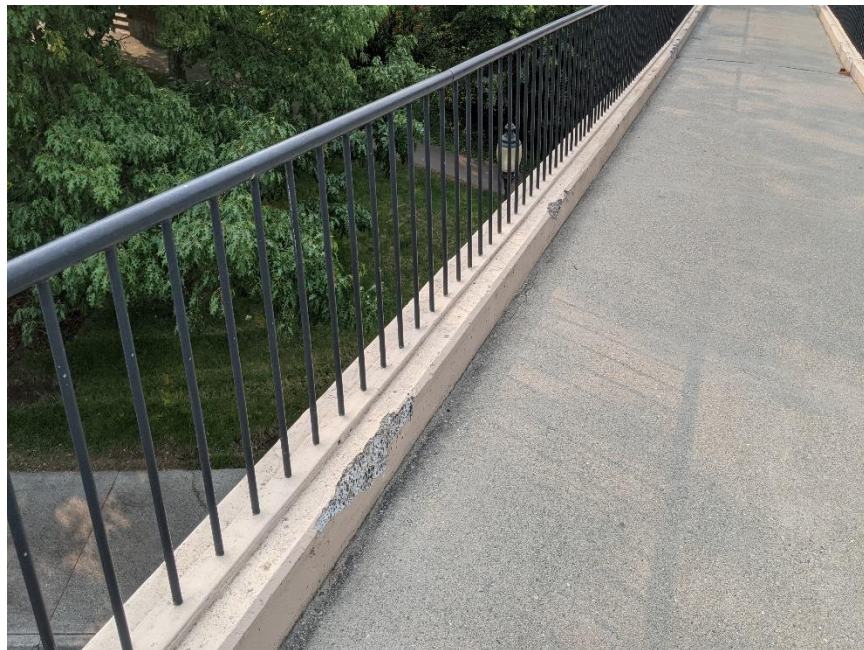
Photo 80: Typical Spalls in Concrete Curb

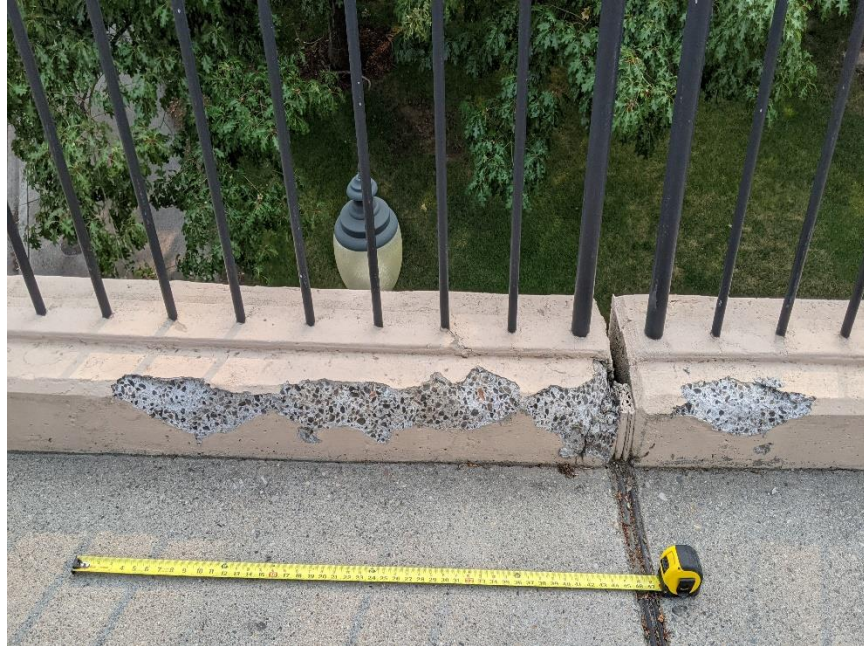
Photo 81: 4FT Long Spall in Span 3 East Curb at South End, Looking East

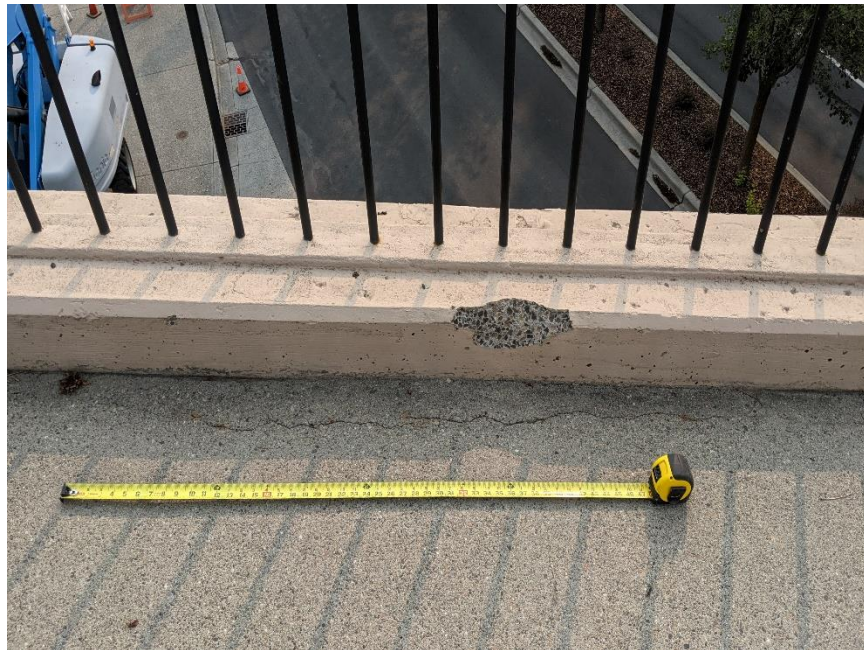
Photo 82: Typical Spalls in Concrete Curb

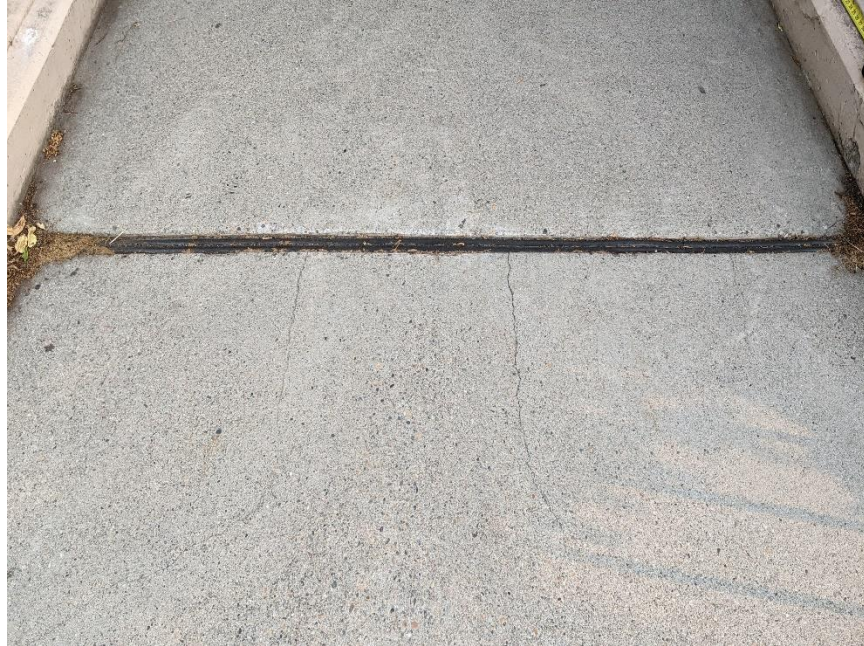
- The majority of the joint material had deteriorated and had lack of adhesion with the adjacent concrete surfaces. (See Photos 83 and 84)
- The joint exhibits minor amounts of debris impaction along the top edge. (See Photos 83 and 84)
- From the corrosion and deterioration of the elements below the joints, it is evident that the joints leak and are no longer sealed.

Photo 83: Typical Expansion Joint, Looking North

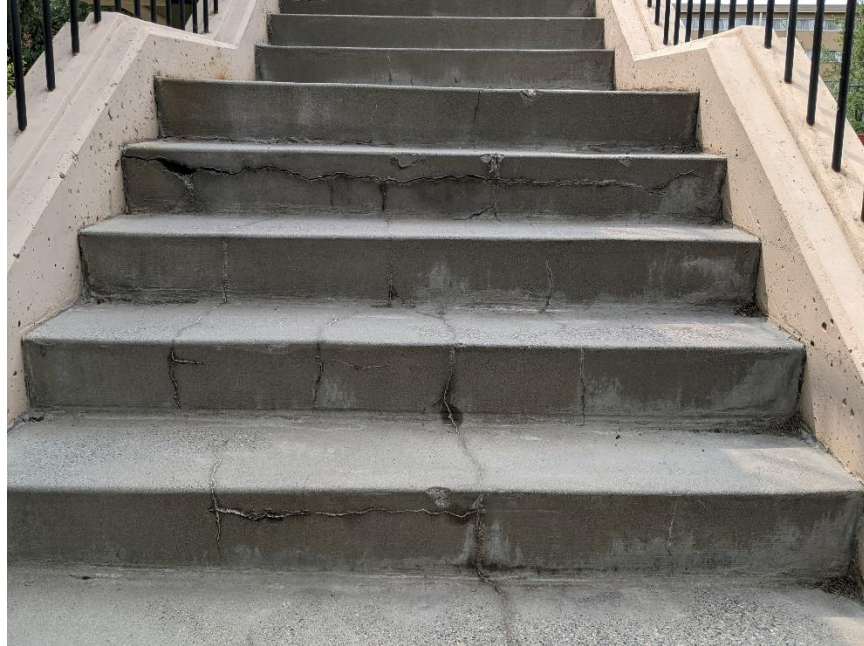
- The treads and risers exhibit longitudinal and transverse 1/16-in. cracks throughout that also propagate into both landings. (See Photos 85 and 86)
- The majority of the steps had transverse cracks on the riser face approximately 2-in. to 3-in. below the tread with heavy leakage accumulation. The heaviest areas were located on the bottom two stairs. (See Photos 87 and 88)
- The under deck had hairline to 1/16-in. cracks with moderate to heavy rust staining and efflorescence throughout. (See Photos 89 and 90)

Photo 85: Typical Cracking in Stair Treads and Risers, Looking South

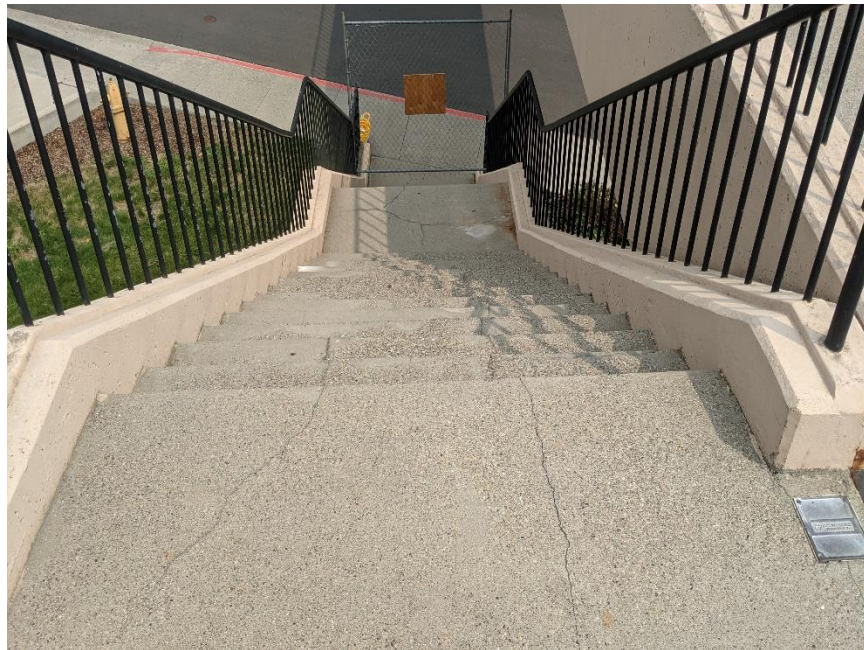
Photo 86: Typical Cracking in Stair Treads and Landings, Looking North

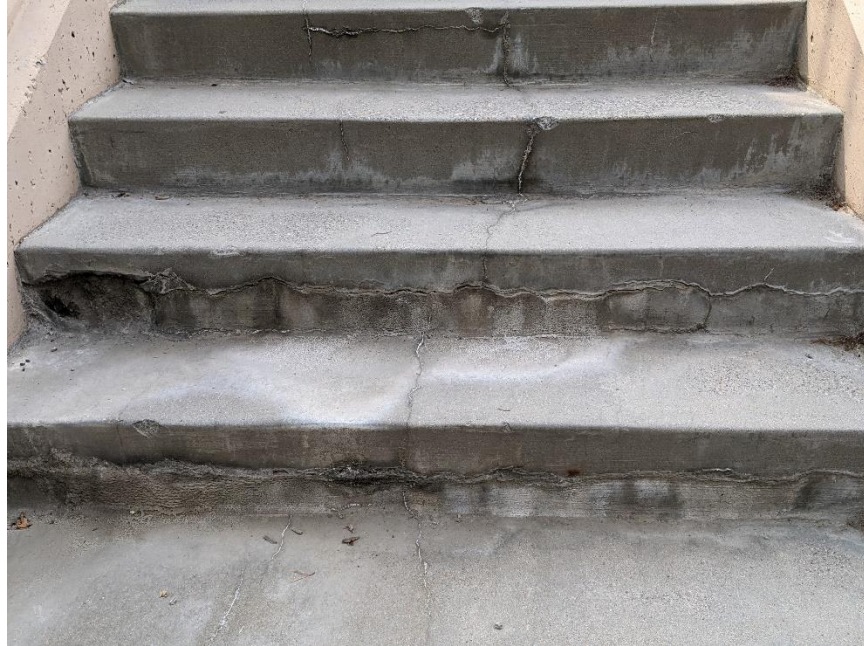
Photo 87: Typical Transverse Cracks and Accumulation in Risers, Looking South

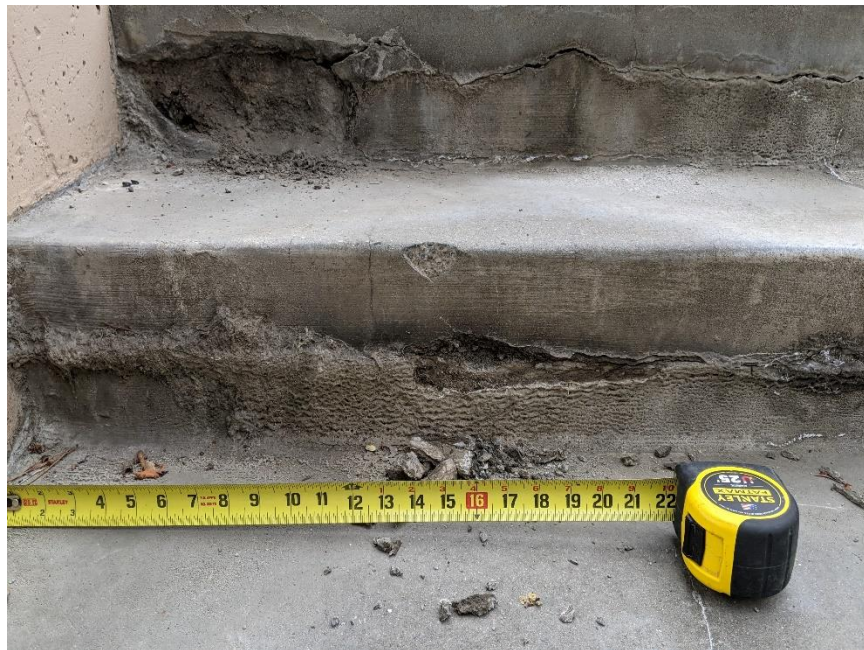
Photo 88: Cracks in Bottom Two Stairs, Looking South

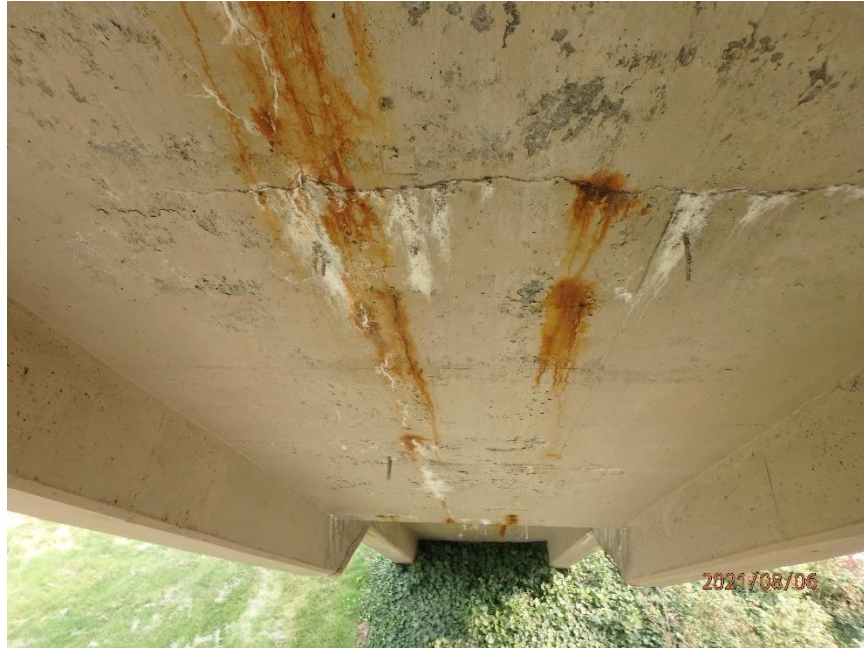
Photo 89: Typical Cracking and Staining in Underdeck, Looking North

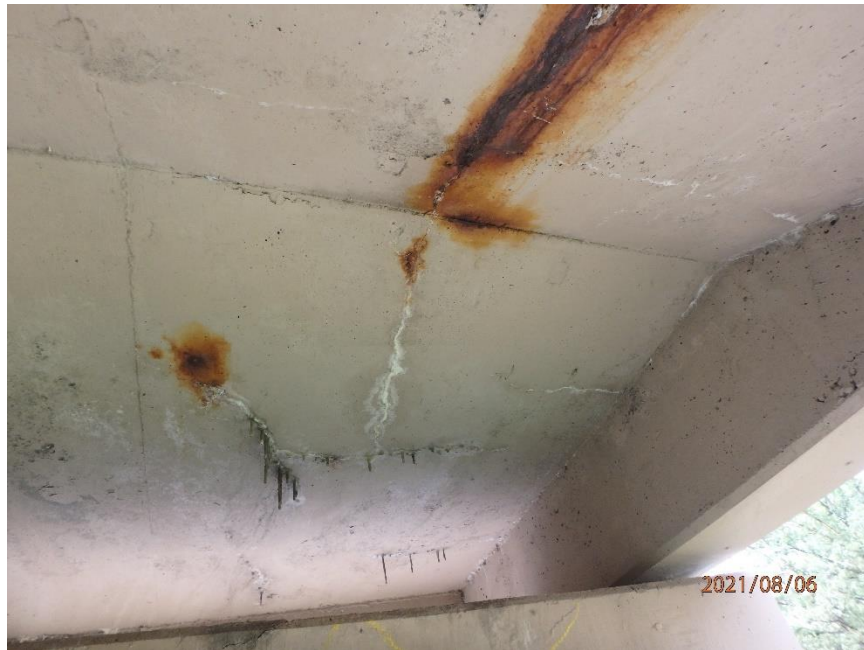
Photo 90: Typical Cracking and Rust Staining in Underdeck, Looking South

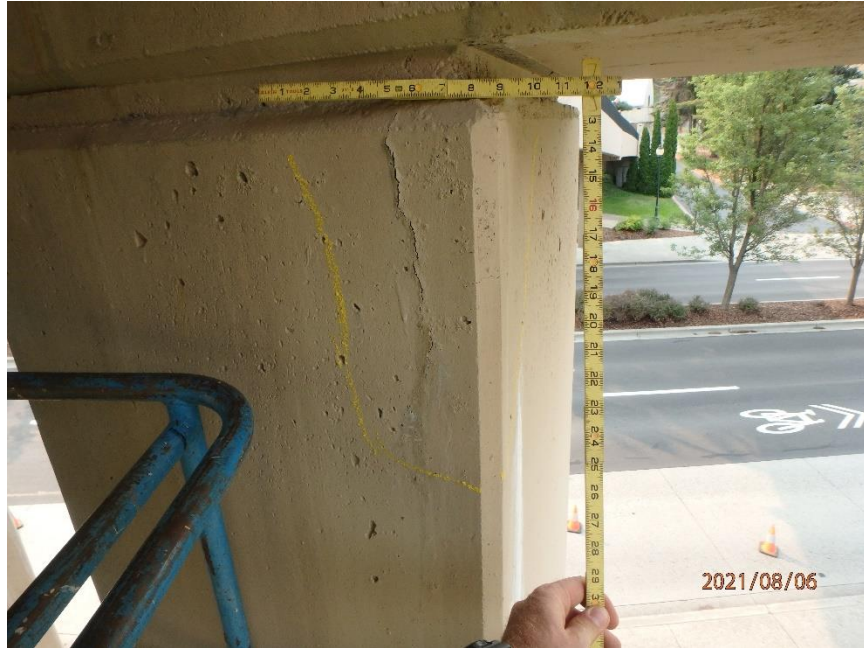
Photo 91: Delamination in Top Northwest Corner of Pier 2B, Looking South

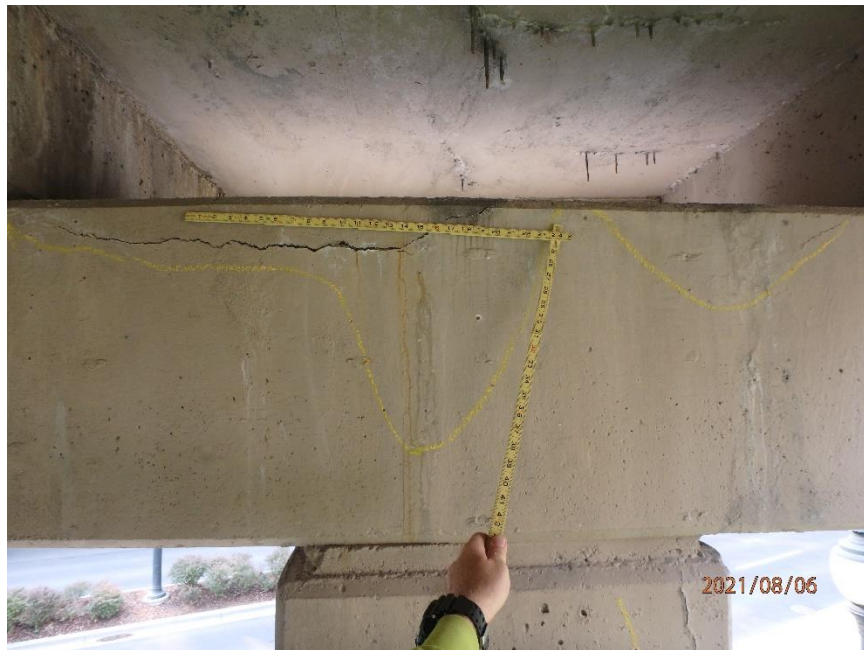
- Pier Cap
 - The top corners of both south and north faces were delaminated and cracking measuring 16-in. high by 4.5 ft long for the north face and 6-in. high by 4 ft long with up to 1/4-in.-wide cracking for the south face. (See Photos 92 and 93)

Photo 92: Delamination and Cracking of the North Face of Pier 2B Cap Top Corner, Looking South

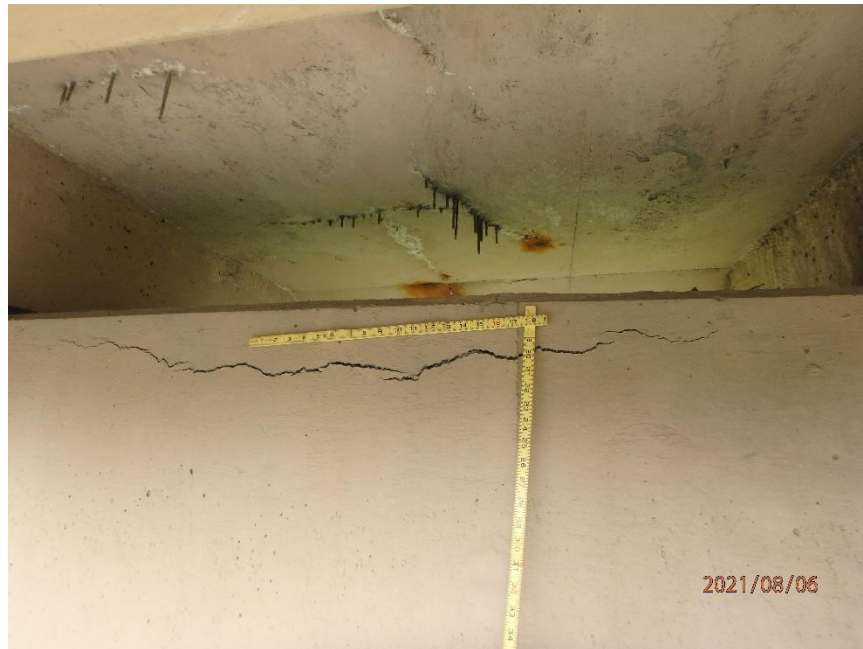
Photo 93: Delamination and Cracking of the South Face of Pier 2B Cap Top Corner, Looking North

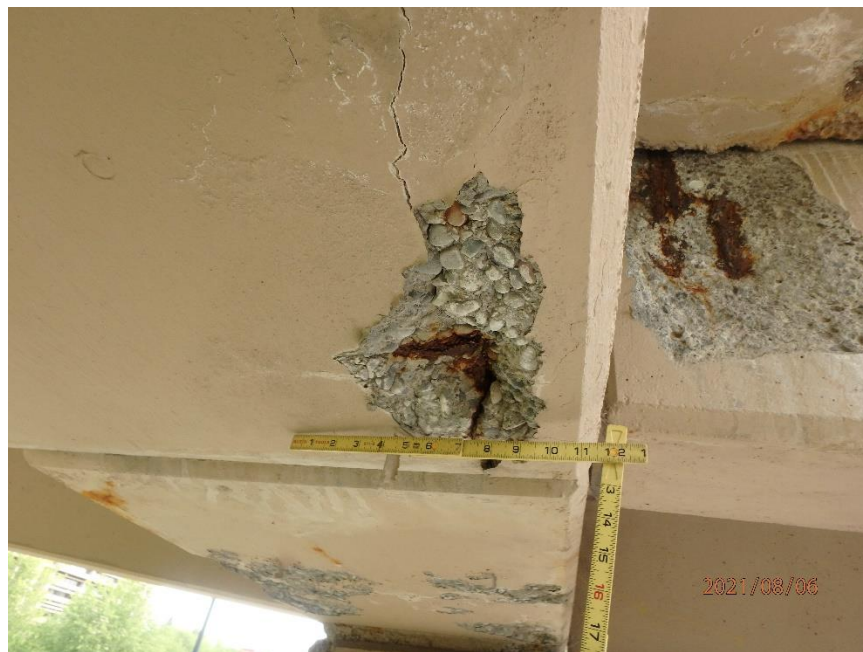
- The underside at the east end had a spall measuring 6-in. wide by 13-in. long by 2-in. deep with 2 exposed bars. (See Photo 93)
 - Small areas of spall up to 6-in. diameter with 1-in. penetration were observed in random locations.

Photo 93: Spall in Underside of Pier 2B Cap at East End, Looking East

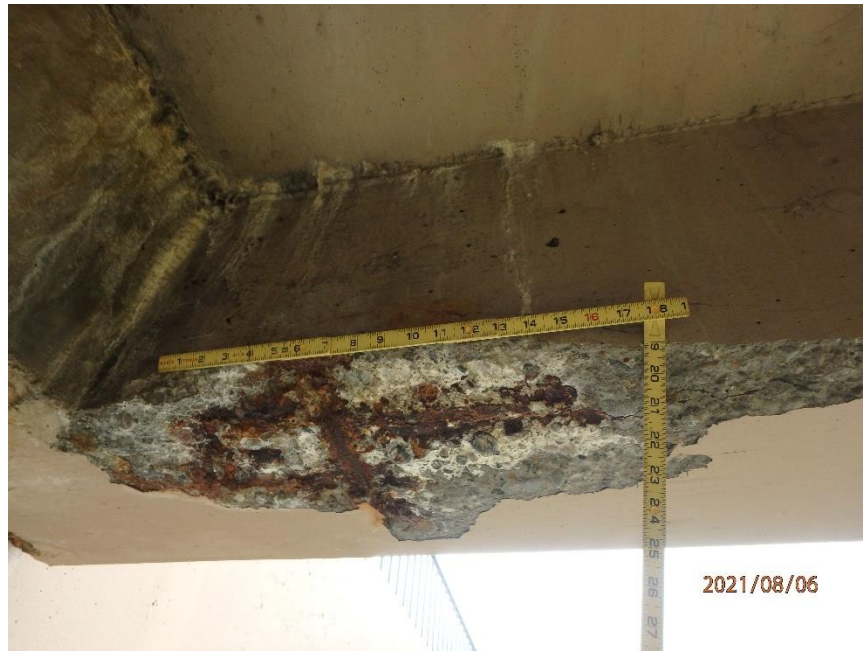
- The girders around the top landing exhibited two large spalls measuring 29-in. long by 11-in. wide by 1-in. deep with 4 exposed bars at the north bottom edge of the south girder and 12-in. long by 5-in. wide by 1.5-in. deep with 2 exposed bars at the southeast bottom corner of the south girder. (See Photos 95 and 96)

Photo 95: Spall in North Bottom Edge of South Stair Girder, Looking South

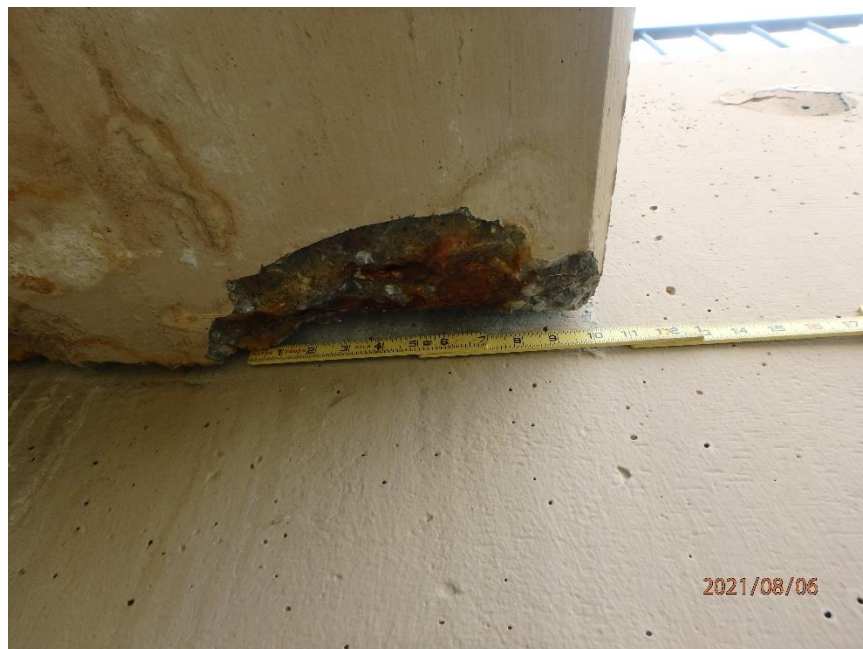
Photo 96: Spall in Southeast Bottom Corner of South Stair Girder, Looking East

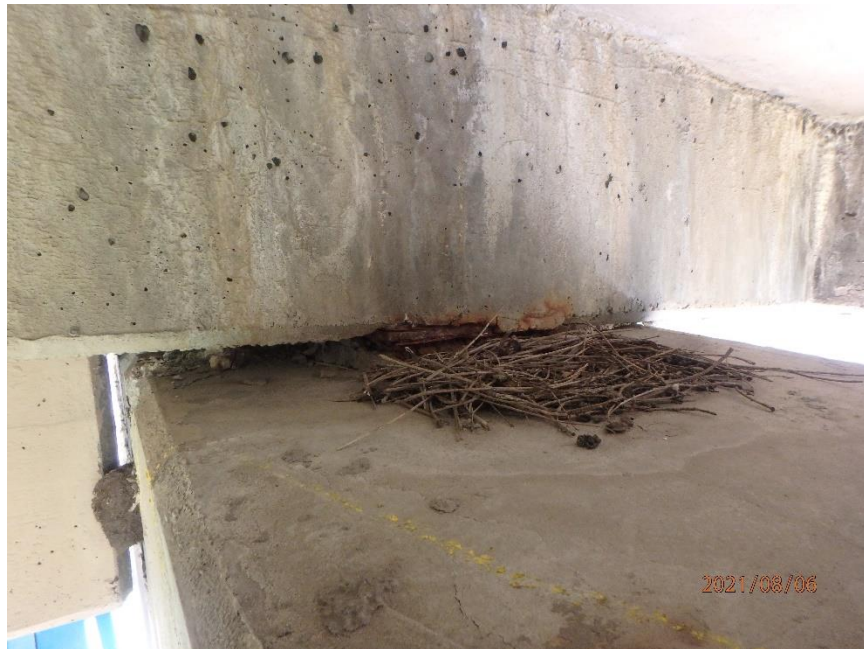
- The bearings between the girders and pier cap at the east and west sides had 1/8-in. to 1/4-in. pack rust in the steel plates. (See Photos 97 and 98)

Photo 97: East Bearing at Pier 2B Cap, Looking Southeast
