Garfield High School
Landscape Renovation Proposal
Autumn 2001

EHUF 480: Selection and Management of Landscape Plants
Mitchell Almaguer-Bay, Barbara Barnes, Jennifer Carlson, Jesse Craven, Cynthia Durfee,
April Mulcahy, Rachel Ramos, Zheng Yin [and Jean Gauthier]

Center for Urban Horticulture/Sustainable Community Landscapes
University of Washington

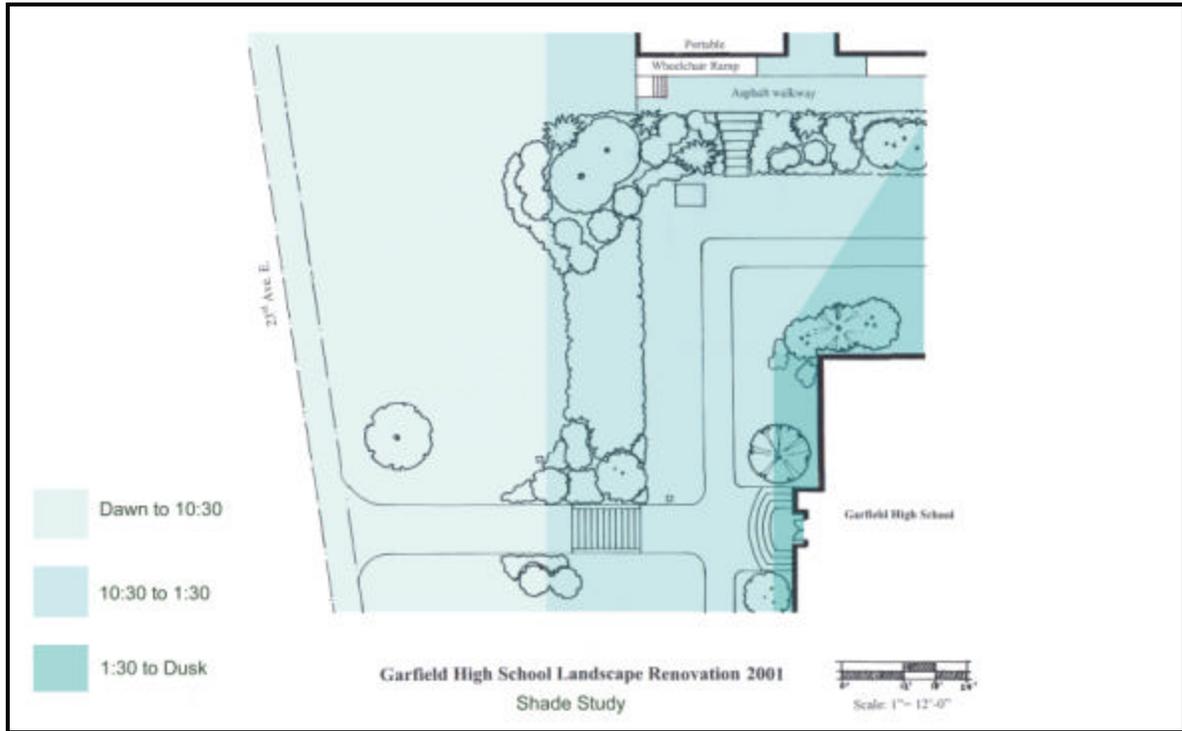
Figure 2. Shade Analysis.

Overview. A shade study (Figure 2) conducted in late fall, revealed that portions of the site were partially to fully shaded during the day. The western bed was in full sun conditions from eleven o'clock on. Shade cast from the building and the prunus trees caused the northern bed to remain mostly shaded. Summer will bring about more light for both beds, with the western bed receiving sun earlier in the day and for a longer duration.

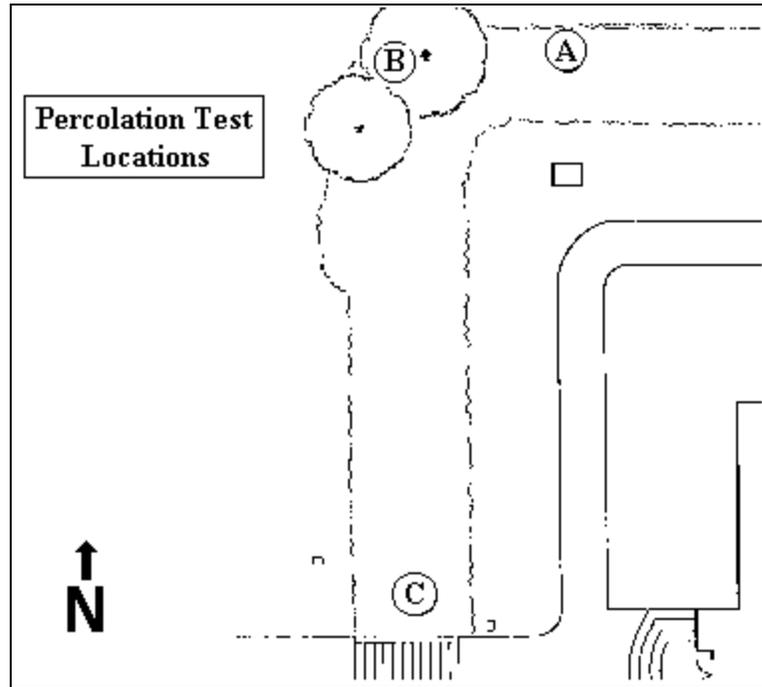
Figure 3: Percolation test locations

Percolation. Hydrology was further evaluated by measuring gross percolation in three locations (Figure 3). One test was conducted at the base of the slope at the design area’s northernmost end (A). A second test (B) was performed mid-slope, amid the ivy under the canopy of a large *Prunus* (cherry) tree, representing understory conditions. Finally, a third percolation test was conducted near the stairs at the south end of the bed (C).

These coarse results indicate excellent drainage with regard to avoidance of saturated or anaerobic conditions. However, they also suggest that this sloped site may dry out fairly rapidly, particularly during arid western Washington summers.

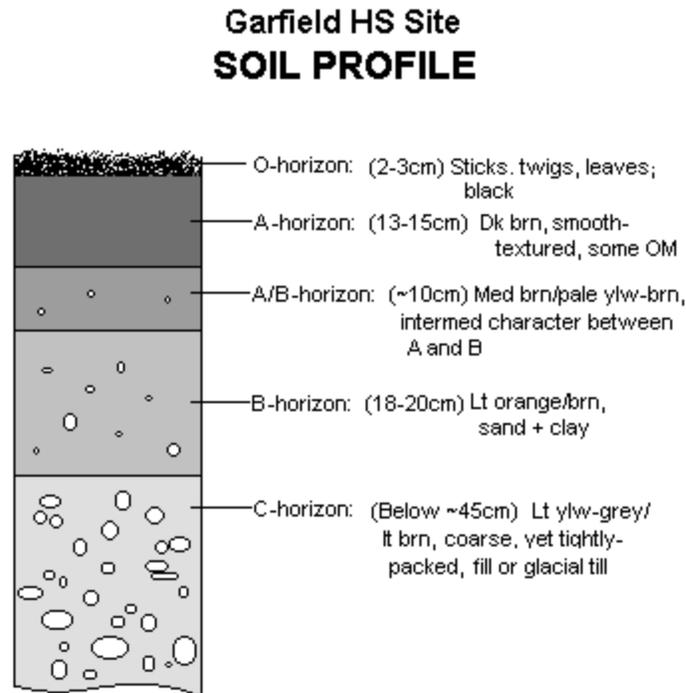
Figure 4: GHS Soil profile.

Soil Profile. A soil pit was dug on the north-facing slope to a depth of approximately 60 cm (Figure 4). The location was chosen based on two criteria: it is typical of conditions in the site with respect to vegetation (under dense ivy cover) and could be accessed without causing additional compaction to the planting bed.

The soil profile for the Garfield site included a surface layer of leaves, twigs and partially decomposed organic debris followed by relatively fertile topsoil with moderate organic matter content. Below the topsoil was an intermediate zone transitioning to subsoil with accumulated clay and little organic content. The final horizon was primarily fill or glacial till, packed tightly and without significant alteration from the parent minerals from which it was derived.

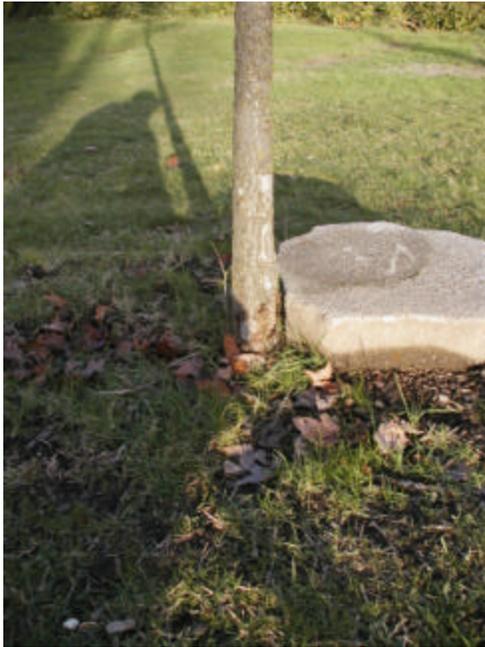
Figure 6: Damaged *Liquidambar styraciflua*

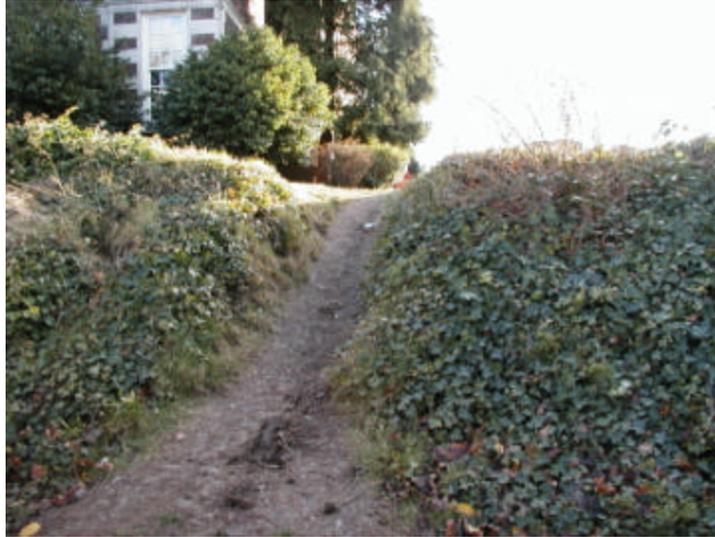
Figure 7. Existing Footpath.

During School Hours. During school hours most of the students are moving from the building, along the sidewalk, then using the footpath to access the portables. This traffic has compacted and eroded the slope, creating a hazardous and unsightly condition.

Our design also addresses other foot traffic issues on the site by recognizing a social path (Fig. 7) and installing steps to resolve the situation. The step framework will use 6" x 6" landscape timbers set into the slope, with compacted 5/8" crushed rock to create a tread surface. This portion of the design, if adopted, should be bid out to local construction contractors for installation.

Installation of the Steps. This portion of the design, if adopted, should be bid out to local construction contractors for installation. We envision steps constructed of railroad timbers backfilled by crushed gravel. Alternatively, poured concrete steps could be constructed.

A path leading from the existing sidewalk to the step should be installed at the same time to prevent further degradation of the area. Existing 3' x 3' concrete pavers, which have been overgrown by grass, are located at the bottom of the western bed. This material could be removed and reinstalled above. Another option may be to pour a concrete pathway.
