SHORE STEWARDS NEWS

July/August 2016

Island County, Washington

Issue No. 110

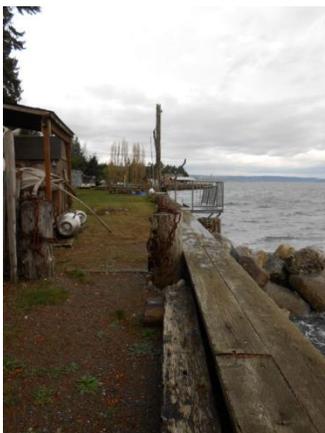
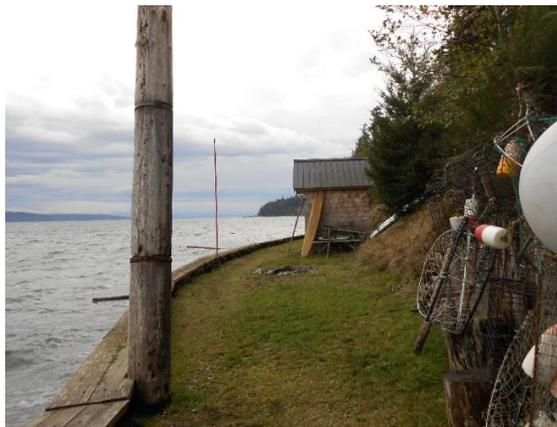
Camano Island Photos
by Scott Chase

The photos below illustrate a situation in which replacing a section of an existing bulkhead with a more natural shoreline was not recommended after a site visit by a well-known engineer who specializes in soft-shore alternatives. The continuous wood and rocky groin bulkhead, located in front of multiple properties and located just a few feet away from structures, sheds and access trails, was not a good candidate for replacement by more natural alternatives. Removing a short section of bulkhead in a location like this one would likely result in erosion for the property owner and neighboring properties. It is highly unlikely that a property owner today would be allowed to construct any structures so close to the shoreline, but until recently, this was common in many coastal communities.

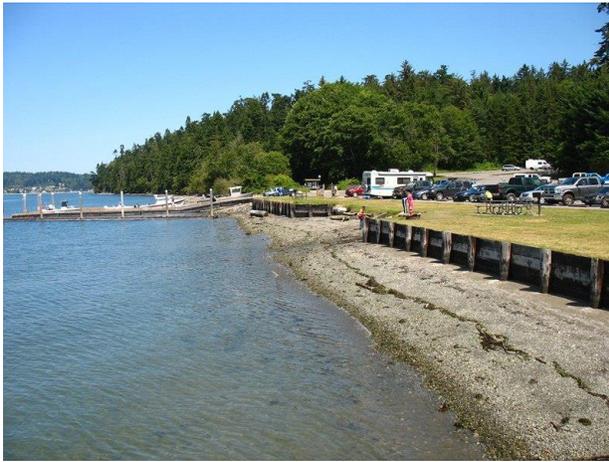
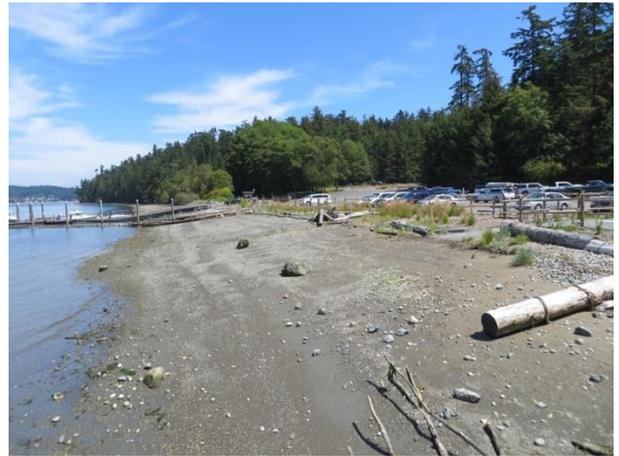
Photos above by Sarah Schmidt

Large drift logs and root wads (large woody debris) are readily available on the upper beach tidal zones of Puget Sound, and are being increasingly used in alternative or “natural” shoreline protection projects. As part of a professionally engineered project, the logs are often anchored perpendicular or at an angle to the shoreline, with different results. They can be used to disperse wave energy, or to corral additional wood debris, sand or beach sediment. Logs that are lower on the beach and subject to wave energy may be partially buried, whereas logs higher on the beach may be more loosely placed and used to protect vegetation, which in turn protects against erosion. When possible, logs should be large, with root wads and branches left intact, and include naturally rot-resistant varieties such as Western red cedar and Douglas fir. This method of shoreline protection is often used in conjunction with revegetation and beach nourishment. The photos below show how creosote bulkheads at Cornet Bay on Whidbey Island were replaced by a more natural, sloping beach, with anchored logs placed both parallel to the shoreline on the upper beach area, and also perpendicular to function like a groin. Native vegetation has replaced the grass on the upper beach to protect against erosion.

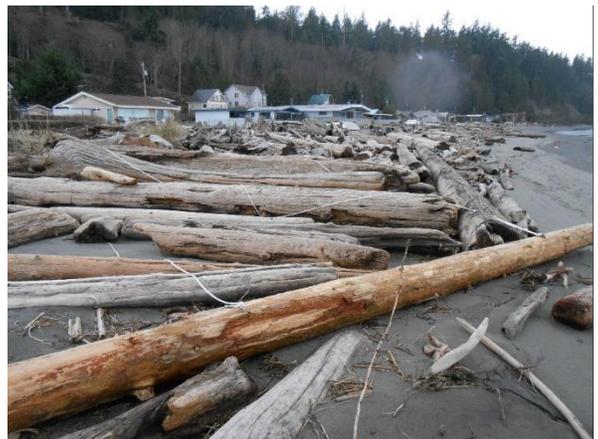
Photo by Scott Chase

Large wood placement should always be designed and implemented by a professional who has experience with this method, and has knowledge of coastal processes. Some property owners may attempt to create their own large wood placement, with mixed results. At right is an example of a property owner who used cables and ropes to tie dozens of logs together, adding new ones as they washed up. This has resulted in upper beach erosion.

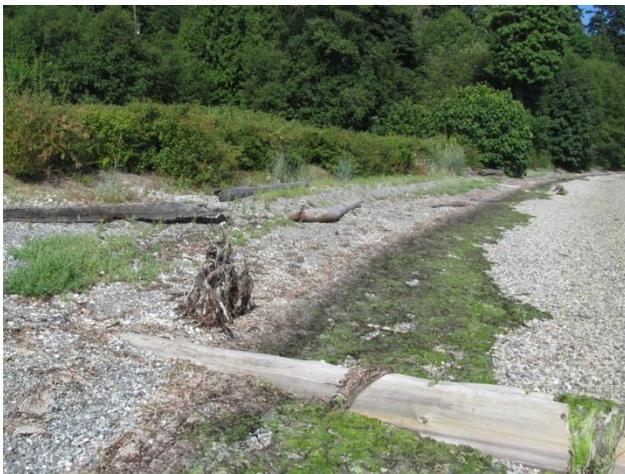
The photo at left, courtesy of Hugh Shipman, Washington State Dept. of Ecology, shows a nourishment project from the north side of Weaverling Spit on southern Fidalgo Bay. This was undertaken several years ago.

For many low-to-medium wave energy sites around Puget Sound, beach nourishment is often used to slow erosion and restore beach conditions to more closely resemble their past appearance. Used primarily with small scale projects, nearby upland coarse sediments are placed in backshore and upper beach areas to create protective berms. The use of rounded gravel and sand to create a gradual beach grade differs from larger beach-fill situations that increase the height and width of beaches. It is best to match sediment size as closely as possible to the natural sediment found on the beach. The objective is to slow beach erosion by allowing the beach to replicate a natural one. Erosion continues to take place, so periodic material additions may be needed. This method works best in locations where the waves break parallel to the beach, rather than breaking at an angle, which typically causes more erosion and sediment movement. Beach nourishment is often used along with large wood placement.

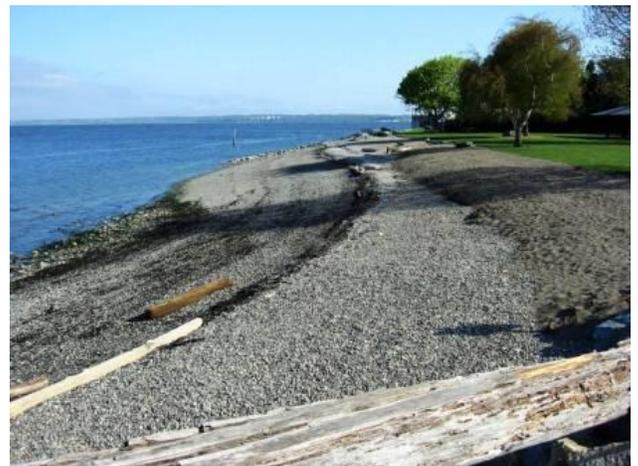
The 2005 Marine Park Beach restoration project in Bellingham included the replacement of 5,600 tons of concrete rubble and rock on the shoreline with a gently sloping 300 foot wide sand and cobble beach. Photo at right courtesy of Hugh Shipman.

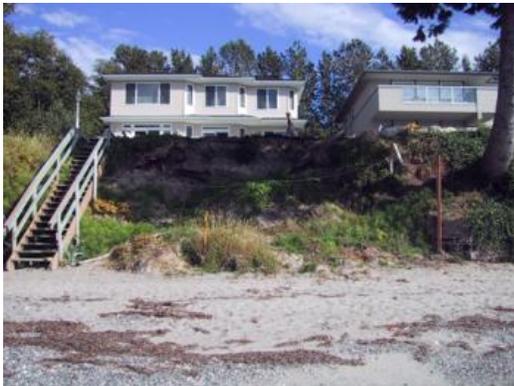
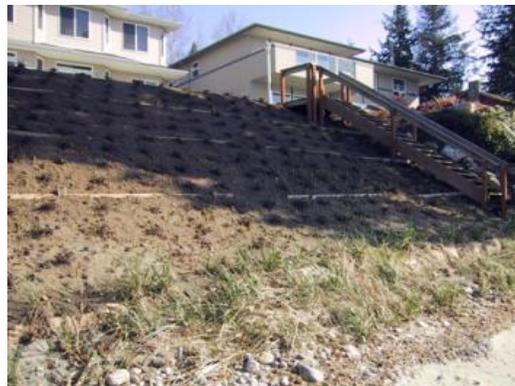
*Photos
courtesy
Washington
Dept. of Fish
and Wildlife*

The two photos above illustrate reslope and revegetation undertaken at a medium-high bank site in Puget Sound. A bluff slump had left the upper bluff area overly steep and unstable, with the sediment accumulating at the toe. The slope was regraded, then planted with appropriate native species.

Bluff resloping or recontouring and revegetation refers to the reduction or lowering of the slope's grade to increase stability, accompanied by the planting of vegetation, preferably native species best suited for marine environments. Generally, the upper portion of a steep slope is graded so that the crest of the slope is laid back. Vegetation is then planted to intercept precipitation and thereby reduce surface erosion and surface water runoff. The root network will increase soil cohesion and reduce the erosion of the surface soils on the bluff. The roots will also help aerate the soil, as well as wicking the water from the soil and evaporating it into the air through the leaves of the vegetation, a process known as evapotranspiration. This helps reduce the quantity and weight of the water on the bluff, lessening the chance of slides.
