**National Center for Transportation
Infrastructure Durability & Life-Extension**

Project ID: 2021-SDSU-02

Repairable Precast Bridge Bents for Seismic Events

Final Report

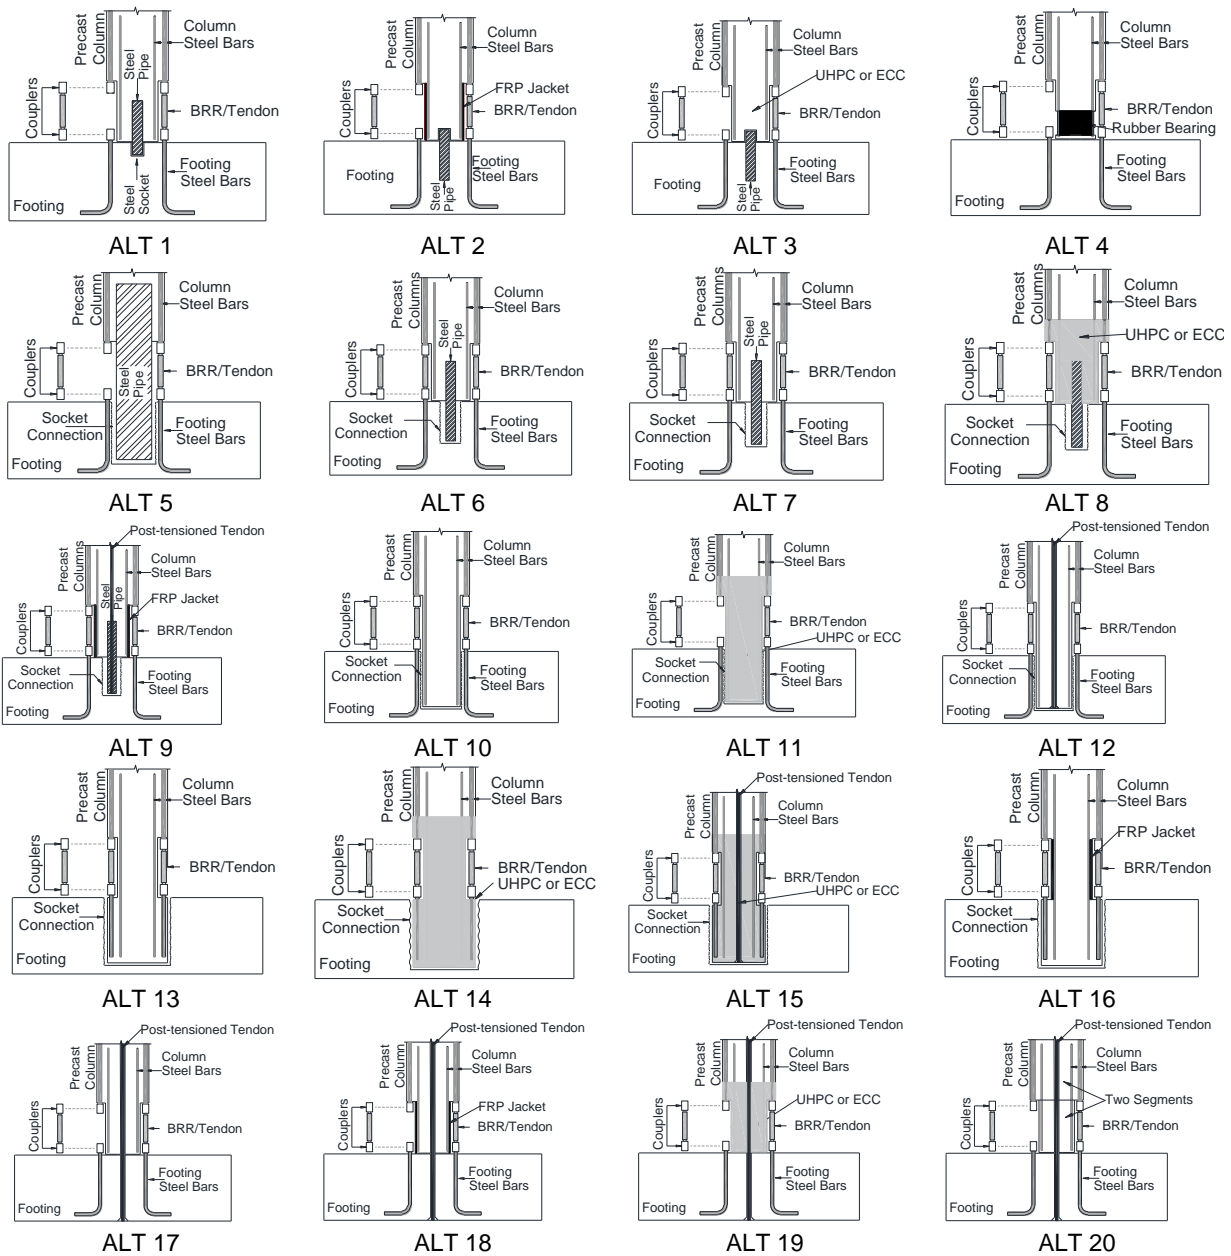
Figure ES.1. Twenty Detailing Alternatives for Repairable Precast Bridge Columns

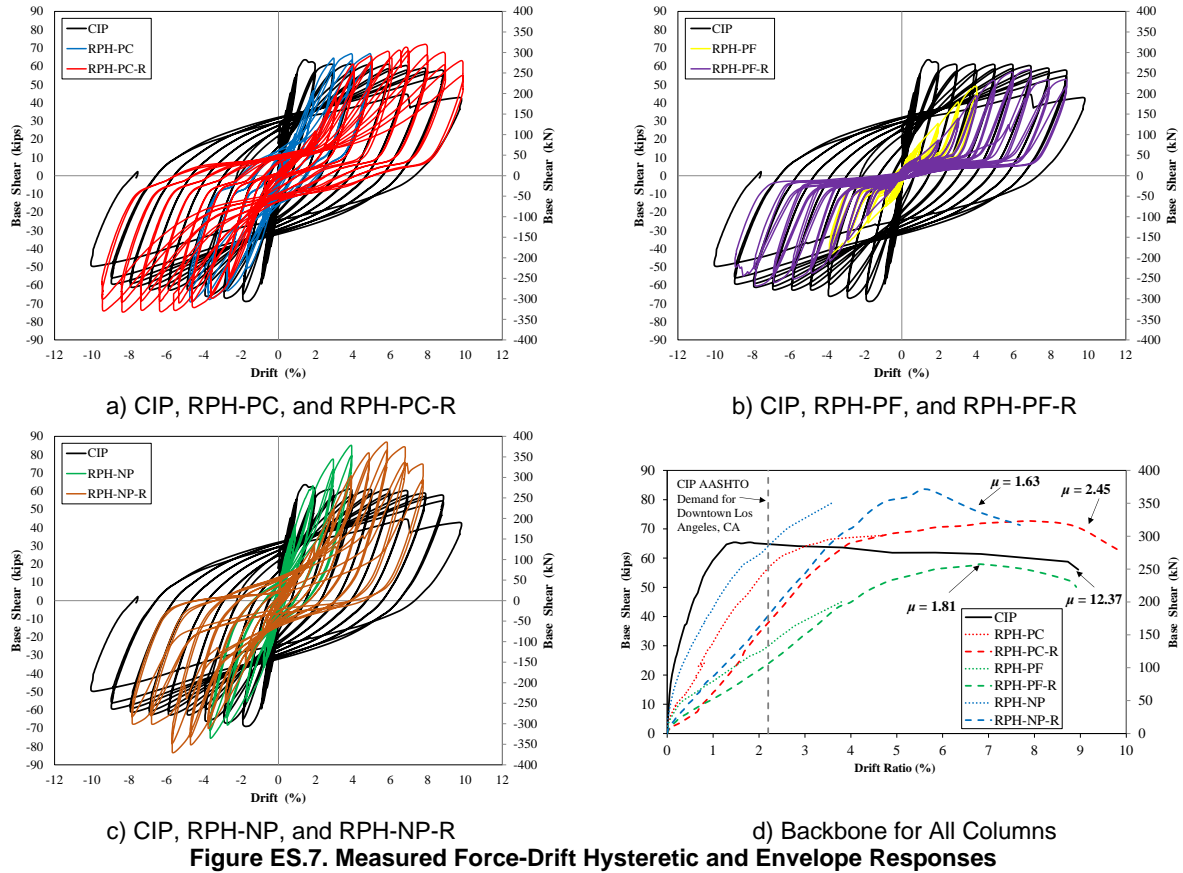
Figure ES.7. Measured Force-Drift Hysteretic and Envelope Responses

Overall, all precast columns were repairable, especially those with tendon fuses, and were retested after being pushed well past the displacement demand of the CIP column with minimal damage.

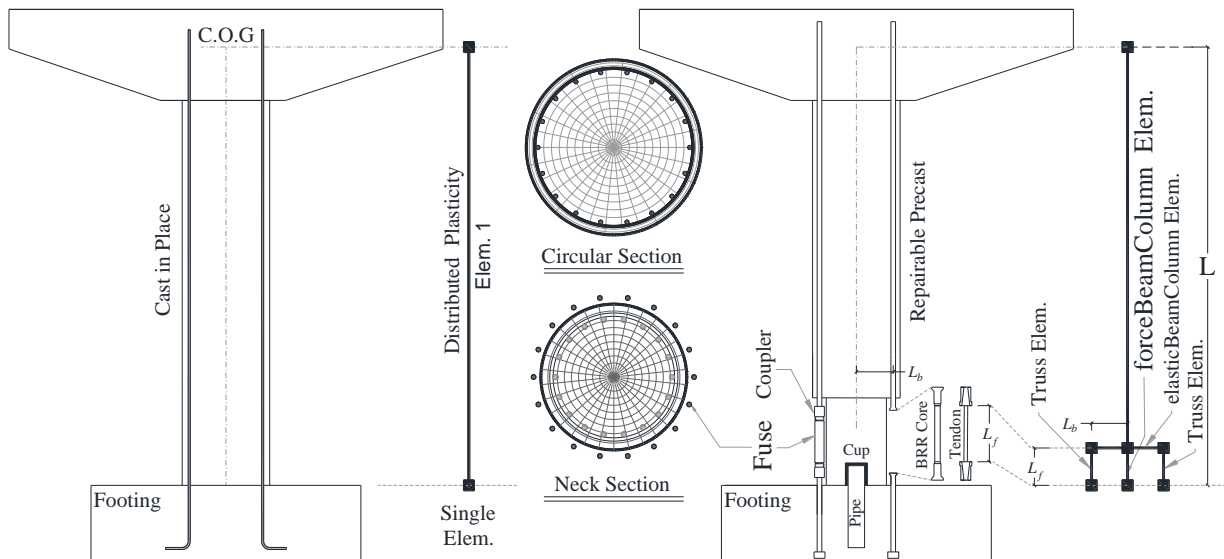
Figure ES.9. Cast-in-Place and Repairable Bridge Column Models

A general modeling methodology was developed for the repairable columns and was slightly modified per column specimen to accommodate different column details. A three-dimensional finite element model utilizing six degrees of freedom (DOFs) and a fiber-section was used to analyze the CIP, RPH-PC, RPH-PF, and RPH-NP columns. **Figure ES. 9** shows the CIP model and the general model developed for the repairable columns.

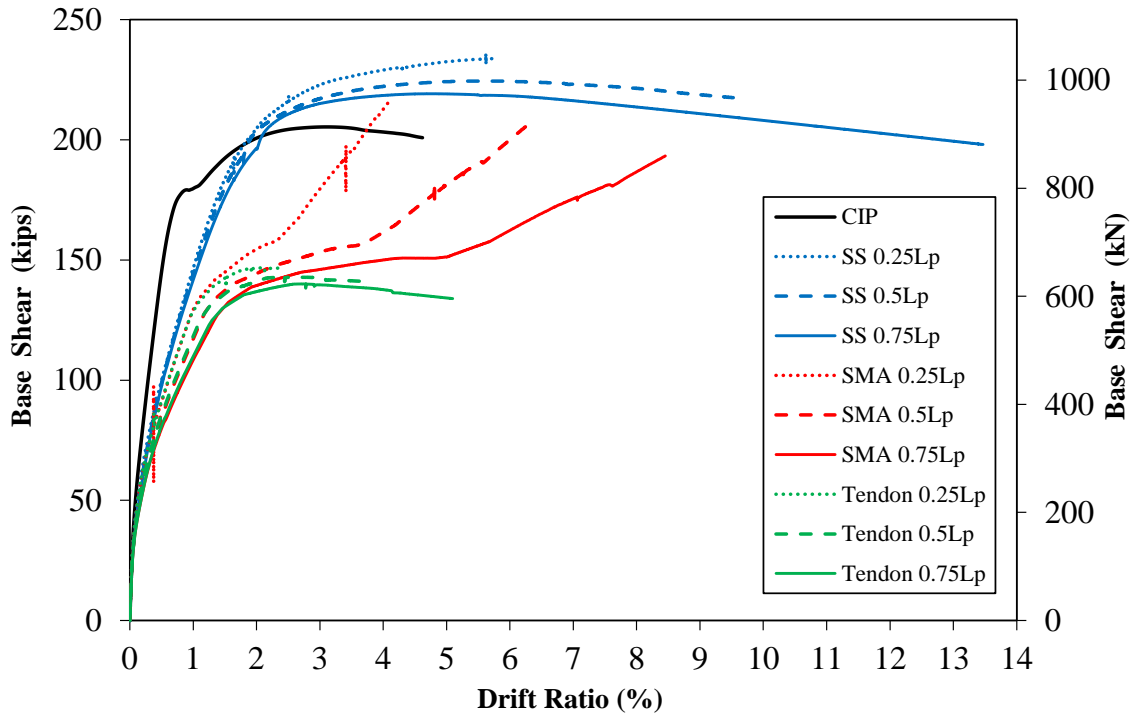
Figure ES.11. Pushover Analysis for RPH-AR4-ALI5

Figure ES.11 shows sample pushover results for CIP and repairable columns utilizing different fuse materials and lengths. Overall, the parametric study indicated that all three material types (SS, SMA, tendon) can be used as external fuses. The designer has the option to match the force and/or displacement capacity of RPH with its corresponding CIP column. The forces can be adjusted by the number or diameter of the fuses. Further, the displacement capacity can be adjusted by changing the fuse length. For example, a designer can increase the number of the 0.7-in. ($\varnothing 18$ -mm) diameter steel tendons with a fuse length of $0.75L_p$ to match the CIP force and displacement capacities.

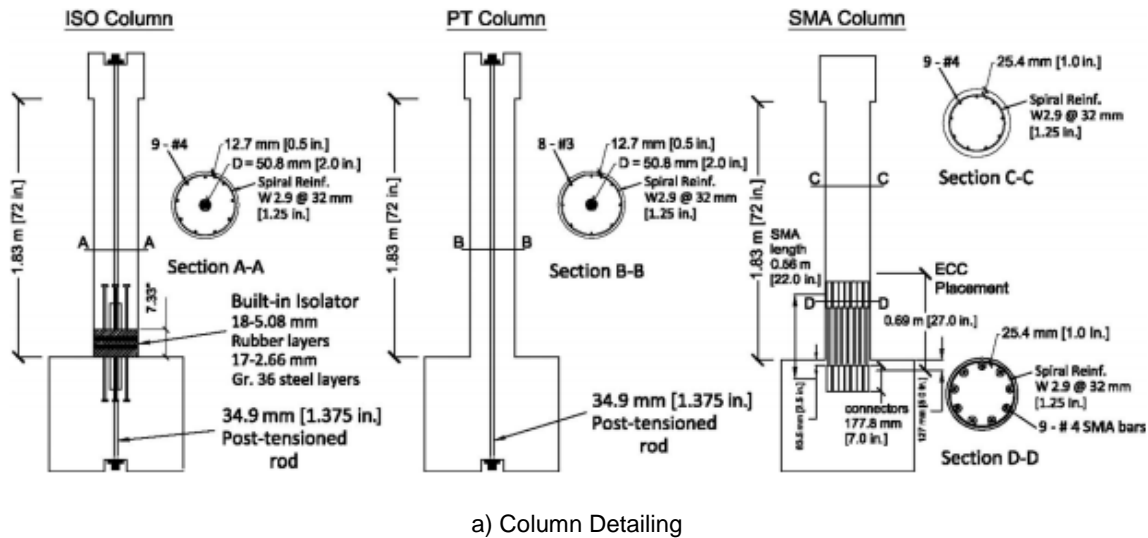
Figure 2.1. Column Detailing and Damage (Noguez and Saiidi, 2012)

Cruz Noguez and Saiidi (2012) tested a 25%-scale, four span bridge constructed with advanced materials under shake table. A two-column bent was built with nickel-titanium (NiTi) SMA as longitudinal bars and ECC in the plastic hinge region (**Fig. 2.1a**). The second two-column bent was constructed with conventional concrete and a rocking mechanism. The third bent incorporated an elastomeric pad in the plastic hinge. In these columns the longitudinal bars were extended through the rubber pad, which was shimmed to prevent buckling. A steel pipe was included in the pad to take shear forces. Concrete blocks and lead pallets totaling 180 kips were placed on the post-tensioned bridge deck to provide an axial load and the bridge was subjected to increasing amplitudes of the 1994 Northridge earthquake record in the longitudinal direction.

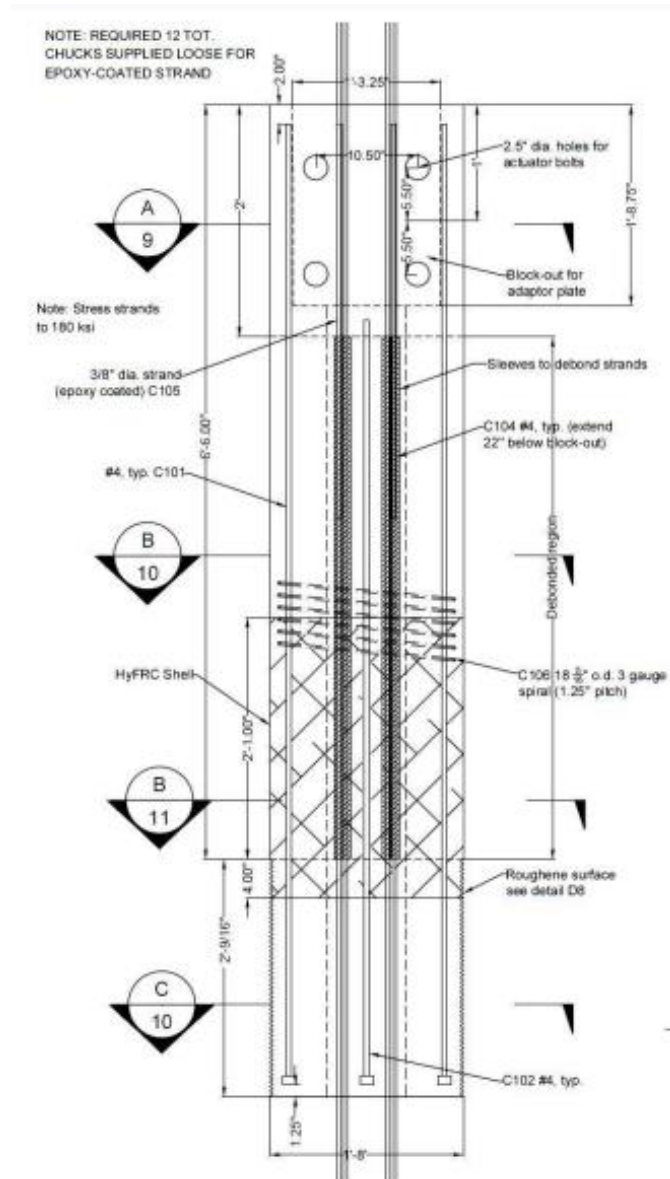
Figure 2.2. Column Detailing by Finnsson (2013)

unbonded over the center 50% of the column length using plastic sleeves and prestressed to approximately 14.4 kips (64 kN). Columns were connected to the footings using grouted socket connections. In one column, stainless steel (SS) bars were used as longitudinal reinforcement in lieu of conventional steel bars.

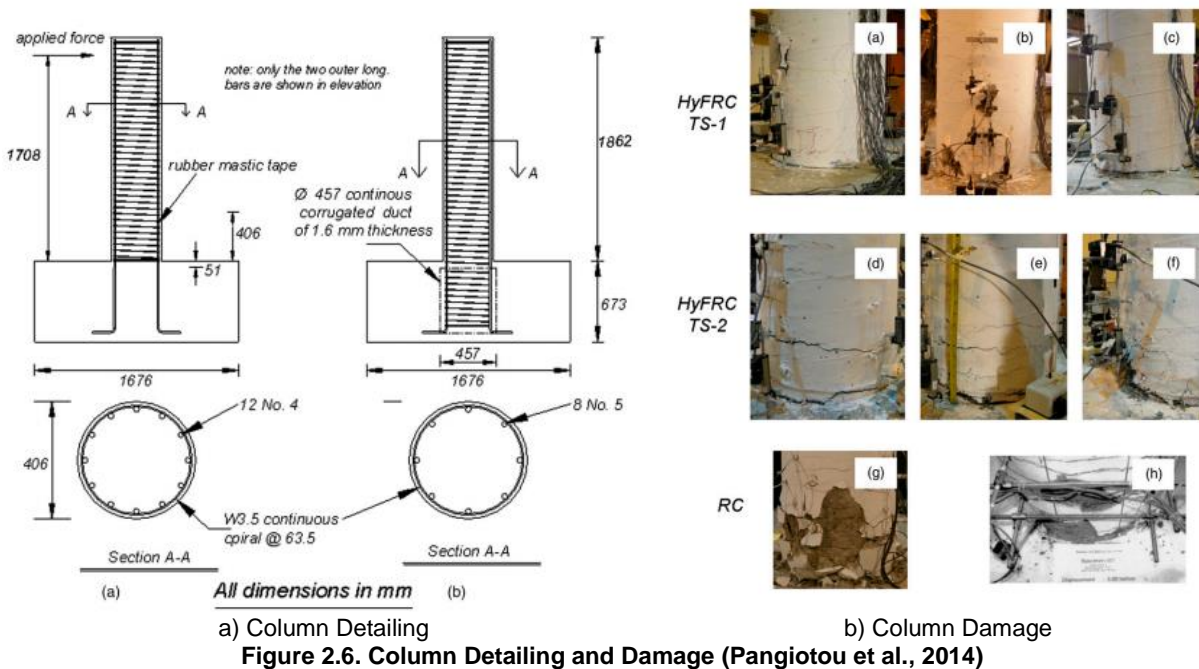
Figure 2.6. Column Detailing and Damage (Pangiotou et al., 2014)

Panagiotou (2014) tested two bridge columns constructed with highly flowable hybrid fiber reinforced concrete (HYFRC) and novel longitudinal reinforcement. The reinforcing bars of the first column were unbonded with tape near the bottom of the column and within the top of the footing to allow the column to rock. The second column was constructed with stainless steel longitudinal bars and an additional portion of HYFRC cast into the footing beneath the column to provide continuity of concrete properties (**Fig. 2.6a**). The specimens were tested unidirectionally under a cyclic lateral load reversal and a constant vertical axial load of 100 kips (445 kN).

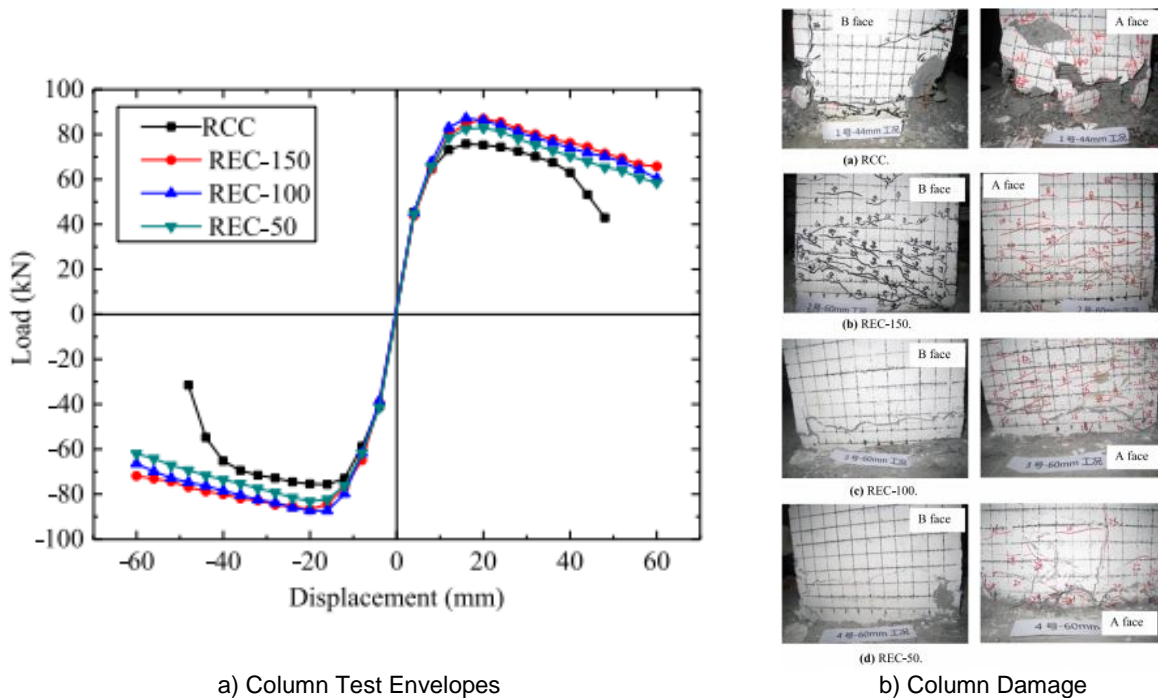
Figure 2.8. Column Test Envelopes and Damage (Zhang et al., 2019)

Zhang et al. (2019) tested three bridge columns with polypropylene fiber reinforced ECC (PP-ECC) jackets with different thicknesses in the plastic hinge region. The PP-ECC was limited to the cover concrete due to the high cost of ECC as well as evidence indicating that ECC in the core has a lower effect on the column ductility than the cover. Two of the 1/5th-scale columns incorporated precast PP-ECC jackets with thicknesses of 50 mm and 100 mm up to a height of 1.33 times the width of the square cross section while a third column was cast with a full PP-ECC plastic hinge. PP-ECC was additionally extended 100 mm into the footing while conventional concrete was utilized for the remaining portion of the columns and footings. All columns were tested under a constant axial load of 20 kN and in flexure using a cyclic loading in the horizontal direction.

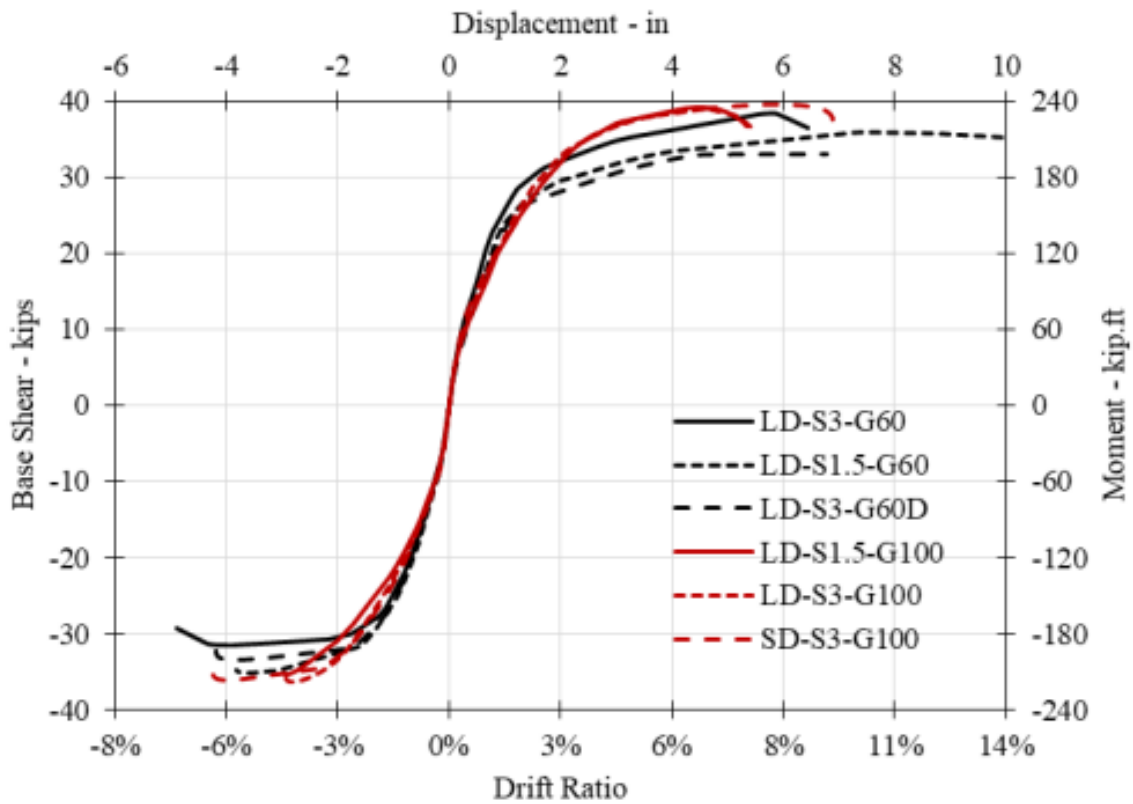
Figure 2.9. Column envelopes by Alian Amiri (2020)

table tested under both short- and long-term duration records from the 2011 Tohoku Japan earthquake and the 1999 Kocaeli Turkey earthquake with a constant axial load of 80 kips (356 kN).

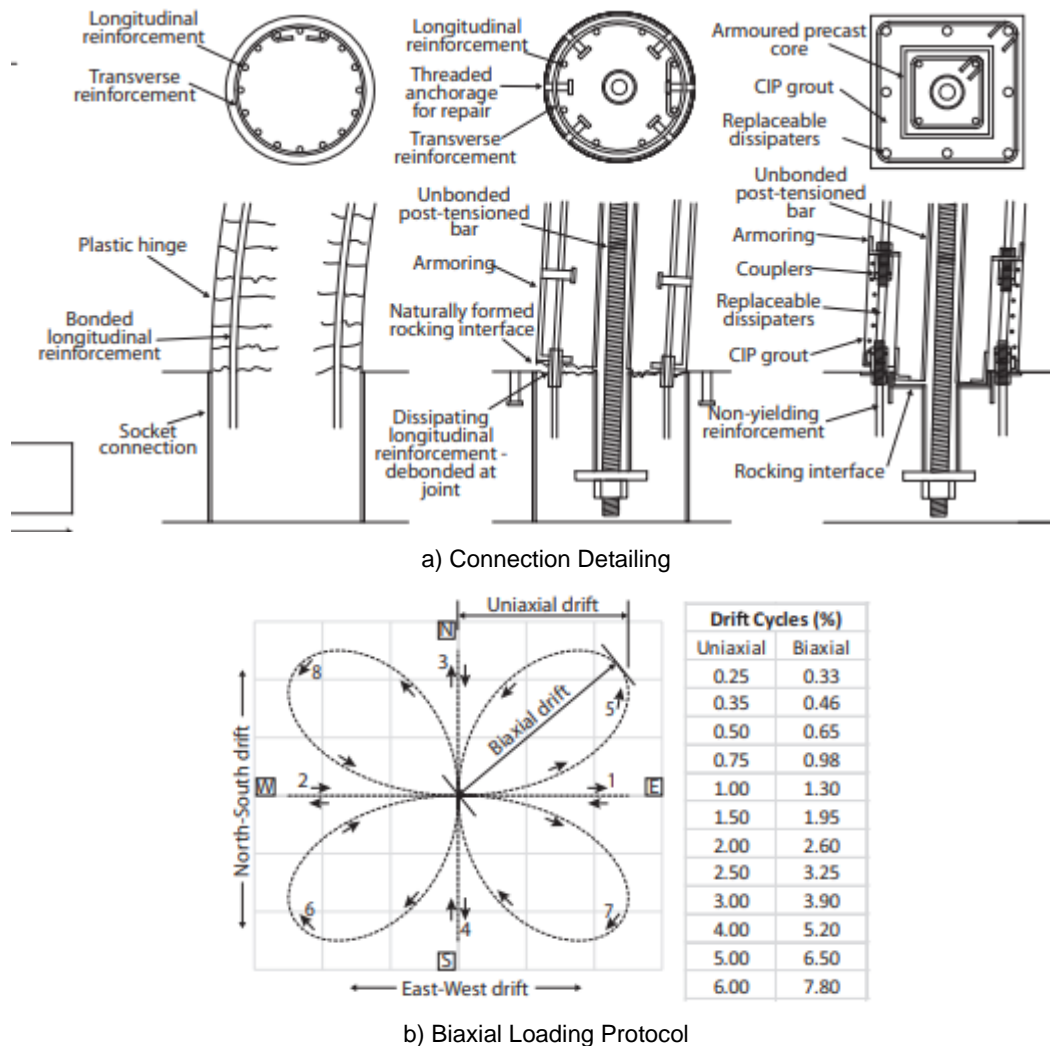
Figure 2.13. Connection Detailing and Biaxial Loading Protocol (White and Palermo, 2016)

White and Palermo (2016) utilized different precast connections in three half-scale concrete bridge columns. The column-to-footing connections included an emulative socket connection, a non-emulative socket connection incorporating post-tensioning, and a non-emulative coupled connection utilizing energy dissipators in the form of grade 300 steel bars in the plastic hinge region covered with grout (**Fig. 2.13a**). The two non-emulative columns were designed to rock at the base. The non-emulative socket column was a previously tested specimen that had been repaired using FRP wrap while the coupled column was designed to be repaired by removing the grout and replacing the energy dissipators which were connected to the column and footing using threaded couplers. The columns were tested under a quasi-static bilateral loading (**Fig. 2.13b**) to a displacement at which the non-emulative coupled column was repaired.

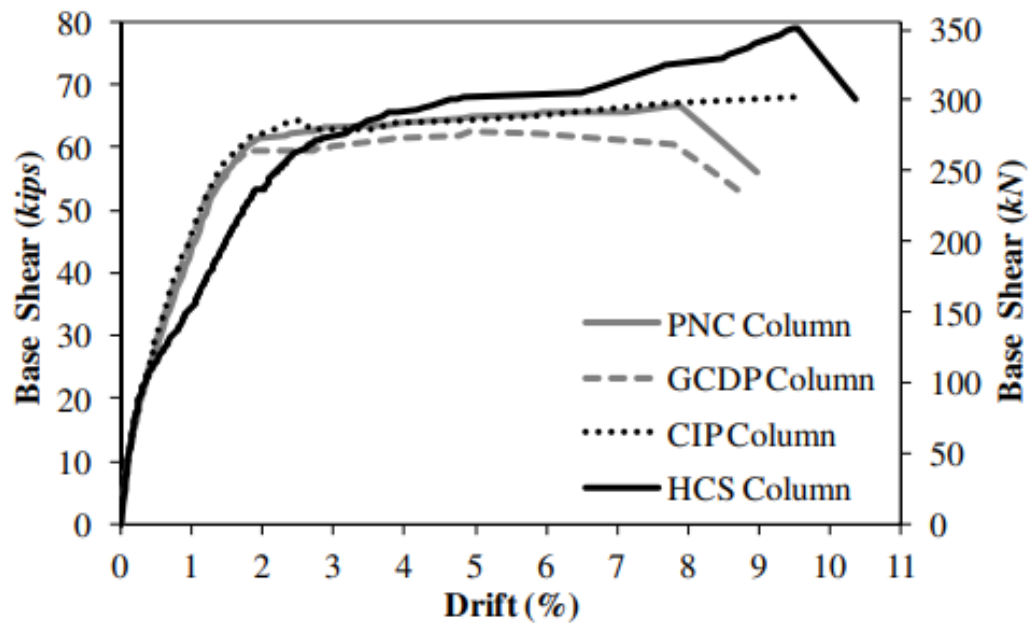
Figure 2.14. Column Test Envelopes (Tazarv and Saiidi, 2016)

Tazarv and Saiidi (2016) tested three half-scale column models using low damage materials and precast connections. All three columns were precast with hollow cores which were then filled with self-consolidating concrete (SCC) after column erection. The first column was connected to the footing by extending the column longitudinal rebar into a series of corrugated ducts which were then filled with UHPC. The second column incorporated debonded longitudinal rebar with an unbonded length of 11 in. (280 mm) within a pedestal. The column was connected to the pedestal using grouted couplers. The connection details for the third column were the same as the first column with UHPC filled ducts. Nevertheless, SMA bars were used in the plastic hinge region and connected to the steel longitudinal bars with headed couplers. Furthermore, ECC was used to construct the lower 3 ft (914 mm) of the column shell. A 220-kip (979-kN) actuator was used to test the columns under a slow reversed cyclic loading with an axial load index of 10%.

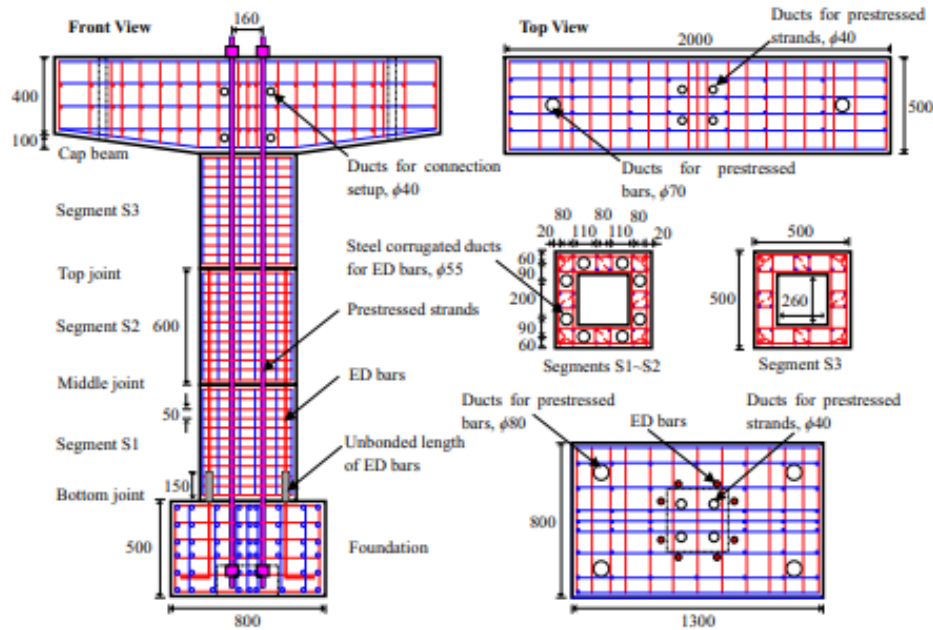
Figure 2.15. Segmental Column Detailing (Wang et al., 2018)

Wang et al. (2018) tested the self-centering capability of three, 1/3-scale precast segmental post-tensioned bridge columns constructed with UHPC. The square columns were constructed using three hollow UHPC segments in addition to a cap beam and footing. Eight steel cables were post-tensioned to a force of 89.9 kips (400 kN) while eight mild steel bars unbonded near the footing were added in UHPC grout filled ducts to promote energy dissipation in addition to the 32 longitudinal steel bars (**Fig. 2.15**). The second column incorporated an increased post-tensioning force while the third column was constructed with additional energy dissipators. Lateral cyclic loading was applied using a horizontal actuator in addition to a 224.8-kip (1000-kN) applied axial load.

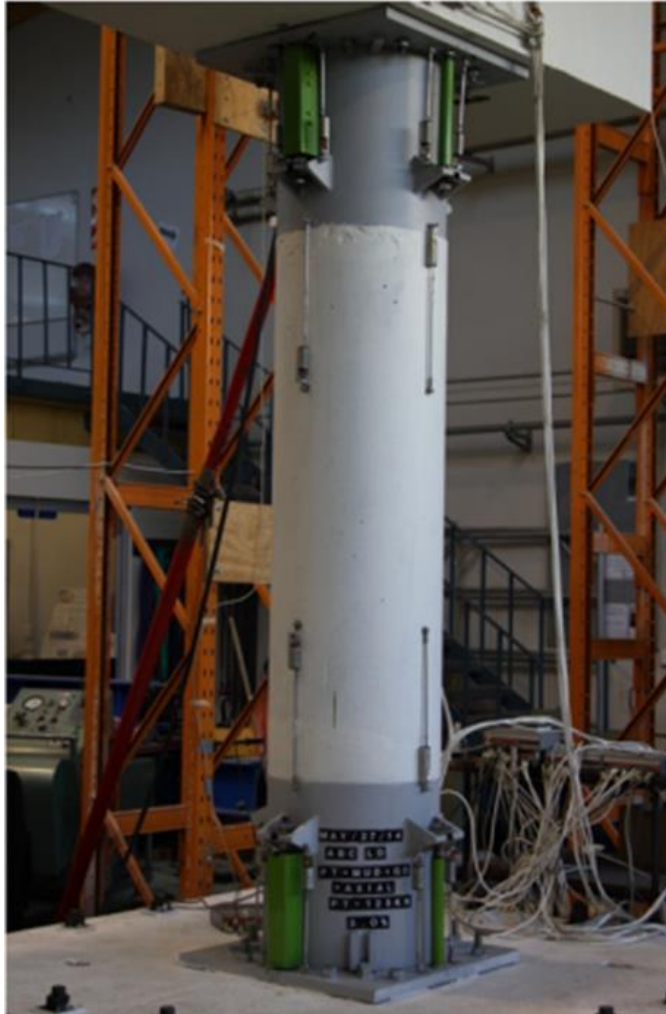
Figure 2.16. Column with External Energy Dissipaters (Mashal and Palermo, 2019)

Mashal and Palermo (2019) tested a half-scale bridge column specimen with dissipative controlled rocking (DCR) connection utilizing post-tensioning and external energy dissipators. External metallic mini-dissipators of two different types were mounted to the column using steel brackets (**Fig. 2.16**). An initial post-tensioning force of 28.1 kips (125 kN) was applied to the threaded post-tensioning bars within the column using hydraulic jacks. A vertical 87.7-kip (390-kN) gravity load was applied with a vertical ram while a horizontal ram was used to displace the column laterally under a unidirectional quasi-static cyclic loading protocol.

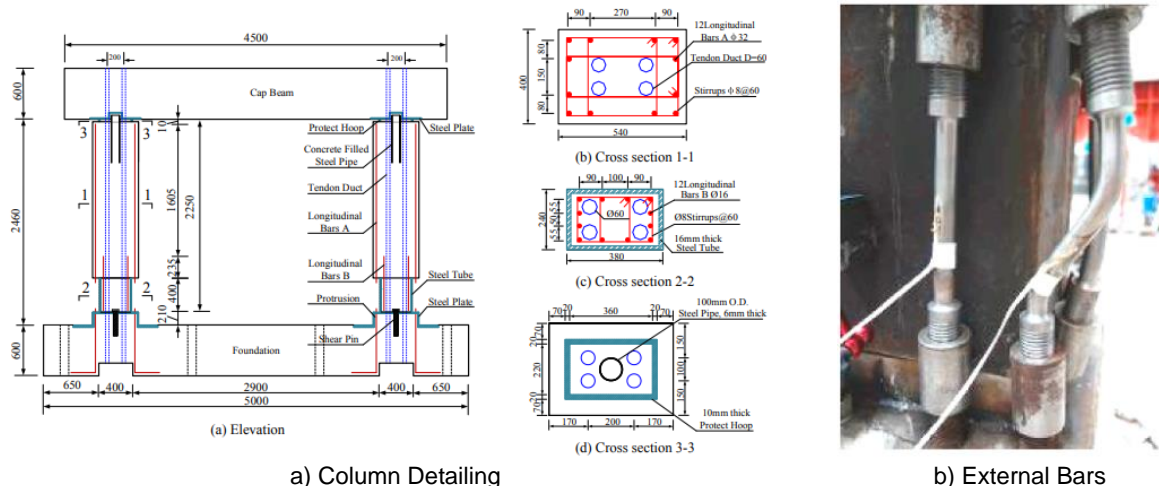
Figure 2.18. Column Detailing and Energy Dissipater Damage (Han et al., 2019)

Han et al. (2019) investigated the combination of replaceable external energy dissipators and unbonded post-tensioning tendons. Three, 1/3-scale double column bridge bents were designed, constructed, and tested under a cyclic lateral loading. An axial load of 194.8 kips (866.4 kN) was applied. The bents incorporated reduced cross sections in the plastic hinge region which were encased with steel tubing as well as steel pipes as shear pin connections and steel plates at the column-footing and column-cap beam interfaces (**Fig. 2.18a**). The first column did not include external energy dissipators while the second and third columns included external “dog-boned” mild reinforcing bars and external buckling-restrained plates in the plastic hinge region respectively which were connected to the main longitudinal reinforcement. Each column in the bents was post-tensioned using four unbonded steel tendons with a total force of 94.4 kips (420 kN).

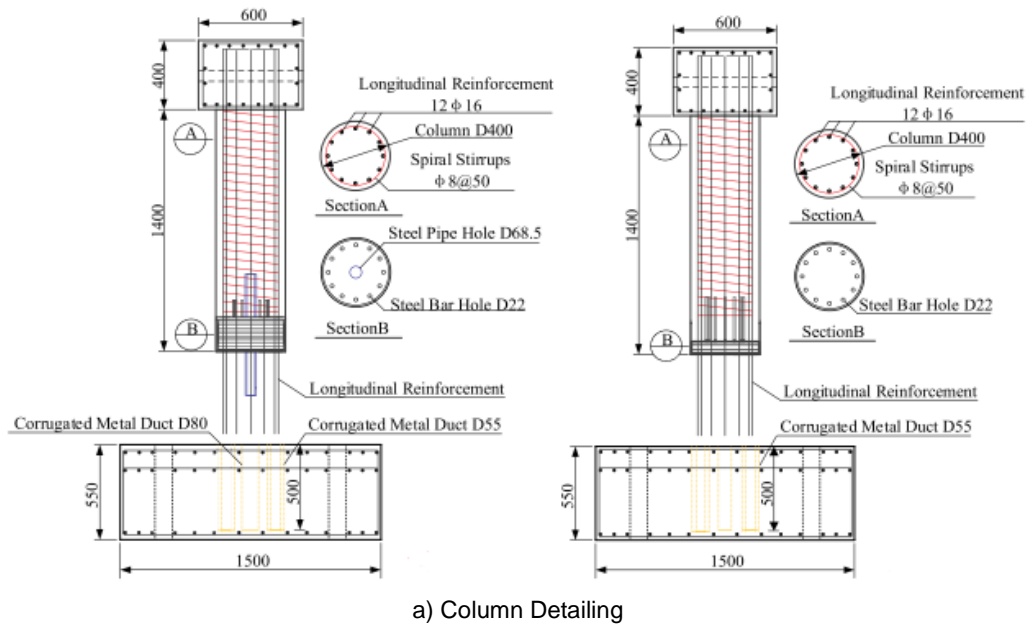
Figure 2.19. Column Damage and Cross Sections (Jia et al., 2016)

Jia et al. (2019) studied the use of elastomeric pads as energy dissipaters in precast bridge columns. Four, 1/4-scaled bridge columns were constructed including a cast-in-place (CIP) column, a typical precast column with a grouted duct connection, and two precast columns using grouted duct connections and laminated and single-layer elastomeric pads, respectively (**Fig. 2.19a**). An additional steel pipe was included in the laminated elastomeric pad column to resist shear forces. For the three precast columns, longitudinal reinforcement was extended into corrugated metal ducts in the footing and filled with grout. The columns were tested under a quasi-static cyclic load with a constant axial load of 80.9 kips (360 kN).

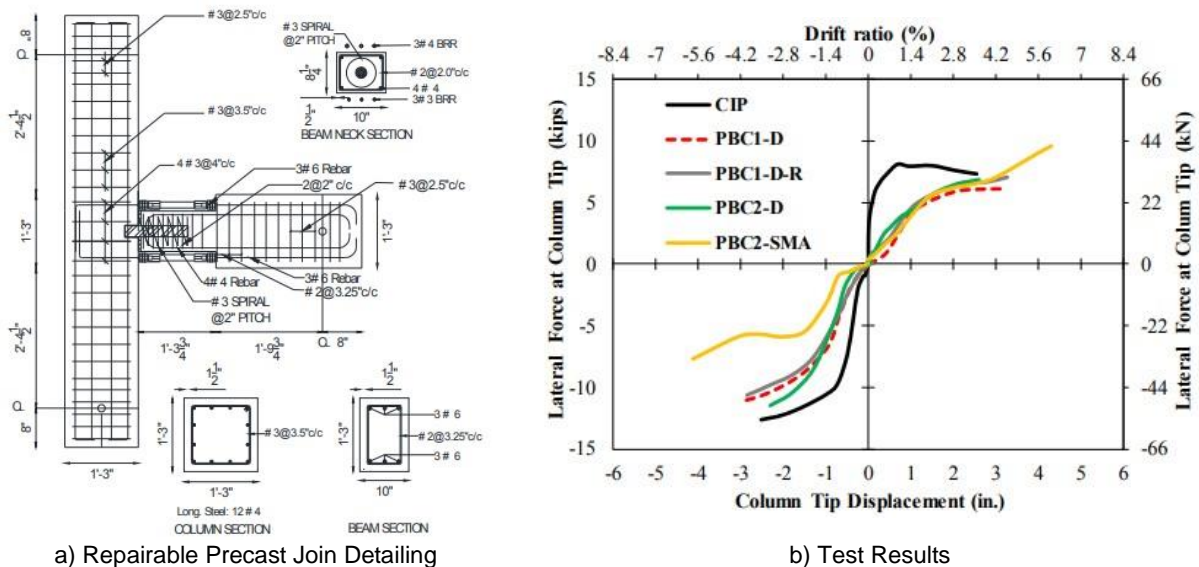
Figure 2.20. Repairable Precast Beam-Column Joint detailing and Test Results (Tazarv et al., 2020)

Tazarv et al. (2020) experimentally tested four, half-scale precast beam-column specimens under cyclic loading. The special moment resisting frame (SMRF) connections were designed using “strong column – weak beam” methodology to achieve a large displacement capacity. Exposed buckling restrained reinforcement (BRR) fuses were used as external energy dissipaters while a steel pipe and cup were incorporated to act as a shear pin at the beam-column interface (**Fig. 2.20a**). BRR fuses were connected to the main longitudinal reinforcement of the beam using headed mechanical bar splices for quick replacement. The column axial load was 68 kips (302 kN). Both unreduced and reduced diameter (dog-bone) steel bars were used in BRR. Each BRR was replaced with a similar conventional steel or SMA fuses after initial testing of each specimen.

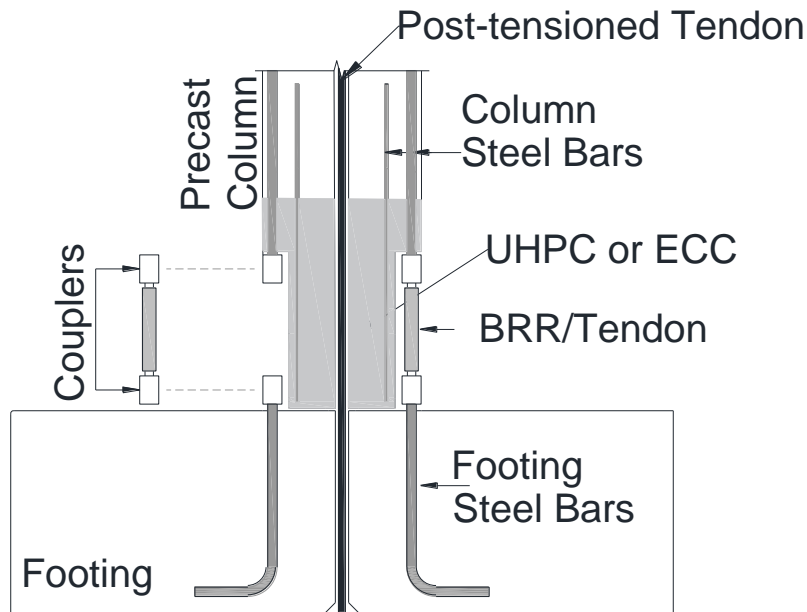
Figure 3.20. Repairable Column 19 Detailing

Table 3.20 includes the rating of Column 19 as well as justification for each point deduction. UHPC and tendons will greatly add to the column costs, thus a full deduction was included. The post-tensioning tendons will also require additional construction, inspection, and maintenance steps.

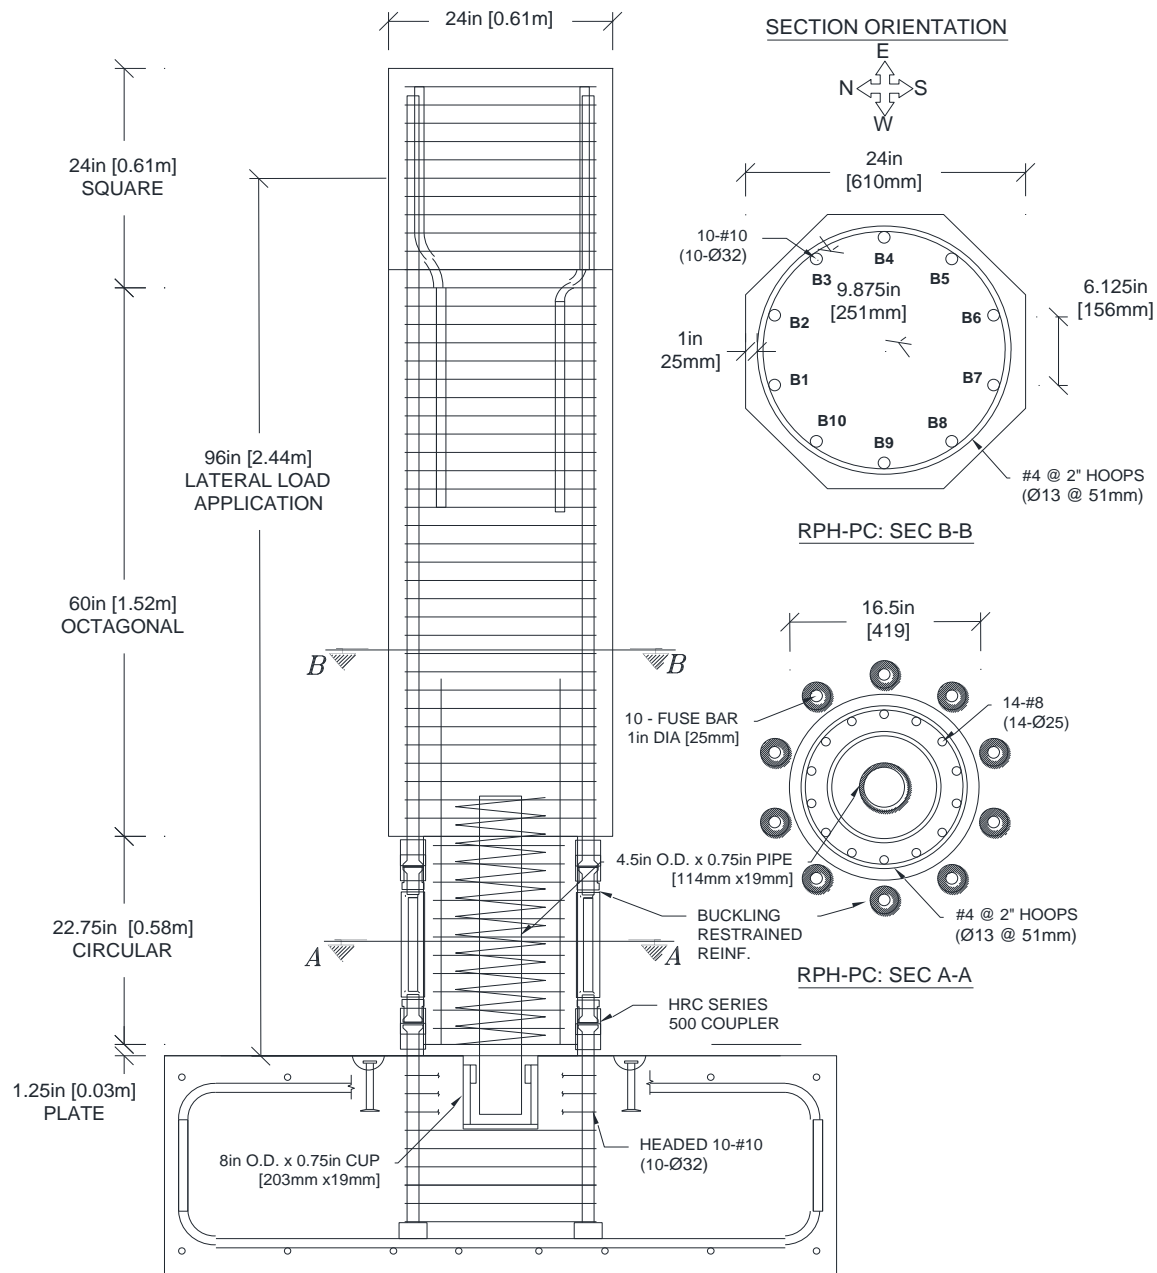
Figure 4.5. Reinforcement Detailing of RPH-PC Column

Longitudinal bars in the RPH-PC column and footing were oversized to No. 10 ($\emptyset 32$ mm) compared with the No. 8 ($\emptyset 25$ mm) bars that were used in fuses. This was done to ensure that the bar yielding occurs within the fuses but not in the column/footing dowels. No. 8 ($\emptyset 25$ mm) stainless steel bars used as the exposed fuses were machined down from No. 10 ($\emptyset 32$ mm) bars (**Fig. 4.6a**) to match the CIP longitudinal reinforcement (**Fig. 4.2**). In initial testing (fuses colored in yellow), the “dog-boned” length was 10.25 in. (260 mm) while the reduced diameter length was 5.125 in. (130 mm) in the second testing in which the column was repaired (fuses colored in green). Different fuse lengths were used to investigate their effects on the column overall ductility. A clear cover of 1 in. (25 mm) was used in the column.

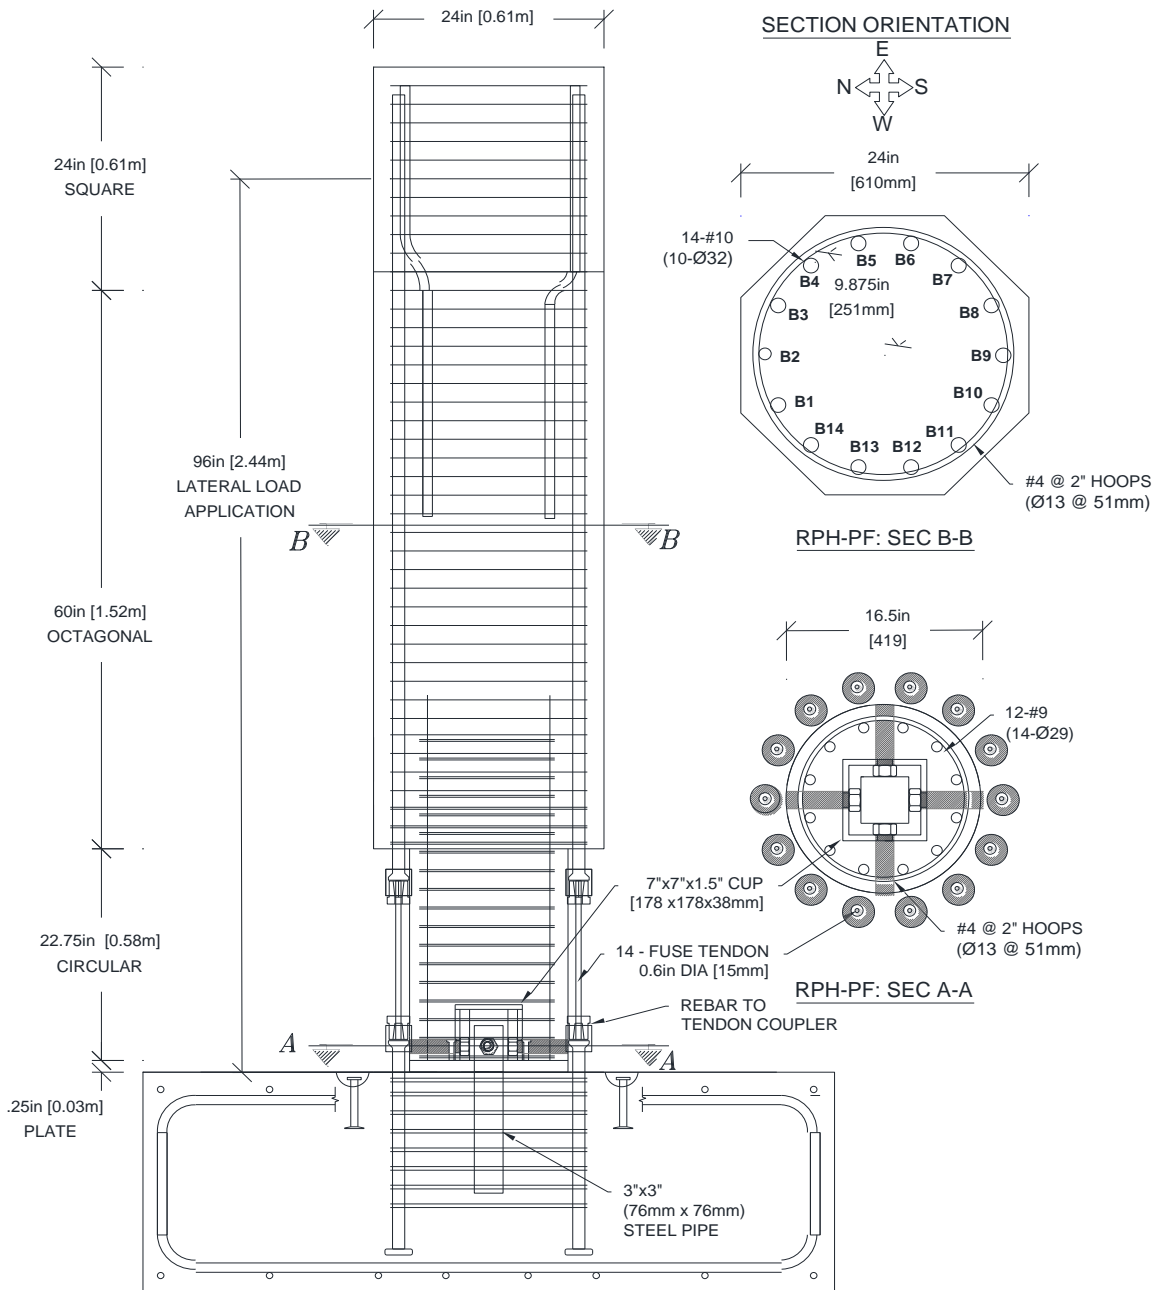
Figure 4.11. Reinforcement Detailing of RPH-PF Column

After testing RPH-PC, the remaining top two column alternatives from **Chapter 3** were constructed at a precast plant, Gage Brothers, and assembled and tested at SDSU. Column alternative 3 was named RPH-PF, a repairable precast column with headed couplers and a pipe embedded in the footing. The detailing of RPH-PF (**Fig. 4.11**) was mostly the same as that of RPH-PC, but with some modifications based on lessons learned from the first repairable column testing (RPH-PC). The same geometry, cross section, and reinforcement as RPH-PC were used in the precast column, neck region, and cast-in-place footing. The clear cover in column was 1 in. (25 mm).

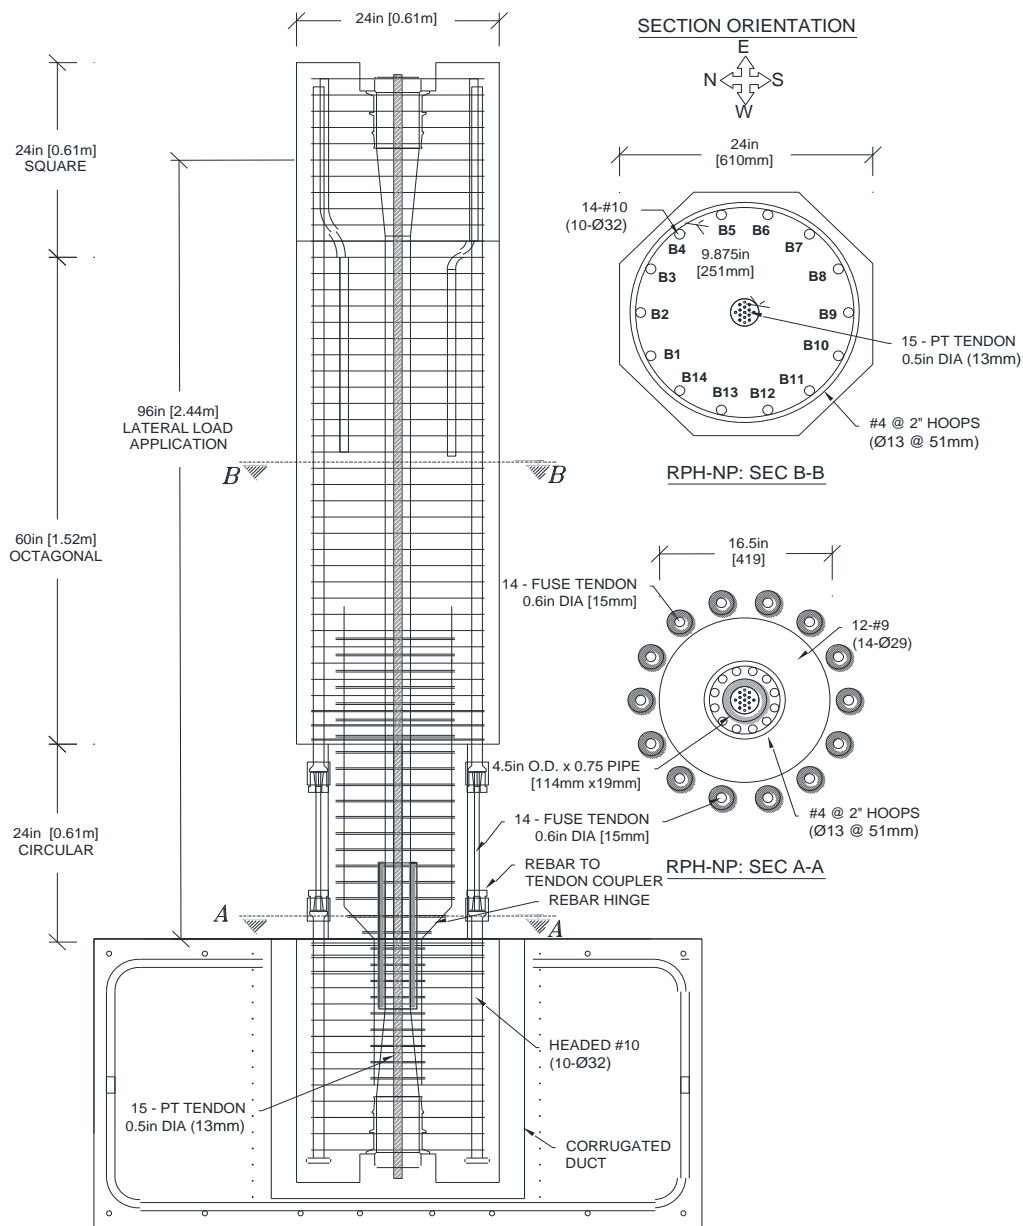
Figure 4.17. Reinforcement Detailing of RPH-NP Column

The repairable design concept of Column No. 15 from **Chapter 3**, which was a hybrid rocking column with replaceable fuses, was included in the test program as the repairable precast column with no shear pin (RPH-NP). **Figure 4.17** shows the hybrid rocking column detailing. The cross-sectional properties, reinforcement, and cementitious materials of PRH-NP were the same as those of RPH-PF. UHPC was used for the entire precast column. Steel tendons were incorporated as tension-only fuses and no BRR was used. The column was fully precast and was connected to the footing using a grouted socket (pocket) connection. To accommodate the socket connection, the height of the footing was increased from 2 ft (610 mm) used in all other columns to 3 ft. (914 mm). The column height from the top of the footing to the centerline of the applied lateral load remained the same as other specimens, 8 ft. (2.44 m).
