**National Center for Transportation
Infrastructure Durability & Life-Extension**

Project ID: 2021-SDSU-02

Repairable Precast Bridge Bents for Seismic Events

Final Report

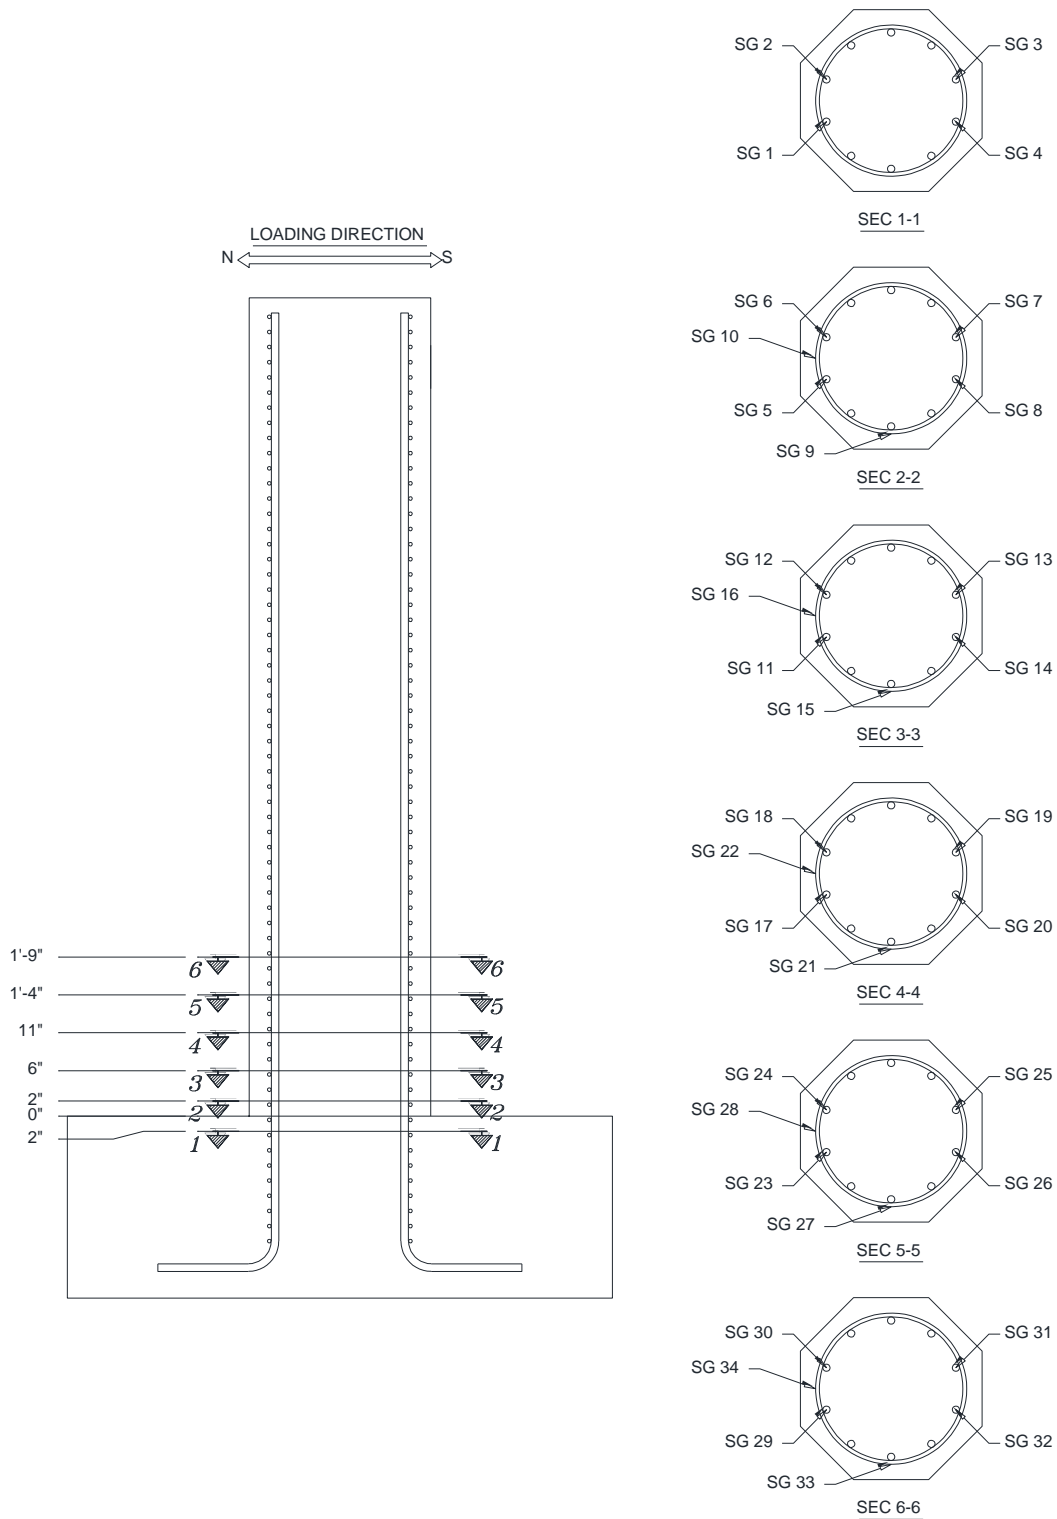
Figure 4.25. Strain Gauge Plan Used in Cast-in-place Column

Test data was recorded using various instruments and sensors. Strain gauges were installed on the longitudinal and transverse reinforcement at various levels within the footing and column cross sections. Concrete strain gauges were also utilized in a circular pattern at the base of the three repairable columns to evaluate concrete stresses at the column rocking interface. **Figure 4.25** shows the strain gauge plan used in the CIP column and **Fig. 4.26** shows the typical strain gauge plan used for the repairable columns. **Table 4.2** presents the strain gauge schedule for the column models. Note in RPH-NP, five strain gauges were placed on post-tensioning tendons at the column base. Three string potentiometers were used to measure the horizontal displacements and rotations of the column head as indicated in **Fig. 4.27** and the actuator load cell measured the lateral load. Rotations and curvatures were measured within the plastic hinge region using linear variable displacement transducers (LVDTs) on the north and south faces of the column (**Fig 4.27**). An additional LVDT was mounted at the base of the RPH-PC column to record lateral slippage due to a possible gap between the pipe and socket in the pipe-pin connections. However, this LVDT was not used in other repairable columns due to no/minimal gap. A 100-kip (445-kN) load cell was placed above each of the hollow-core jacks to measure the column axial load during testing. The axial load was adjusted between test runs at each drift ratio to achieve a constant target axial load of 155 kips (689 kN). This target axial load corresponds to an axial load index of approximately 5% for a design concrete strength of 6,000 psi (41.4 MPa). The actual index varied due to differences in concrete strength on the test day, especially with the use of UHPC in last two test specimens. All instrumentation was connected to a 128-channel data acquisition system using a sampling rate of 10 Hz.

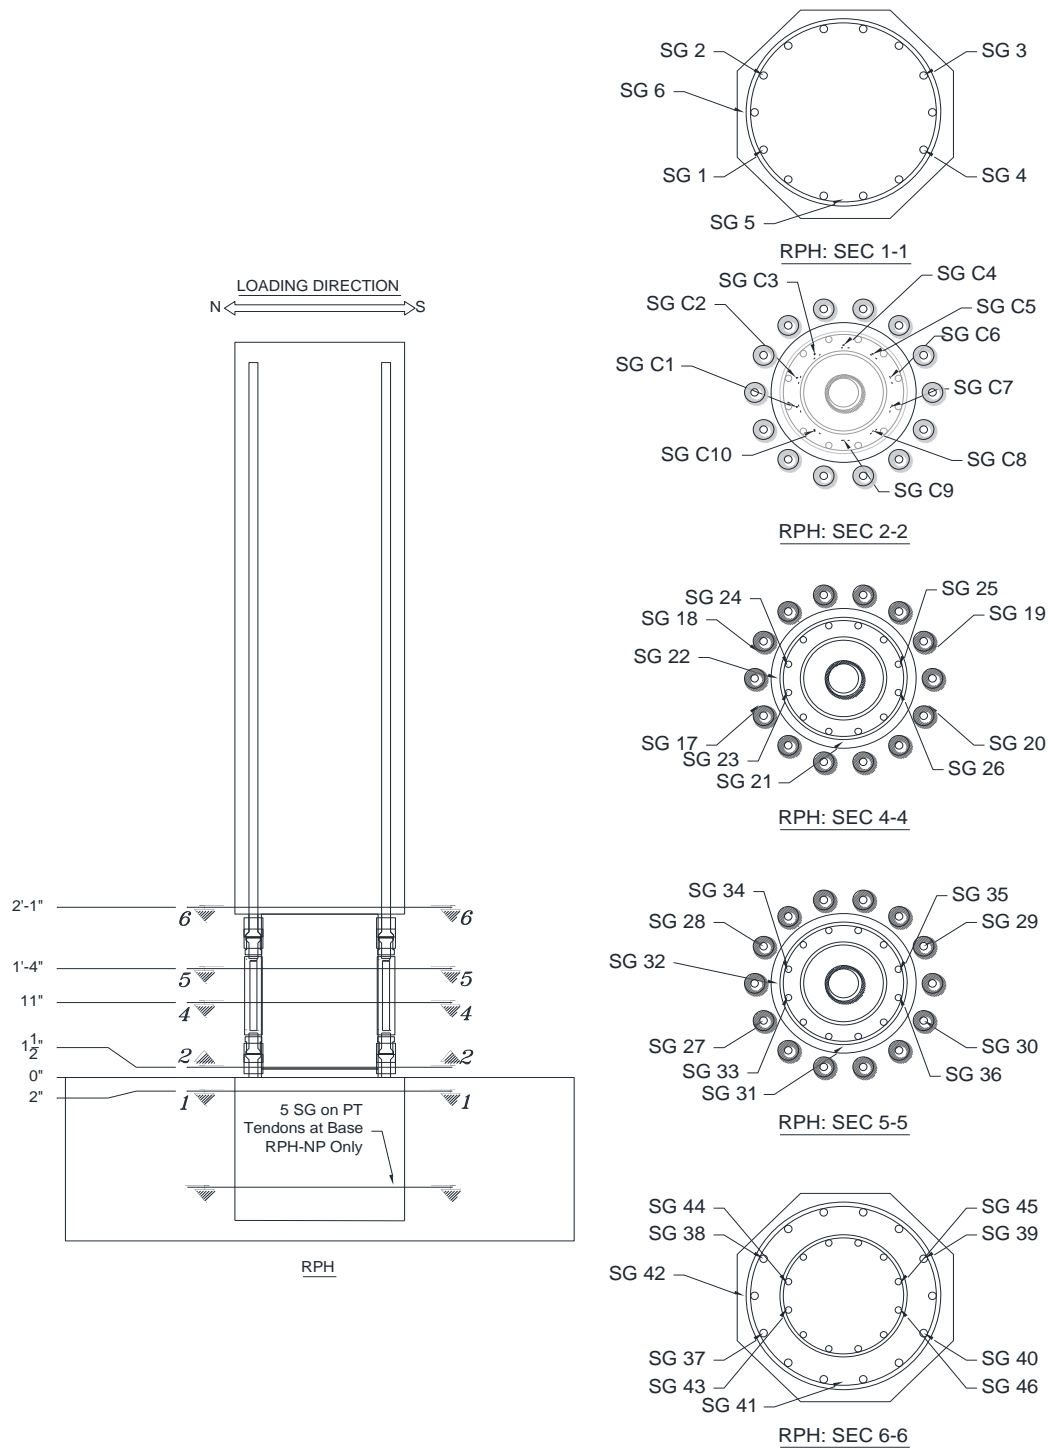
Figure 4.26. Typical Strain Gauge Plan Used in Repairable Precast Columns

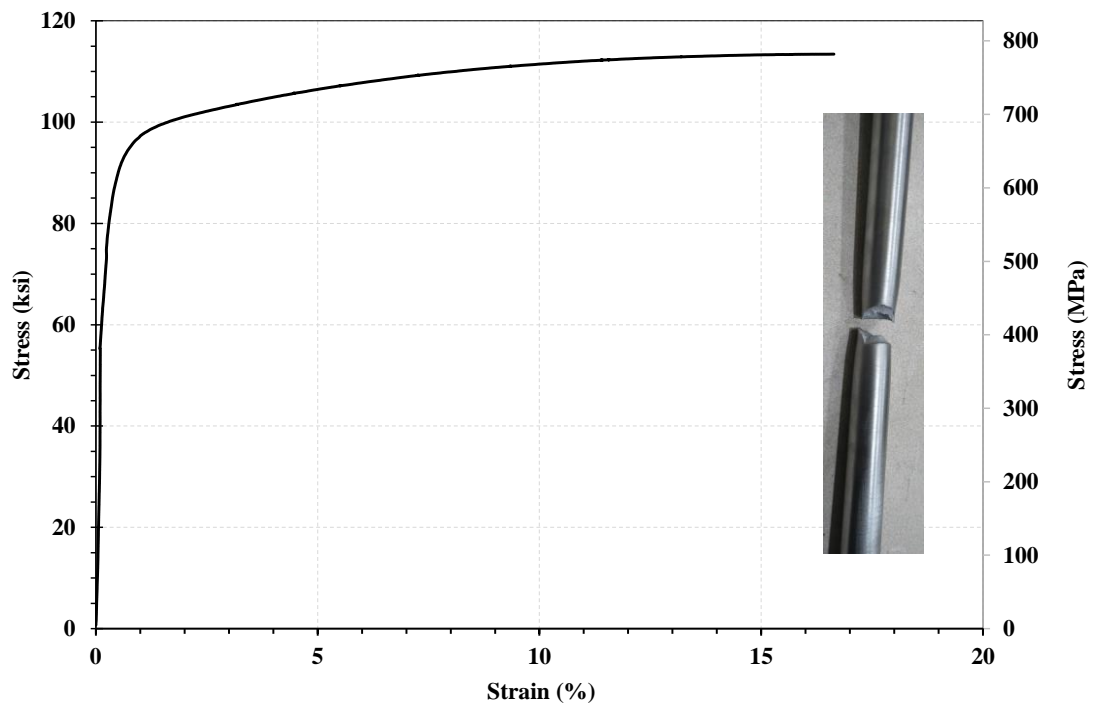
Figure 4.29. Tensile Test Results for 1.0 in. (25-mm) Dog-Bone from No. 10 (Ø32) Stainless Steel Bar

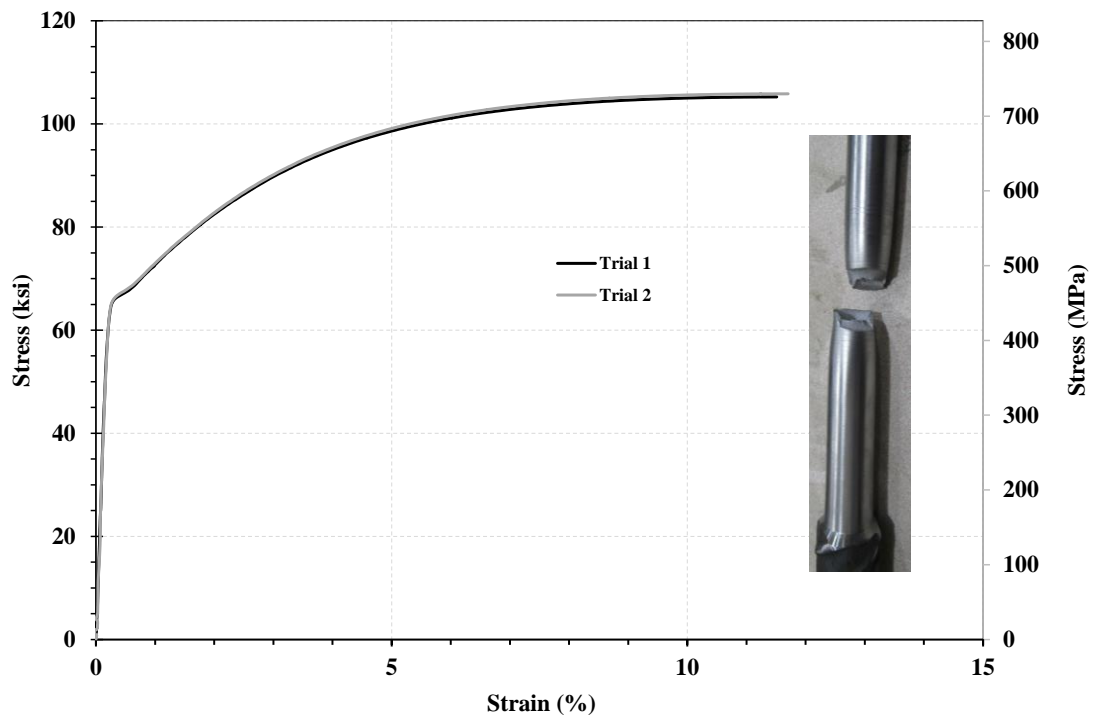
Figure 4.30. Tensile Test Results for 1.0 in. (25-mm) Dog-Bone from No. 10 (Ø32) Conventional Steel Bar

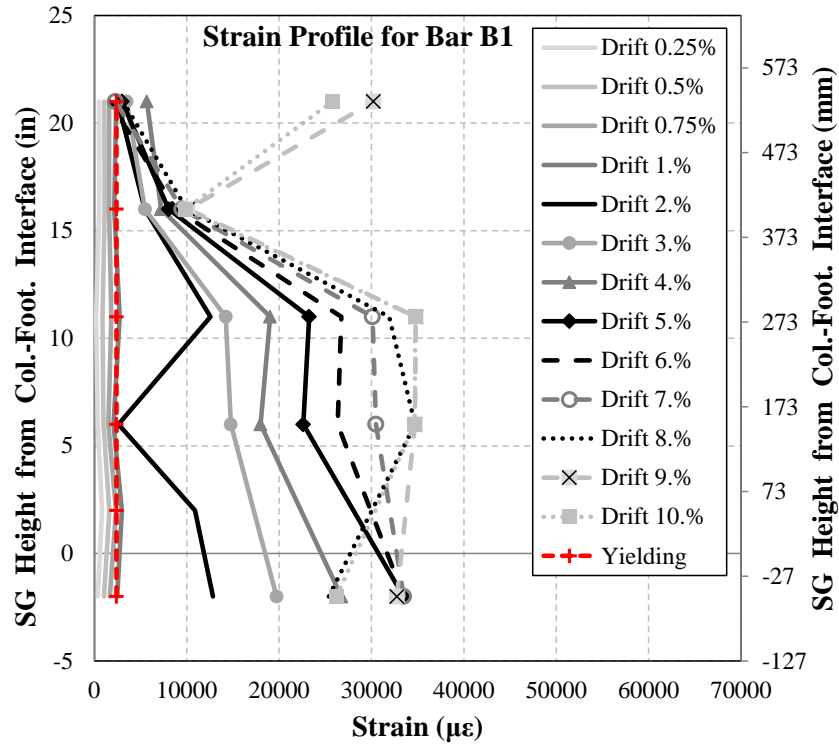
Figure 4.60. Measured Strain Profile for CIP Column Bar B1 (Sjurseth et al., 2022)

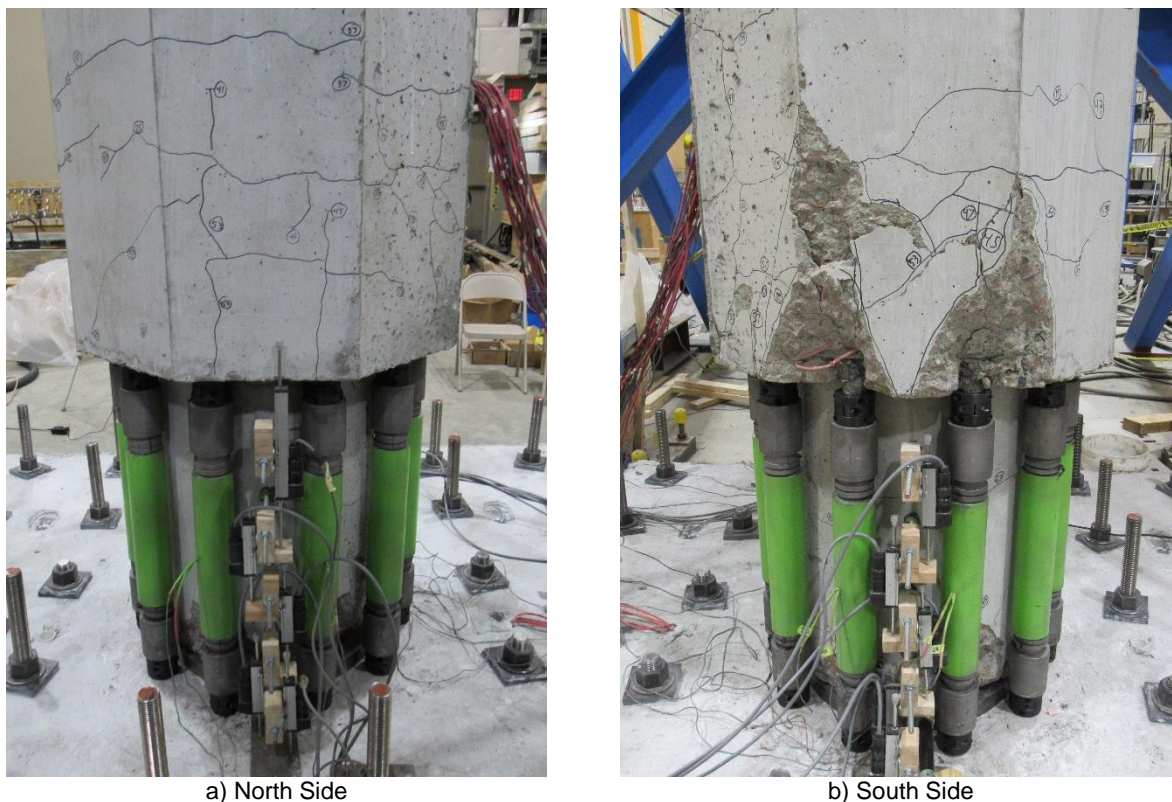
Figure 4.81. RPH-PC-R Column Plastic Hinge Damage before Retesting

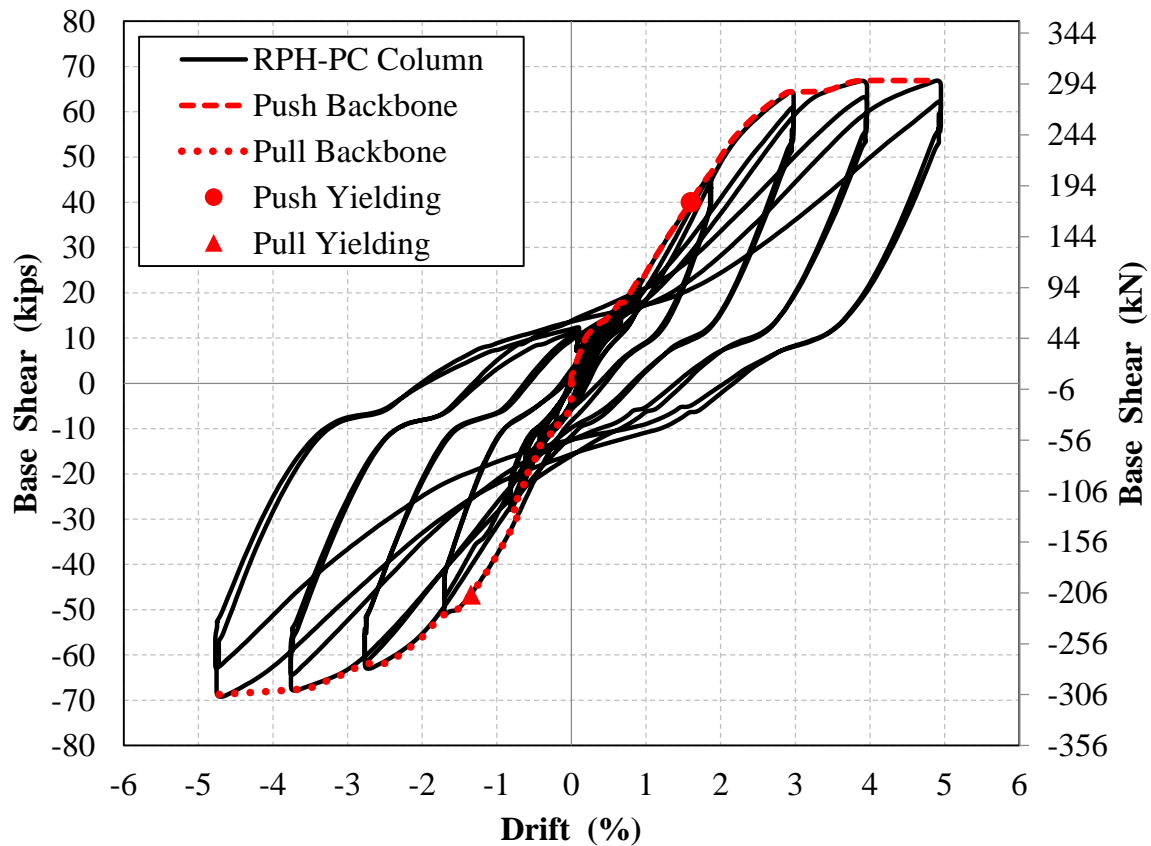
Figure 4.108. Measured RPH-PC Column Force-Drift Hysteretic and Envelope Responses

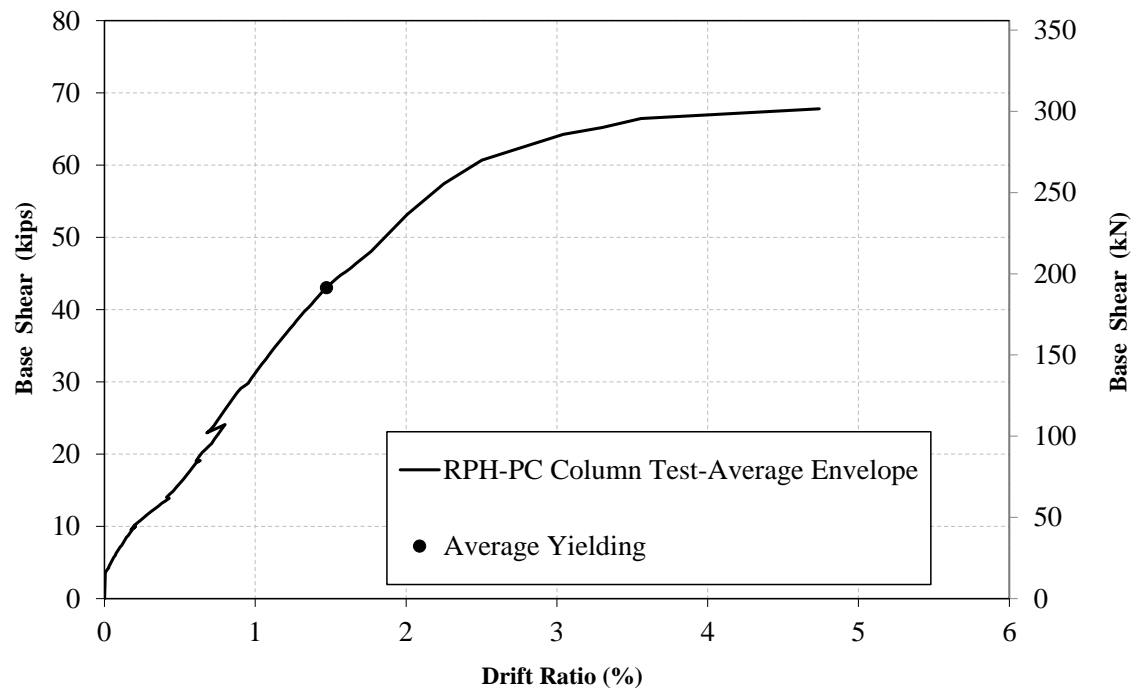
Figure 4.109. Measured RPH-PC Column Average Push/Pull Force-Drift Envelope

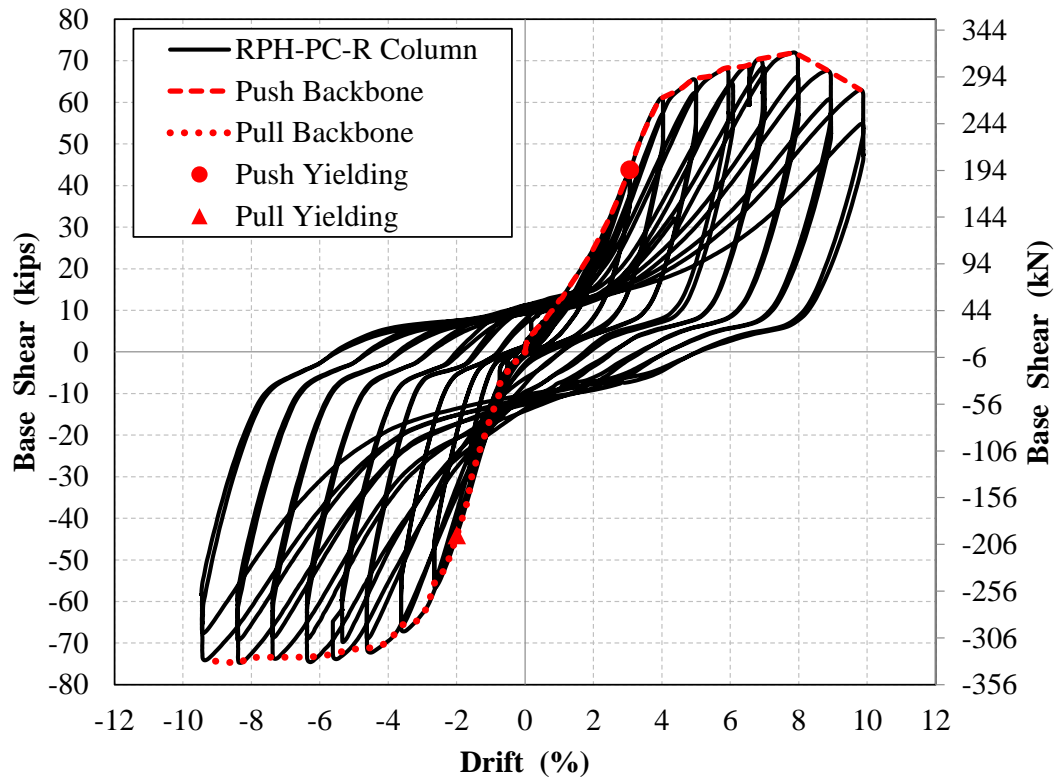
Figure 4.110. Measured RPH-PC-R Column Force-Drift Hysteretic and Envelope Responses

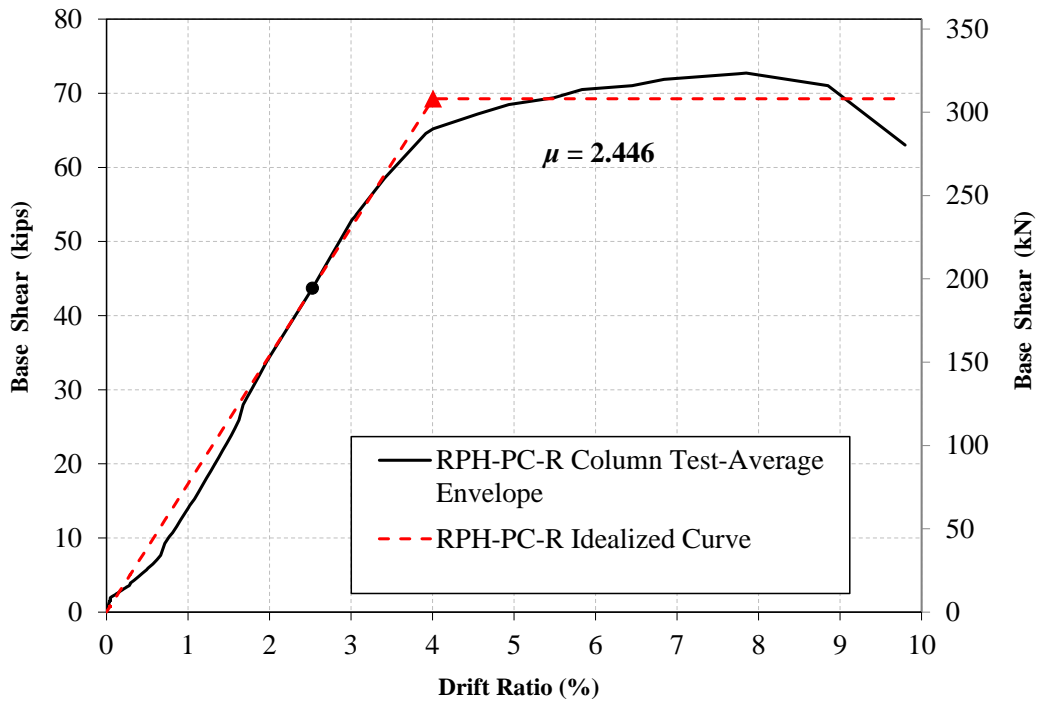
Figure 4.111. Measured RPH-PC-R Column Average Push/Pull Force-Drift Envelope and Idealized Curve

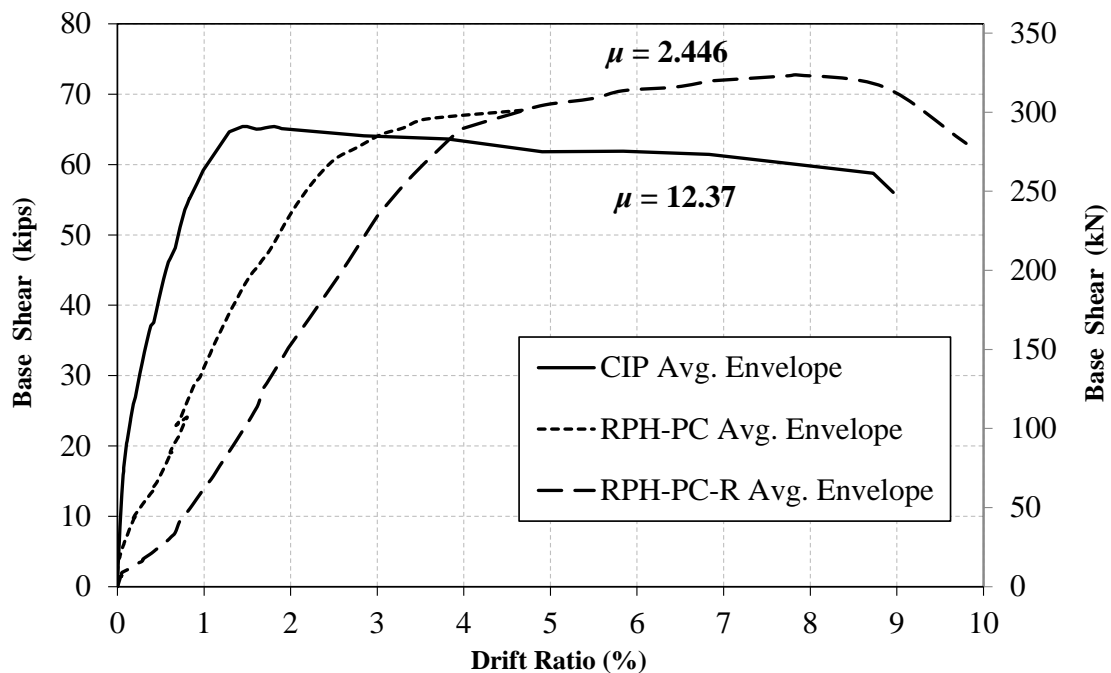
Figure 4.112. Measured Force-Drift Response of CIP, RPH-PC, and RPH-PC-R Columns

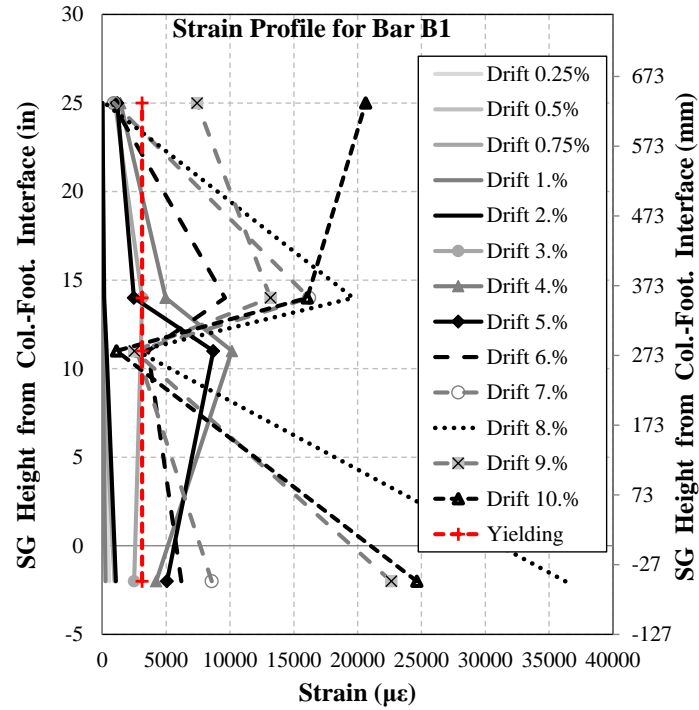
Figure 4.133. Measured Tensile Strain Profile for RPH-PC-R Column Bar B1

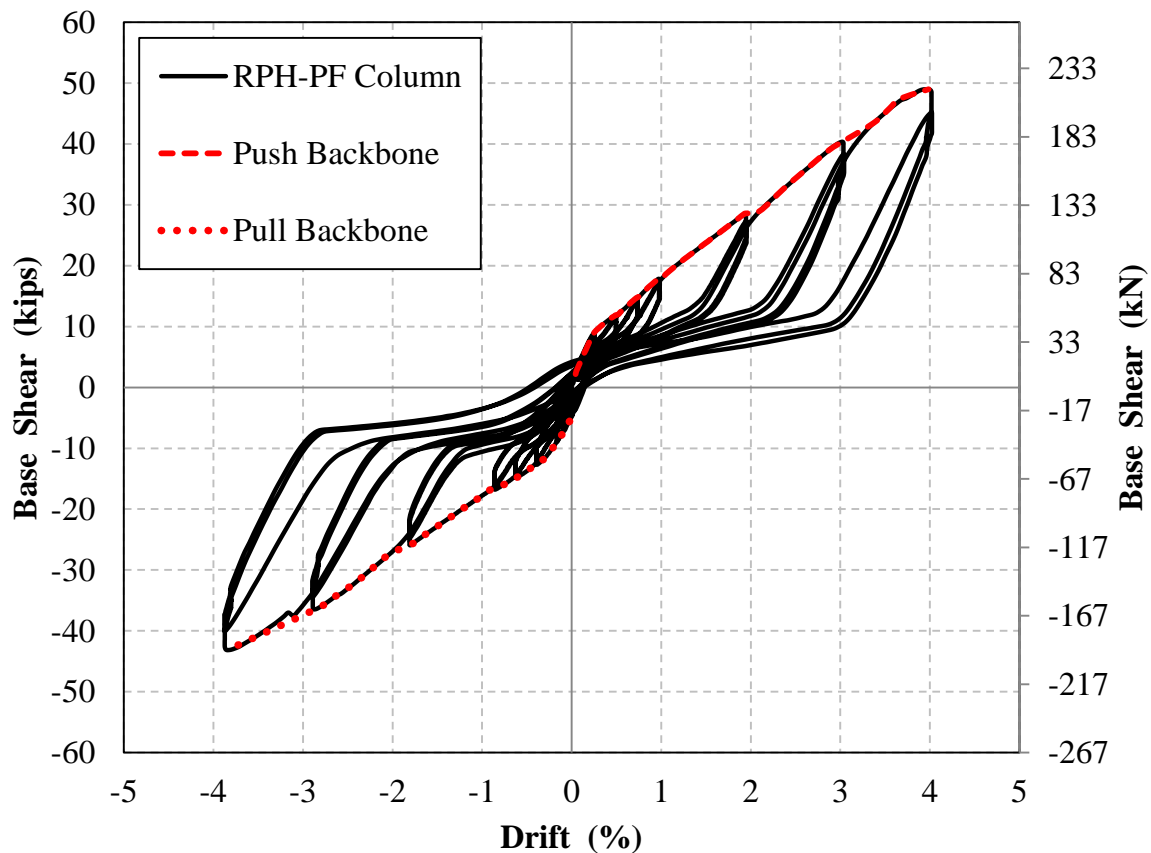
Figure 4.191. Measured RPH-PF Column Force-Drift Hysteretic and Envelope Responses

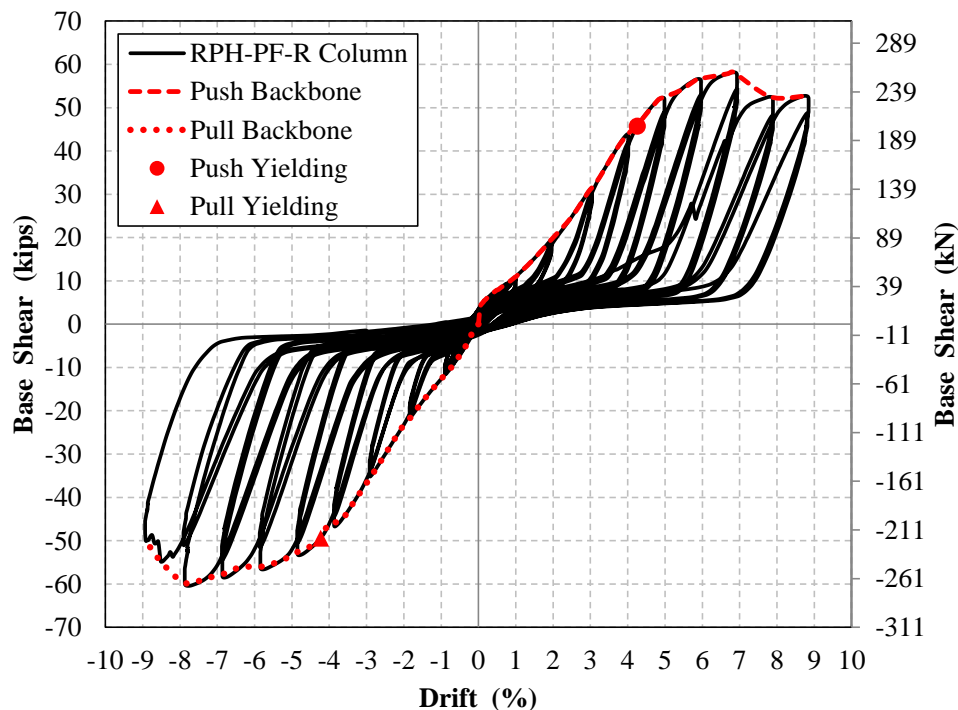
Figure 4.193. Measured RPH-PF-R Column Force-Drift Hysteretic and Envelope Responses

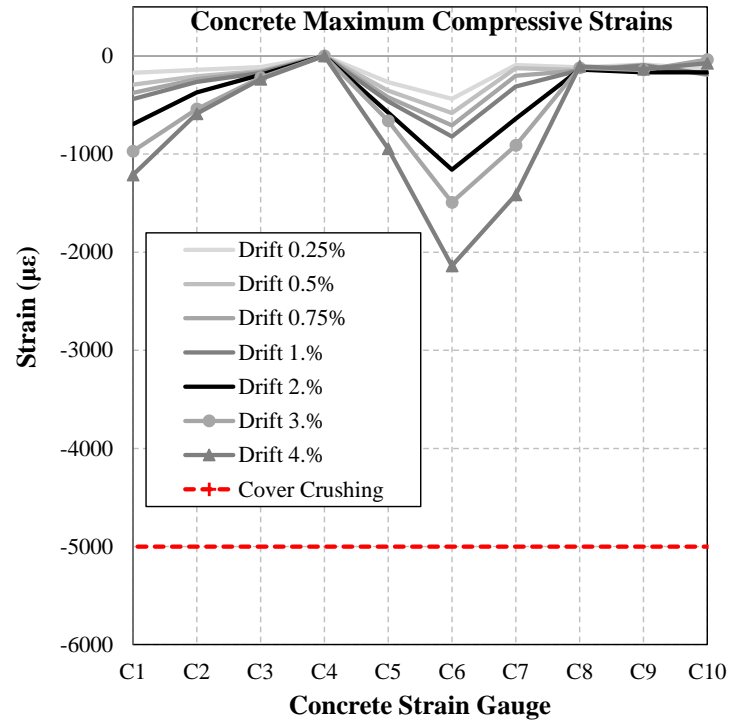
Figure 4.208. Measured UHPC Compressive Strain Profile for RPH-PF

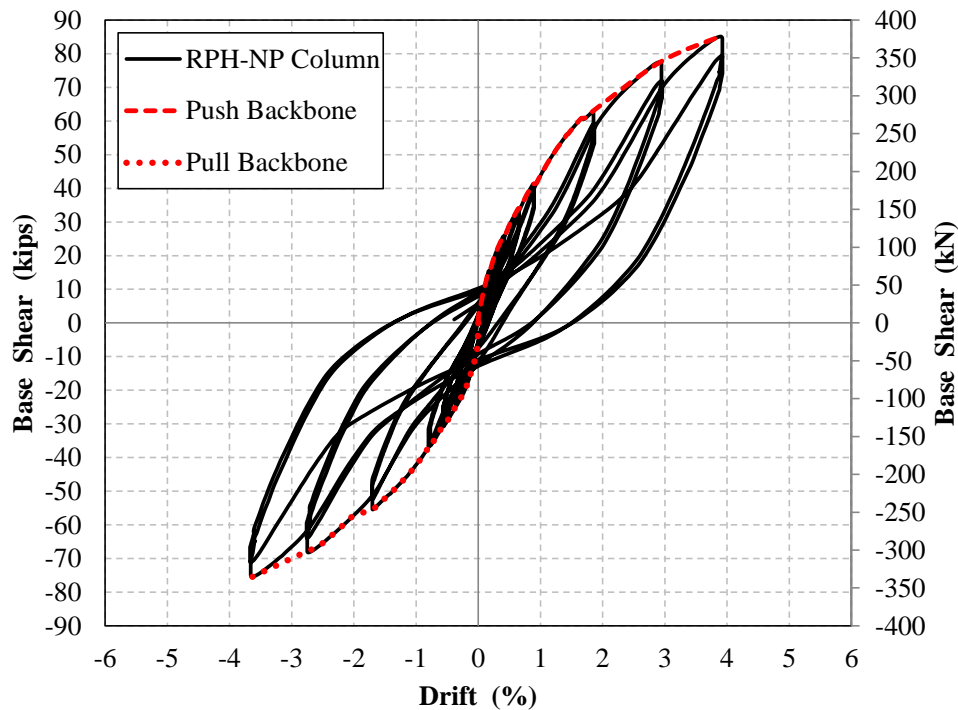
Figure 4.273. Measured RPH-NP Column Force-Drift Hysteretic and Envelope Responses

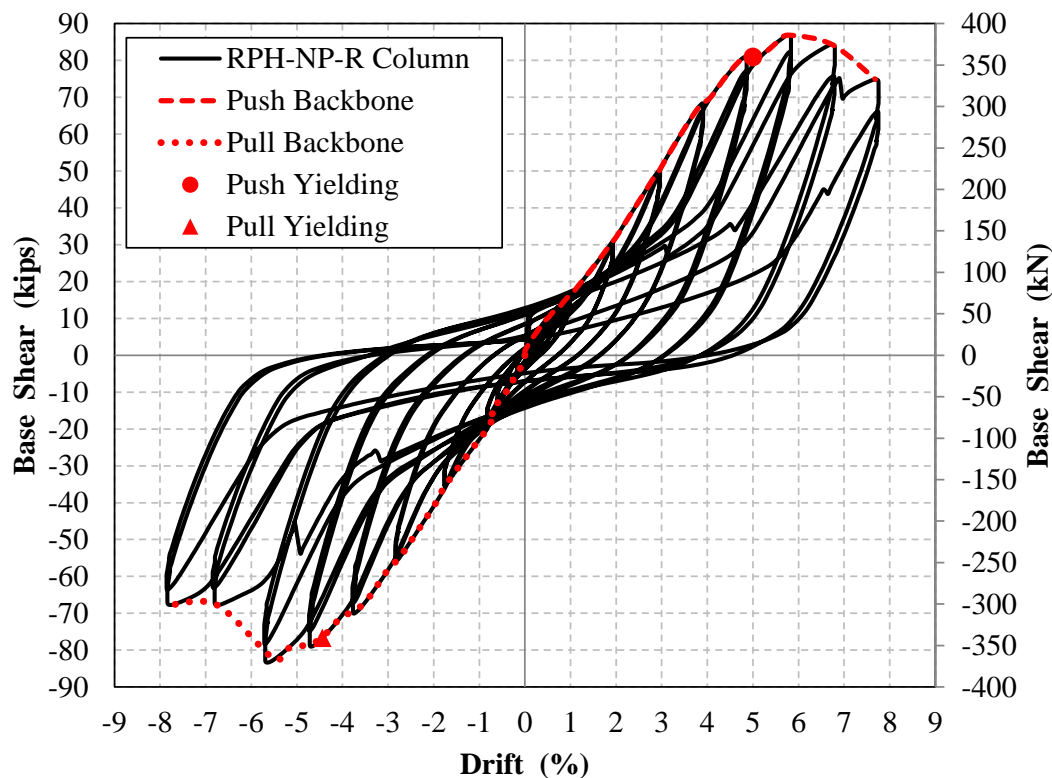
Figure 4.275. Measured RPH-NP-R Column Force-Drift Hysteretic and Envelope Responses

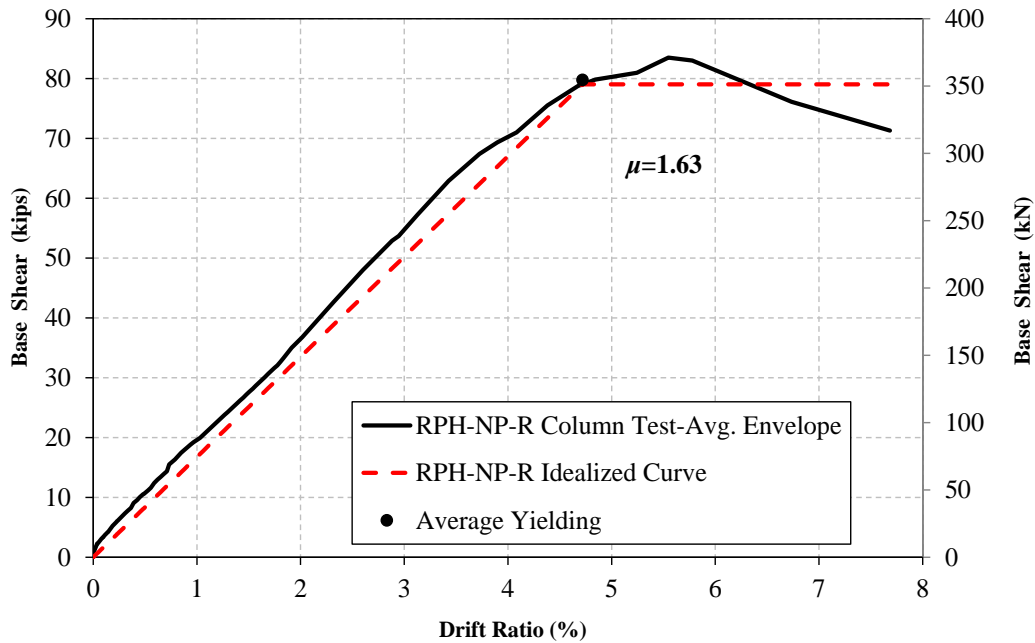
Figure 4.276. Measured RPH-NP-R Column Average Push/Pull Force-Drift Envelope and Idealized Curve

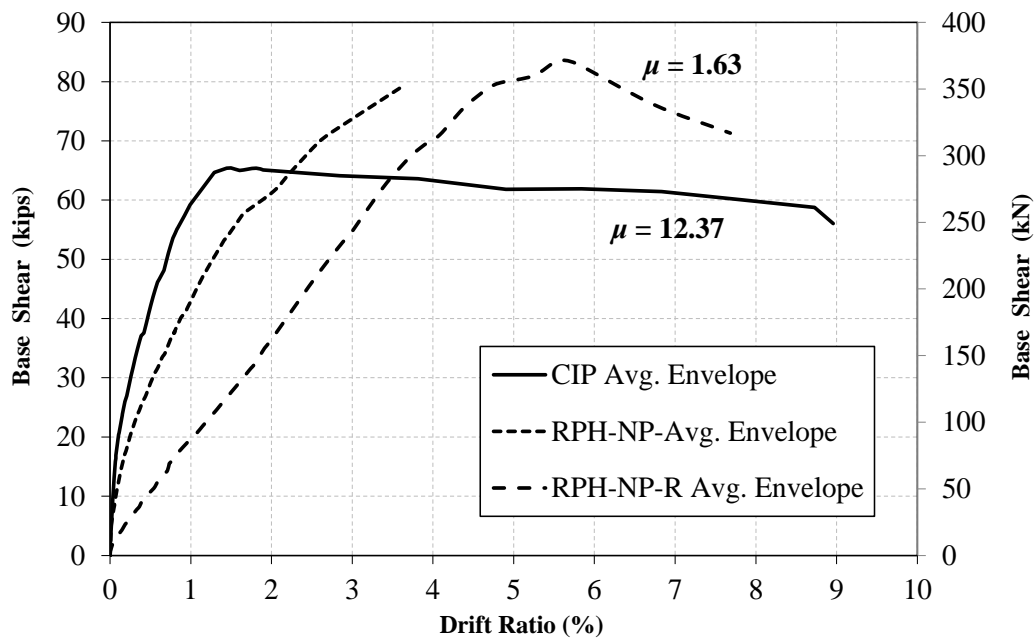
Figure 4.277. Measured Force-Drift Response of CIP, RPH-NP, and RPH-NP-R Columns

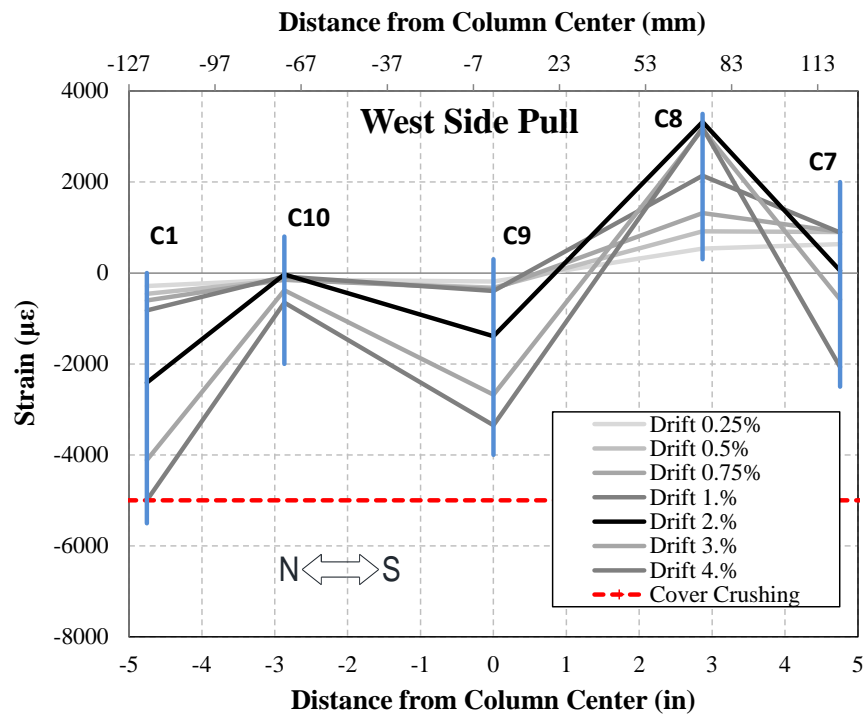
Figure 4.295. Measured UHPC Strain Profile for RPH-NP West Face During Pull Cycles

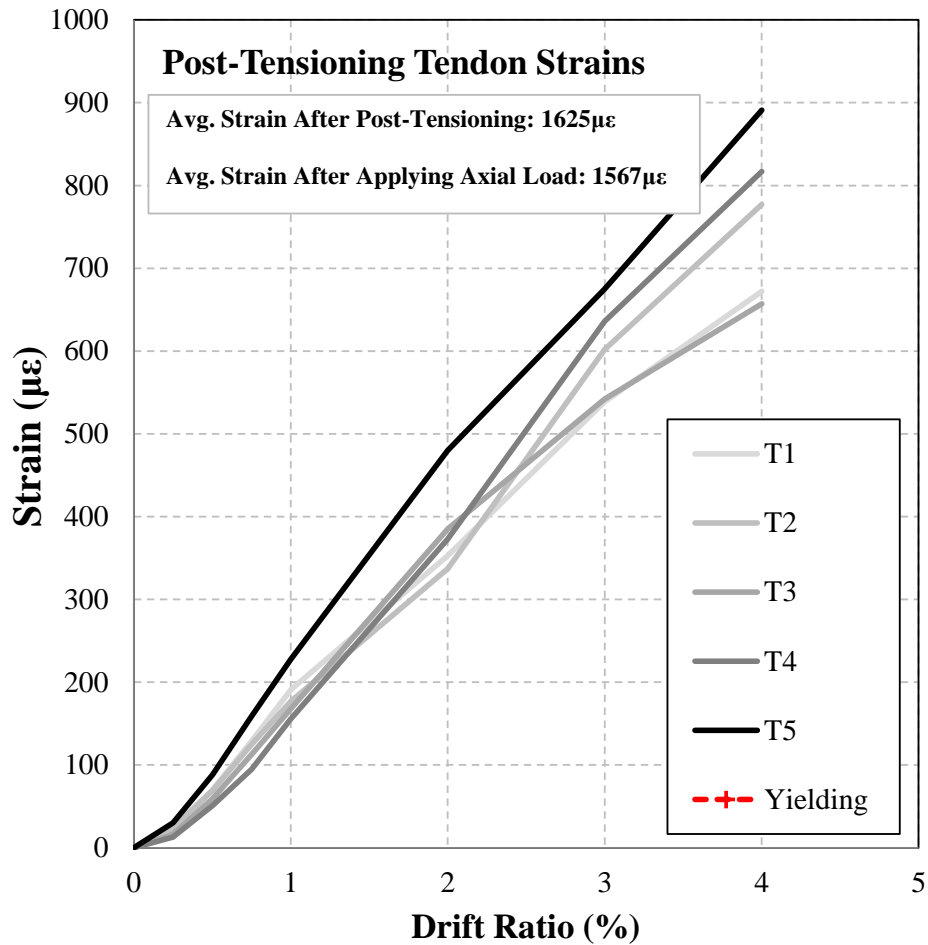
Figure 4.296. Measured Post-Tensioning Tendon Strain Profile for RPH-NP

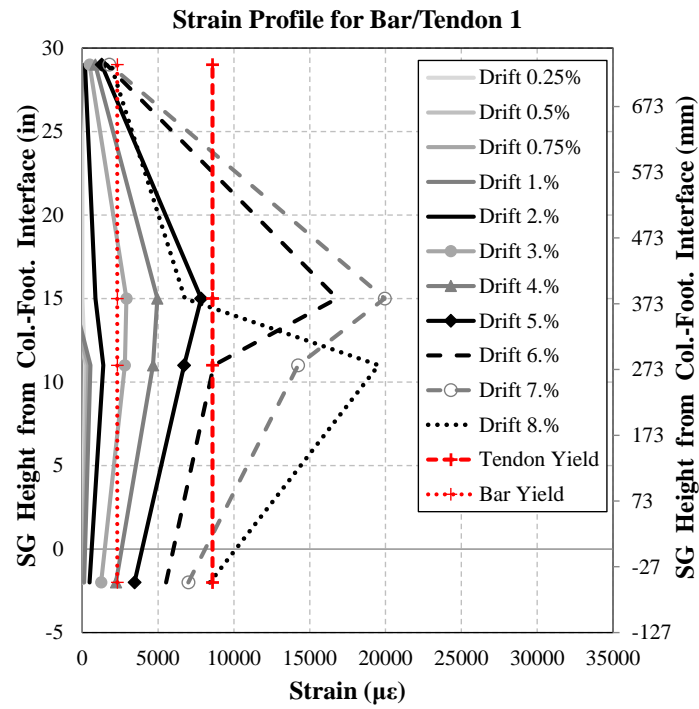
Figure 4.297. Measured Tensile Strain Profile for RPH-NP-R Column Bar/Tendon 1

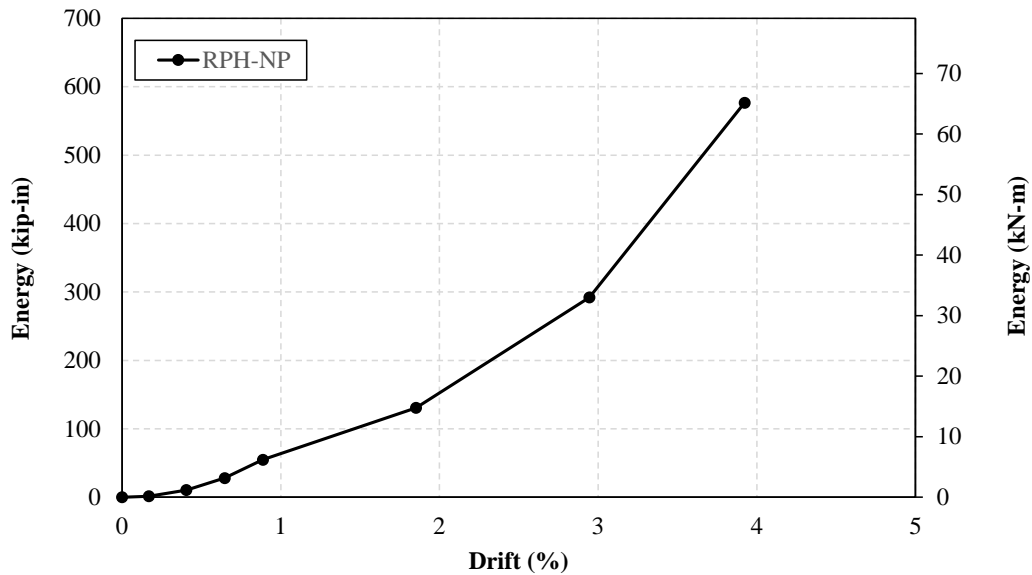
Figure 4.318. Measured Energy Dissipation for RPH-NP Column

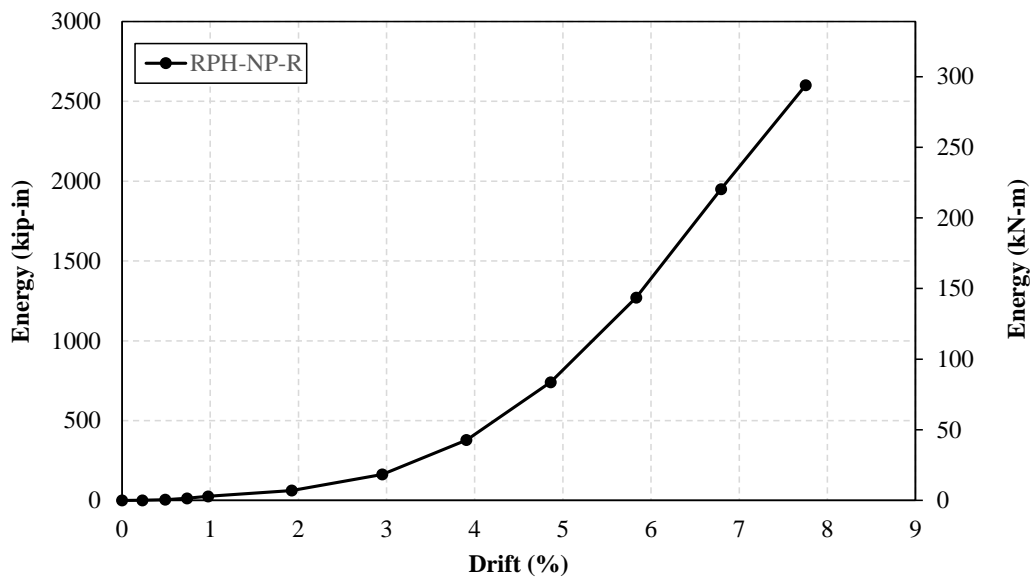
Figure 4.319. Measured Energy Dissipation for RPH-NP-R Column

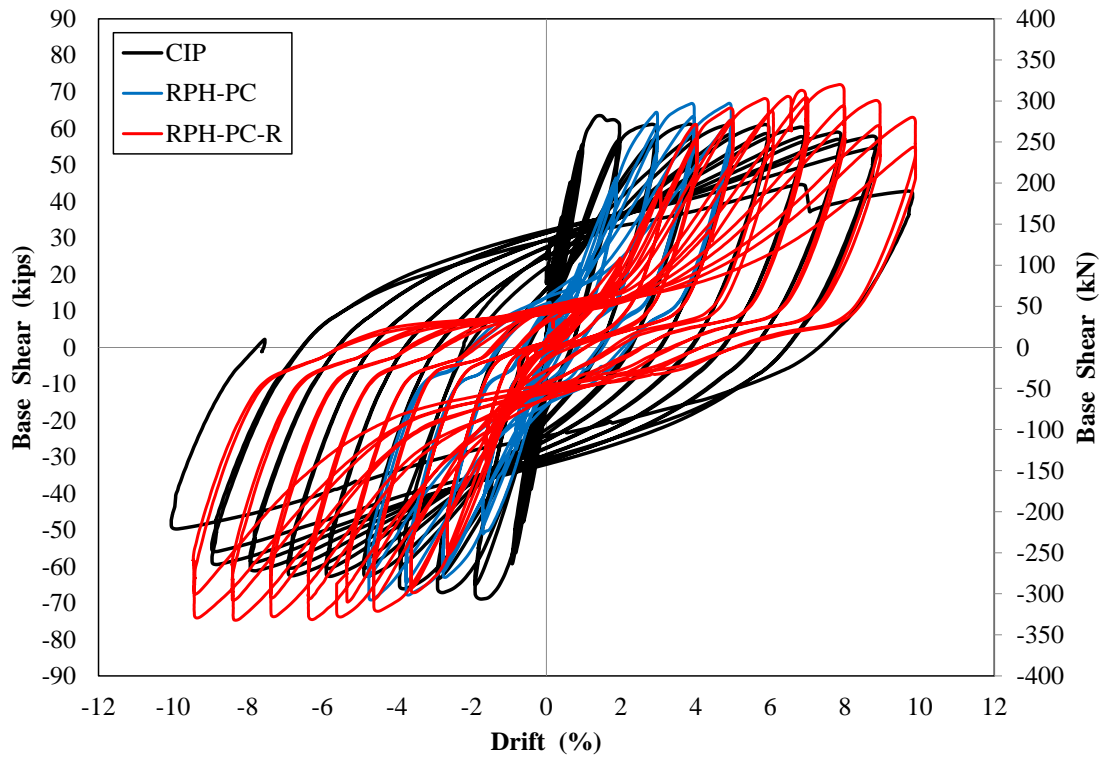
Figure 4.323. Measured CIP, RPH-PC, and RPH-PC-R Force-Drift Hysteretic Responses

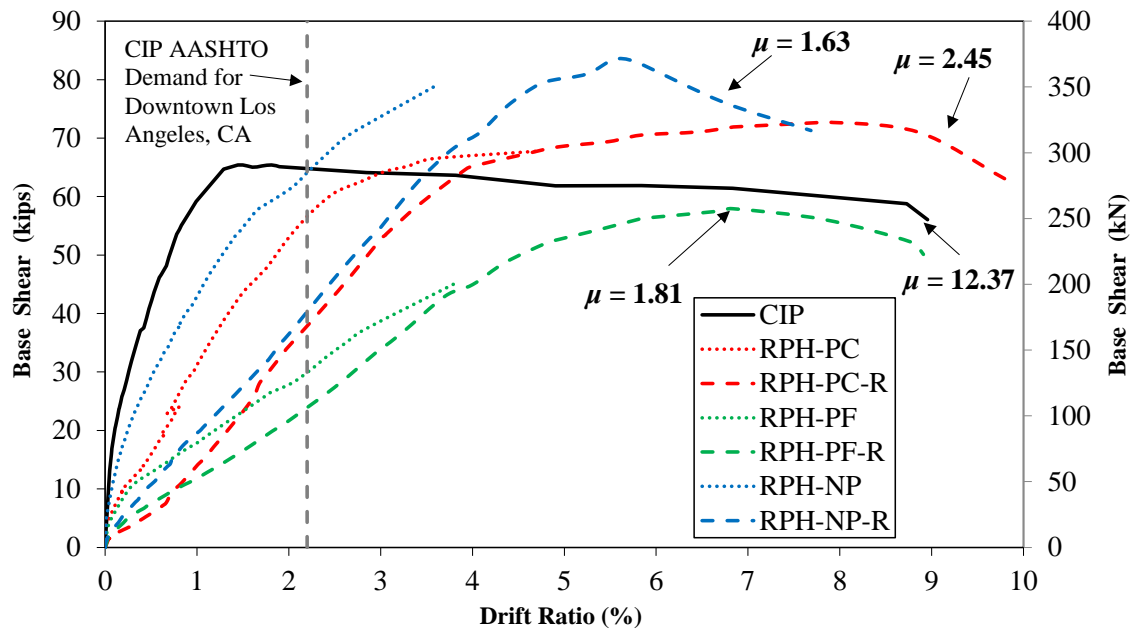
Figure 4.326. Measured CIP and Repairable Column Pushover Envelopes

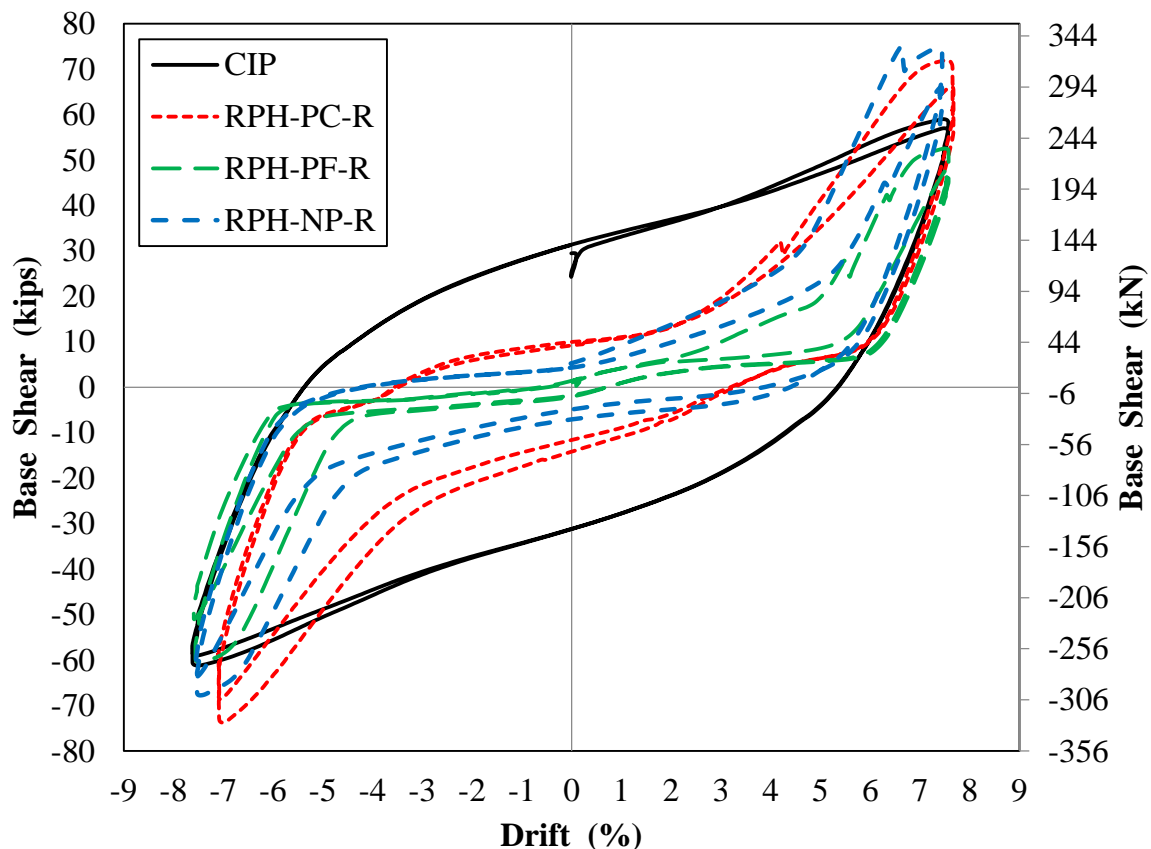
Figure 4.327. Measured CIP and Repairable Column Hysteretic Loops at 8.0% Drift Ratio
