**National Center for Transportation
Infrastructure Durability & Life-Extension**

Project ID: 2021-SDSU-02

Repairable Precast Bridge Bents for Seismic Events

Final Report

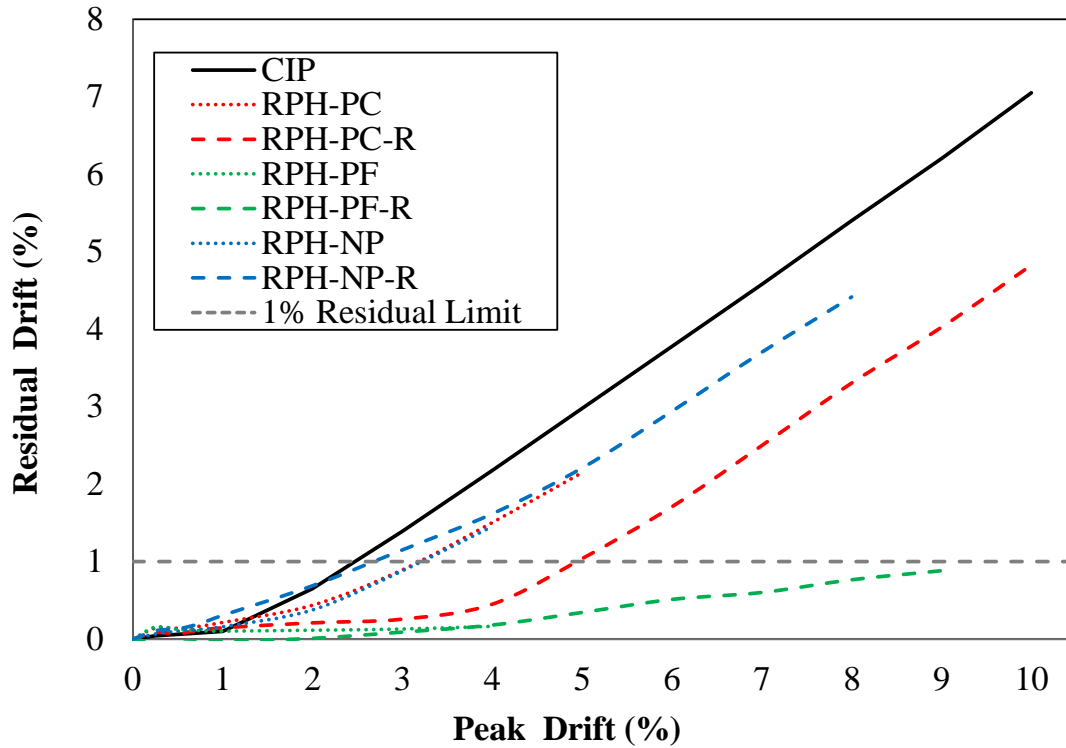
Figure 4.328. Measured CIP and Repairable Column Residual Drifts

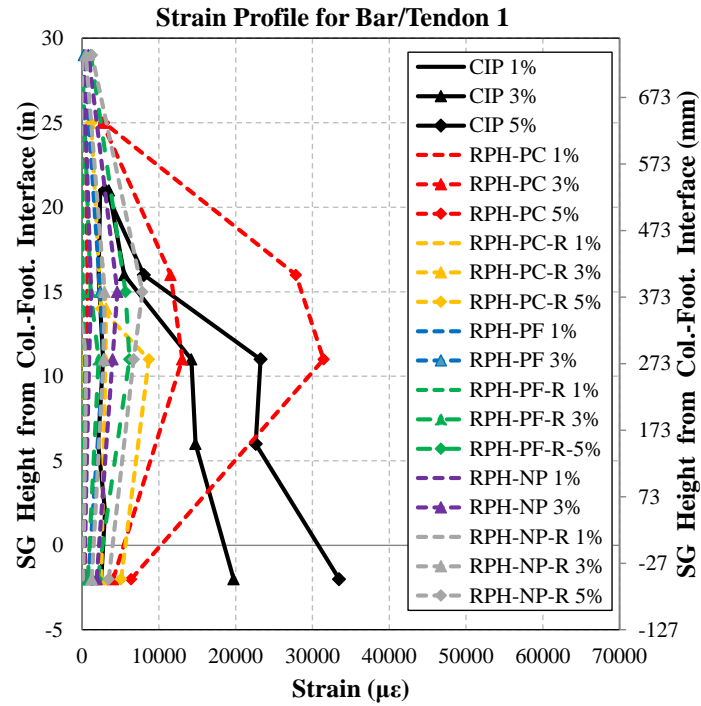
Figure 4.329. Measured CIP and Repairable Column Tensile Strain Profile for Bar/Tendon 1

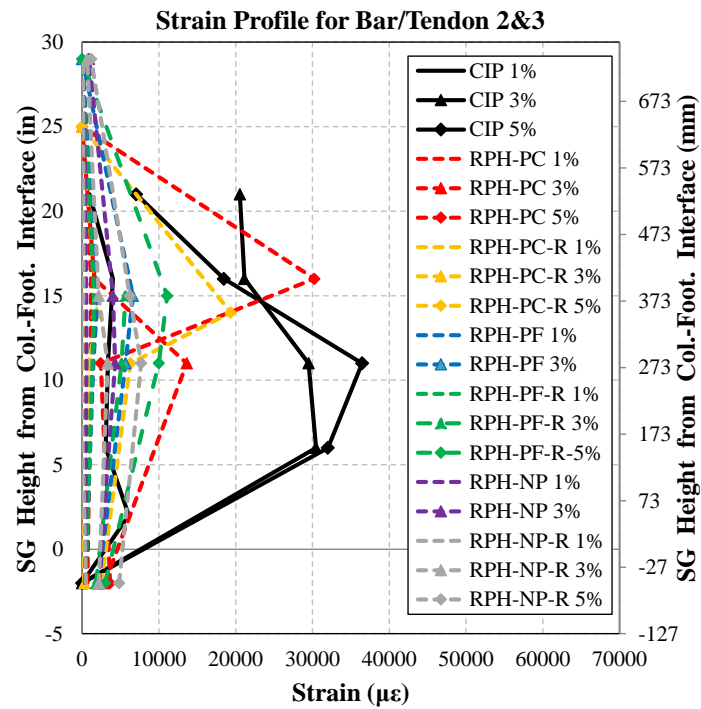
Figure 4.330. Measured CIP and Repairable Column Tensile Strain Profile for Bar/Tendon 2&3

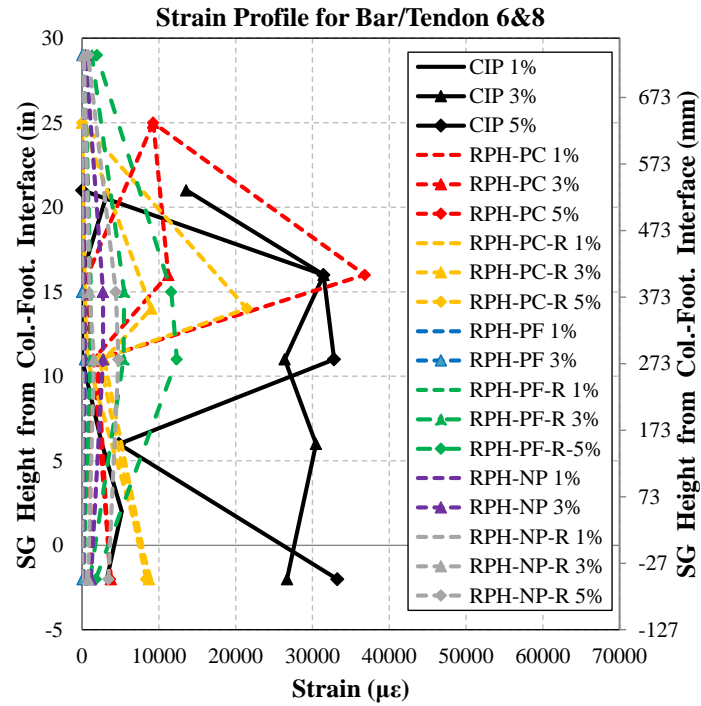
Figure 4.331. Measured CIP and Repairable Column Tensile Strain Profile for Bar/Tendon 6&8

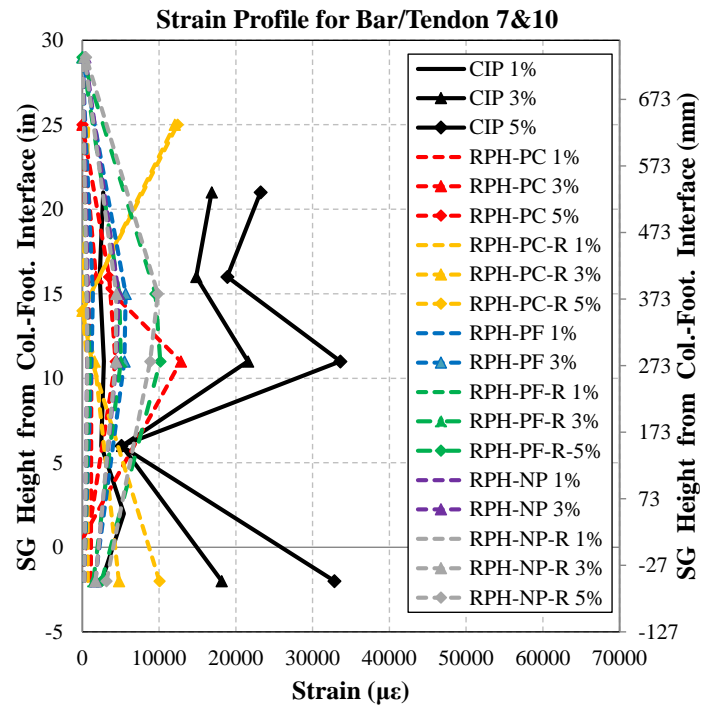
Figure 4.332. Measured CIP and Repairable Column Tensile Strain Profile for Bar/Tendon 7&10

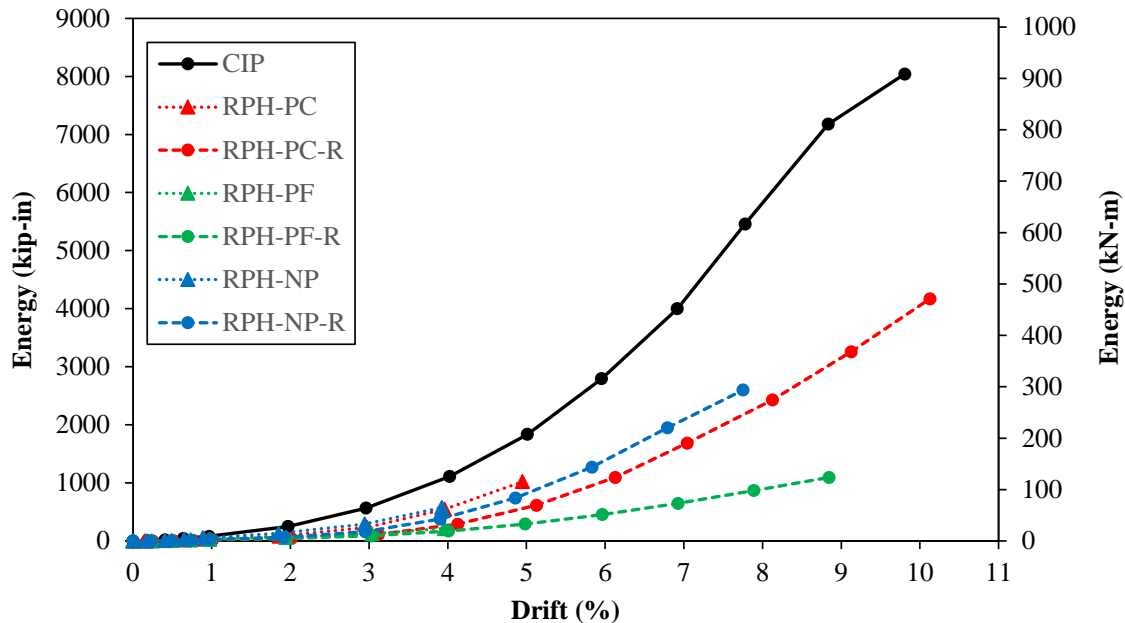
Figure 4.333. Energy Dissipation for CIP and Repairable Columns

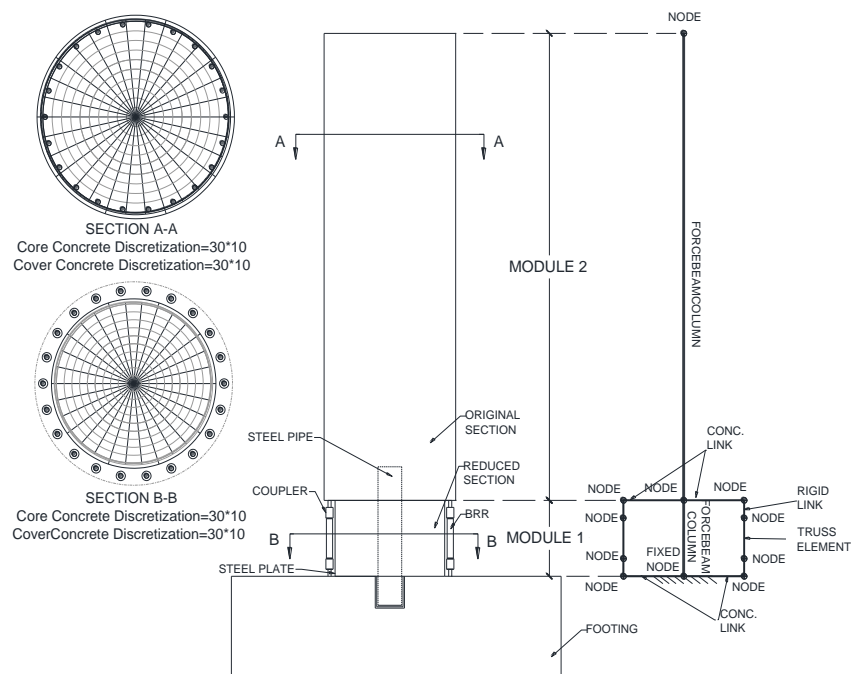
Figure 5.1. Finite Element Modeling Method for Repairable Precast Bridge Columns (Boudaqa et al., 2017)

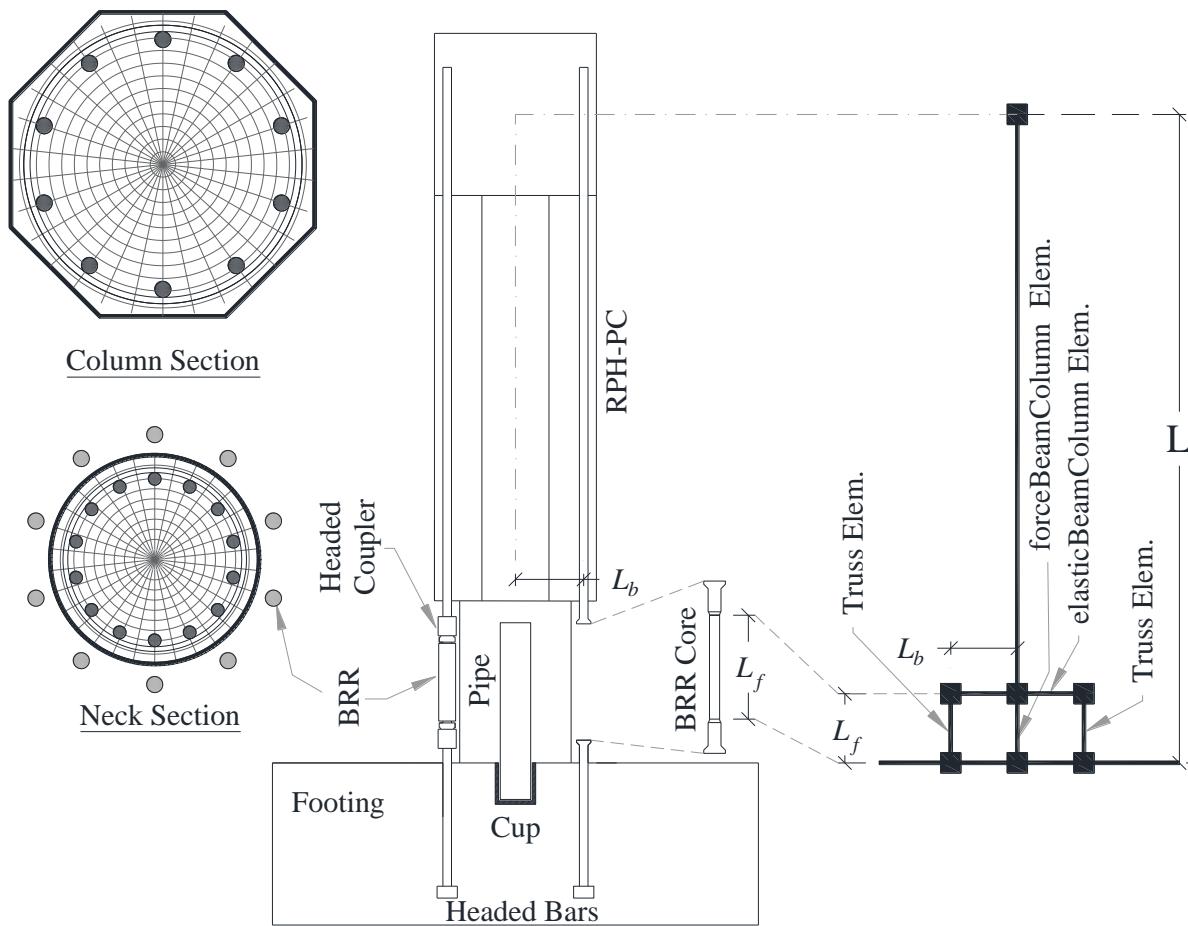
Figure 5.3. Analytical Modeling Method for RPH-PC

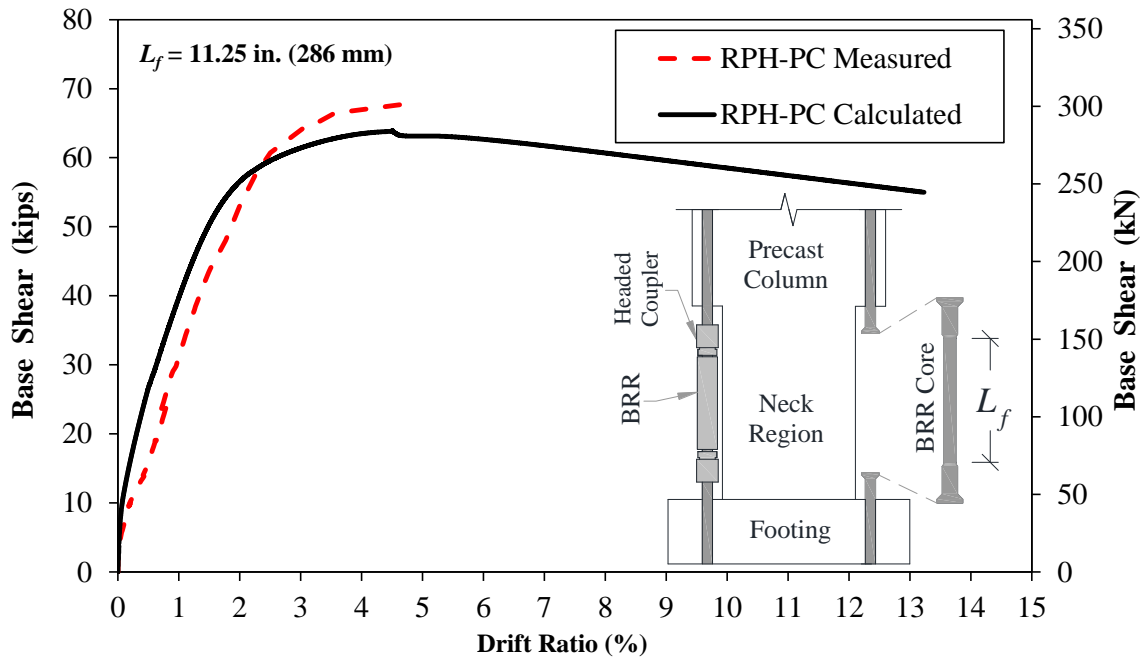
Figure 5.7. Calculated and Measured Force-Drift Relationships for RPH-PC (Long Fuse)

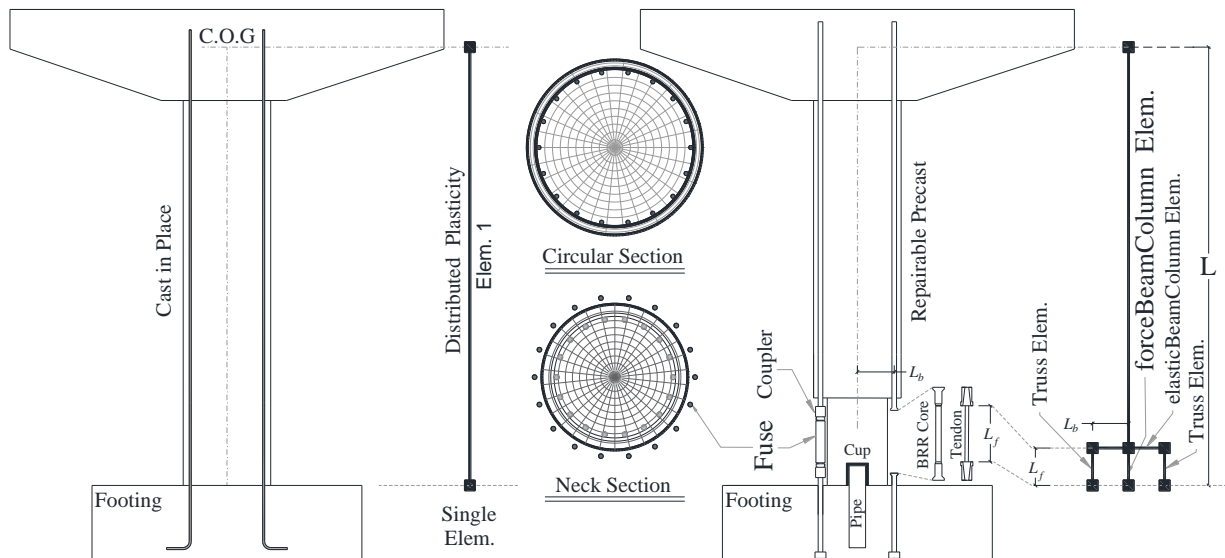
Figure 6.1. Full-Scale Cast-in-Place and Repairable Bridge Column Models

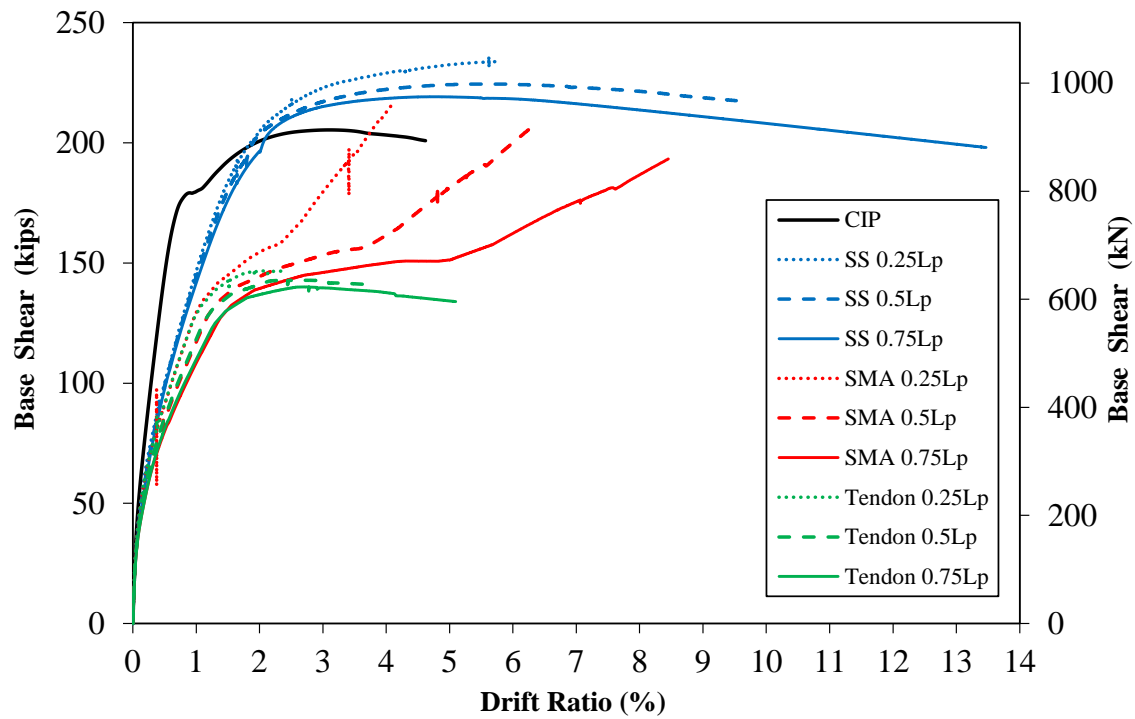
Figure 6.2. Pushover Analysis for RPH-AR4-ALI5

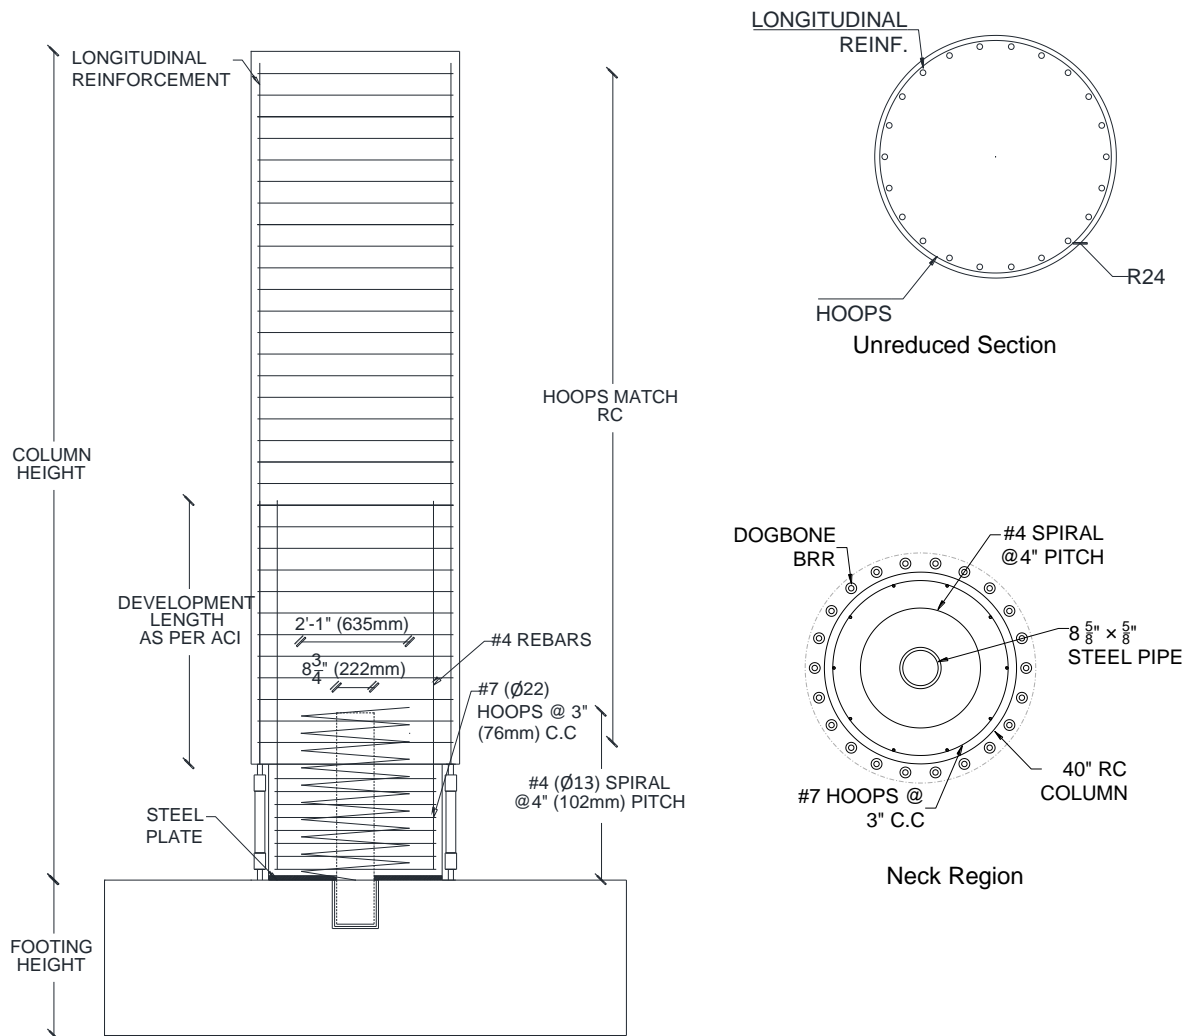
Figure A.5. Proposed Repairable Column Detailing with 4-ft Diameter
