WASHINGTON STATE UNIVERSITY

STEM/Student Success (Dana Hall)

2019 – 21 Request: \$9,600,000

Institution
Washington State University
Project Title
STEM/STUDENT SUCCESS (DANA HALL)
Project Location (City)
Pullman, WA

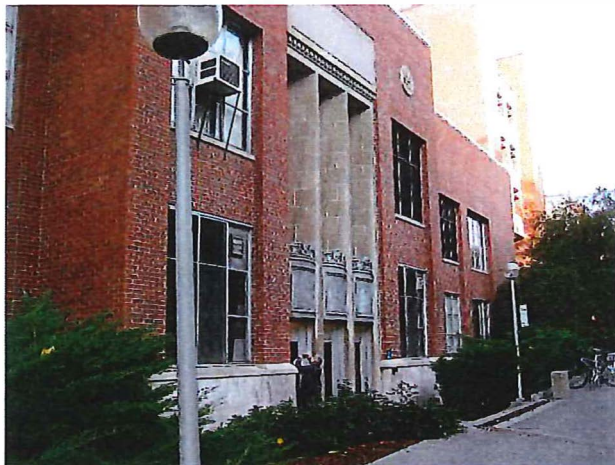
Photo

Dana Hall is located on the Washington State University Campus in Pullman, Washington. The building is situated at the west side of the campus adjacent to Spokane Street. The structure is 90,023 square foot (GSF), four stories with a small partial

basement. The building is rectangular in shape and built on a sloping parcel of land. The building is attached to the Electrical Mechanical Engineering Building on the north elevation. According to WSU information, construction for the building was completed in 1949.

The building contains classroom, laboratories and offices with mechanical equipment located throughout the floors and basement. Per the 2012 International Building Code, Chapter 3, and Section 303 – Assembly Group, this building is classified as Occupancy Group A3. According to the 2012 International Building Code, Chapter 6, Section 602, this building's construction type is Type II - Noncombustible, as determined from field observations.
