Frink Park Site One

A design proposal by
Sean Dugan, Kristina Fenn, Kim Frappier, Katie Gunter, Marcia
Nachtigal, Masako Ota, Emily Rivers, Kirra Swenerton, and Bic Wong

EHUF 480 – Selection and Management of Landscape Plants
Autumn, 2001

University of Washington, Center for Urban Horticulture

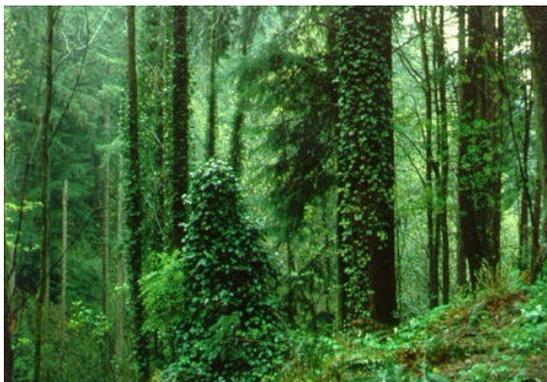
Hedera helix, commonly called English ivy, is a naturalized native of Europe. Culturally, *H. helix* is fairly drought tolerant and grows well in sun or shade and in many types of soil (Morisawa, 1999). *H. helix* reproduces vegetatively as well as by seeds.

Ivy creates dense growth just above the ground preventing sunlight from reaching other plants. Also, the additional weight of the vines growing on trunks and branches make trees more

susceptible to blow over during storms (NPS, 2000). As *H. helix* grows up into the canopy, it covers the apical stem of the tree. This has a similar effect to topping a tree, which induces biologic stress and hastens tree death (Ivy out project). *H. helix* also interrupts the natural process of succession by suppressing growth of conifers that would ordinarily create the next stage of the forest canopy.
