Troy Bridge Inspection

Troy Bridge over NE Stadium Way

Inspection Date: August 6, 2021

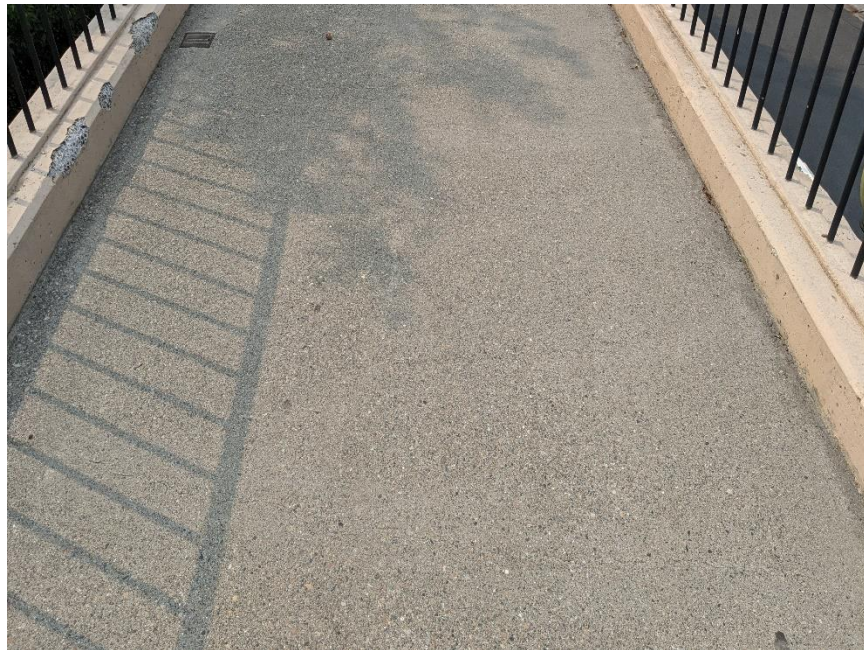
- The top of deck exhibited minor scaling up to 1/16 to 1/8-in. deep throughout. (See Photo 12)
- The top of deck around the snow melt junction boxes exhibited hairline to 1/16-in.-wide cracks. Some areas had minor corrosion staining through the cracks. (See Photo 13)

Photo 12: Typical Minor Scaling in Top of Deck, Looking South

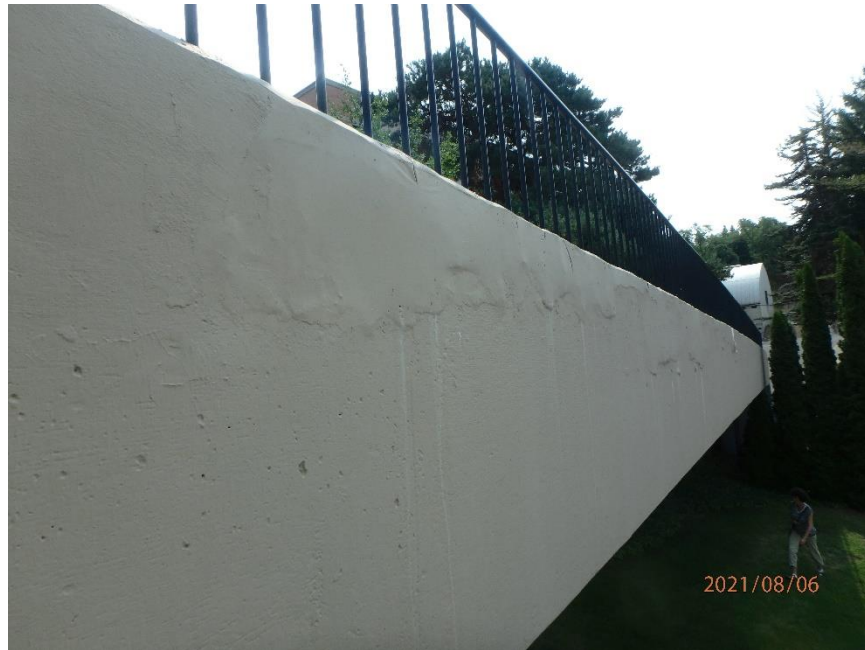
- The west girder in all spans had patches on the west face throughout, concentrated on the top edges of the west face. Most patches were delaminated and unsound. (See Photos 24 and 25)

Photo 25: Typical Unsound Patches in West Face of west Girder Top Edge, Looking Southeast

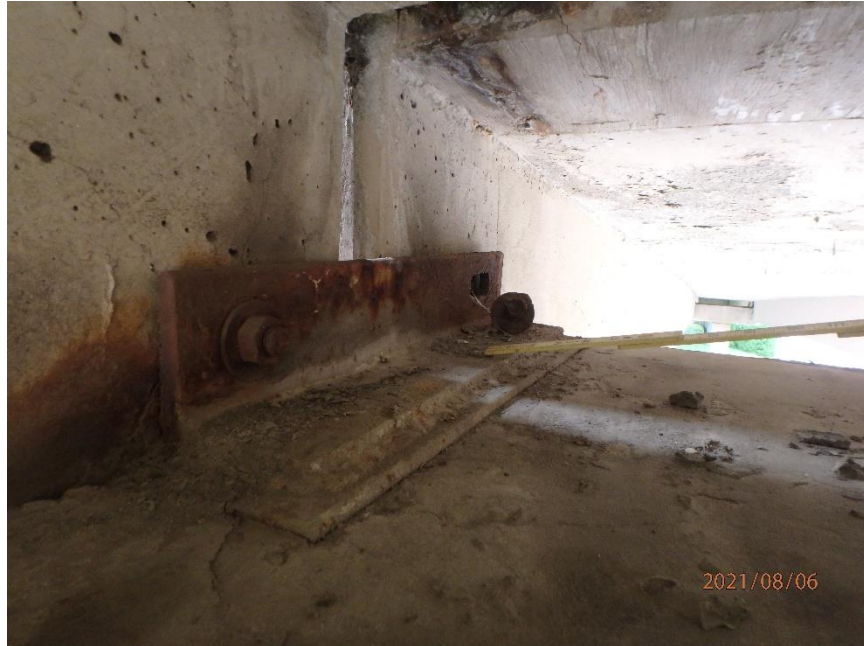
- Both interior faces exhibited multiple hairline diagonal cracks extending from the dapped girder end up to 36-in. long on the east girder and 16-in. long on the west girder. (See Photos 37 and 38)
 - The east girder had a spall at the northeast corner and above the bearing plate measuring 21-in. high by 16-in. long by 1.5 in. deep with 4 exposed bars having approximately 20% loss of section. (See Photos 39 and 40)
 - The west face of the west girder had a spall measuring 16-in. high by 15-in. wide by 1.5-in. deep with 2 exposed bars. (See Photo 41)
 - The steel connection hardware on top of Pier 2 for span 2 to span 3 girders had 2 sheared off bolts at the span 2 connection. (See Photos 42 and 43)

Photo 43: Sheared off Bolt at Pier 2 Connection Hardware, Looking Southeast

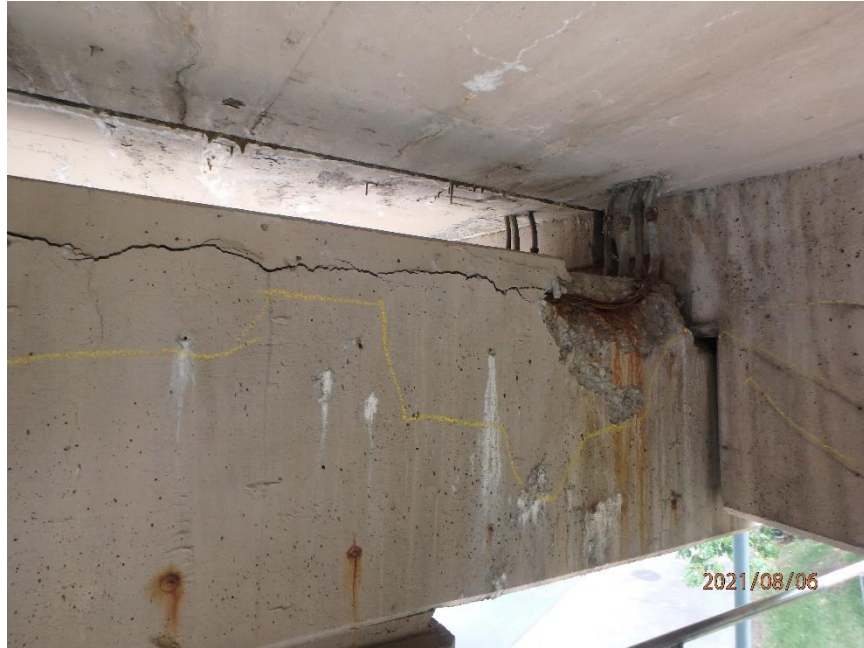
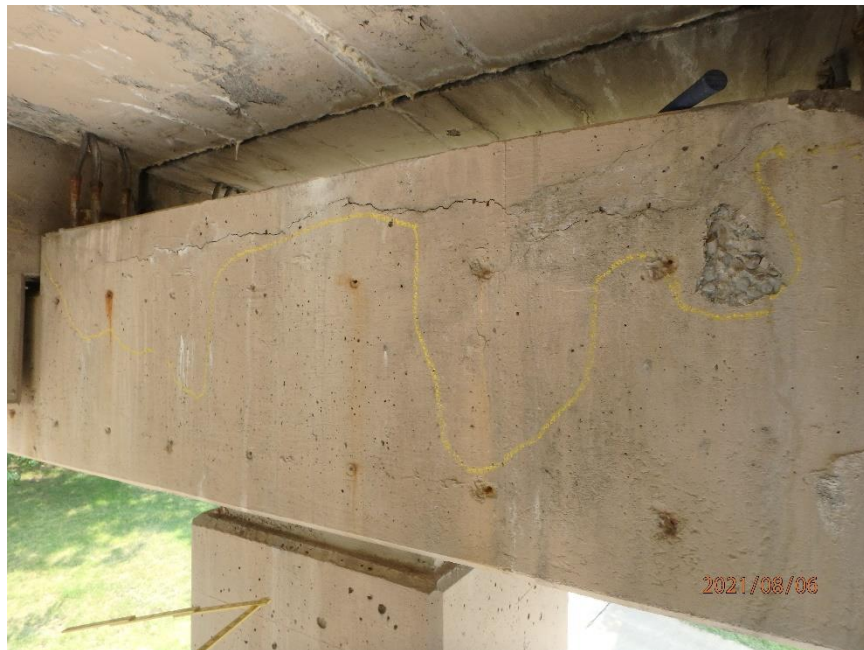
Photo 53: Delamination of the South Face of Pier 1 Cap, Looking Northeast (Yellow Lines Show Delamination)

Photo 54: Delamination of the North Face of Pier 1 Cap, Looking Southeast (Yellow Lines Show Delamination)

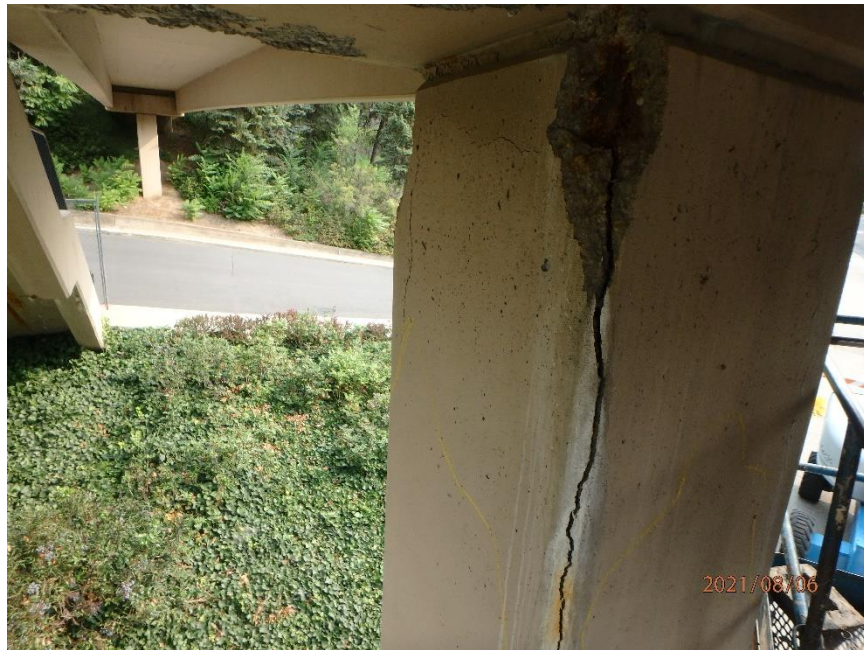
- The north face had a spall at the top west corner measuring 5-in. high by 12-in. long by 3-in. deep. (See Photo 58)
- Pier 2:
 - Pier
 - The top of the pier was delaminated on each face. Measurements of the crack height were taken at each corner: 60-in. at the southwest corner, 32-in. at the northwest corner, 16-in. at the northeast corner and 48-in. at the southeast corner. Cracks propagated down each corner for the length of the delamination up to 1/2-in. wide at the southwest corner. (See Photos 59 and 60)

Photo 60: Delamination in Pier 2, Looking Northeast

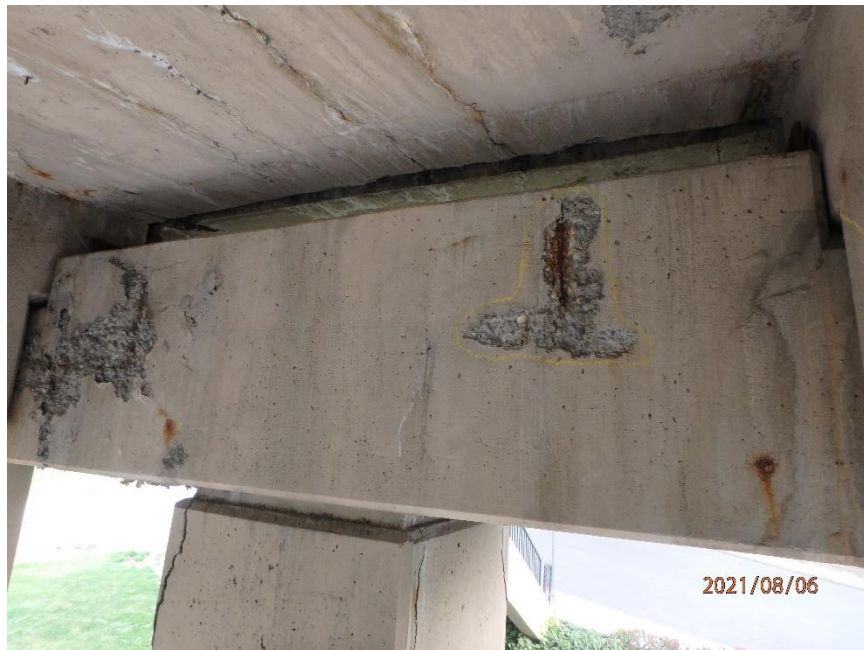
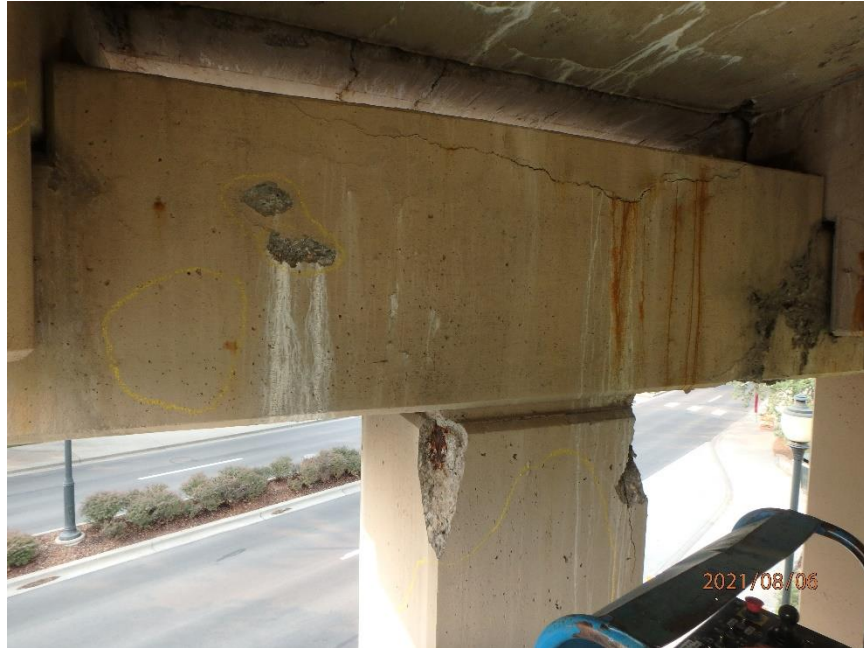
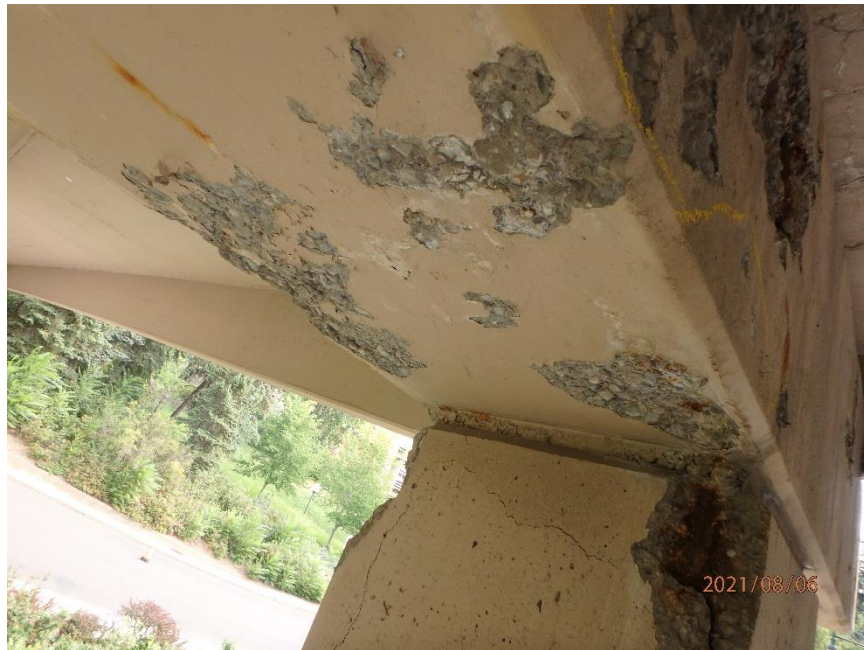
- The top half of the north face had an area of delamination with cracking up to 5 ft long by 8-in. high with rust staining. (See Photo 65)
 - The north, south and bottom faces had large areas of spall, delamination, and scaling throughout up to 1.5-in. deep with exposed bar. (See Photos 66-68)

Photo 66: Pier 2 Cap South Face, Looking Northwest

Photo 67: Pier 2 Cap North Face, Looking Southwest

Photo 68: Pier 2 Cap Bottom Face, Looking Northeast

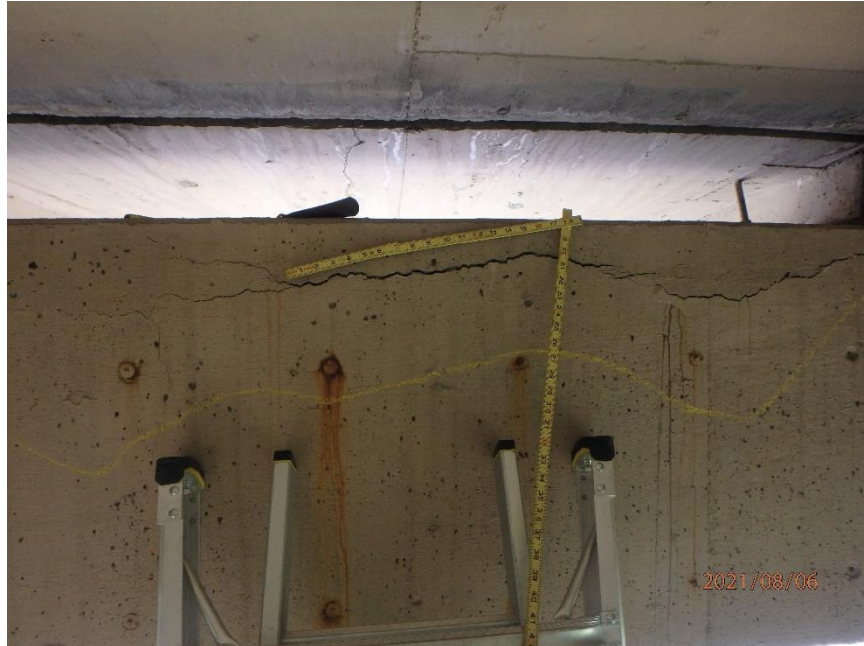
- Pier 3:
 - Pier
 - In good condition
 - Pier Cap
 - The top corners of both south and north faces were delaminated and cracking measuring 15-in. high by 5.5 ft long by 4-in. wide on the top surface for the north face and 13-in. high by 40-in. long by 4-in. wide in the top surface for the south face. (See Photos 69 and 70)

Photo 69: Delamination of the North Face of Pier 3 Cap Top Corner, Looking South

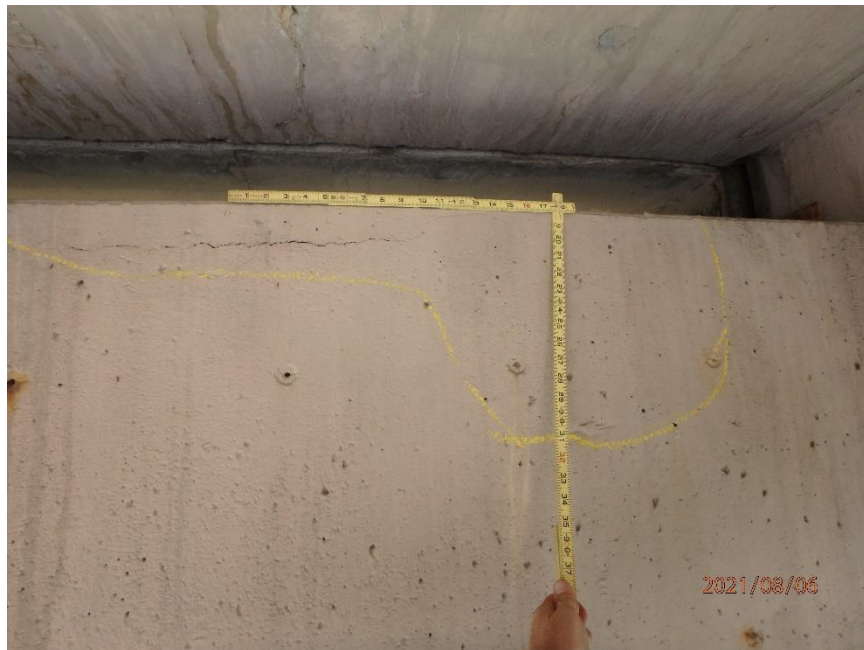
Photo 70: Delamination of the South Face of Pier 3 Cap Top Corner, Looking North

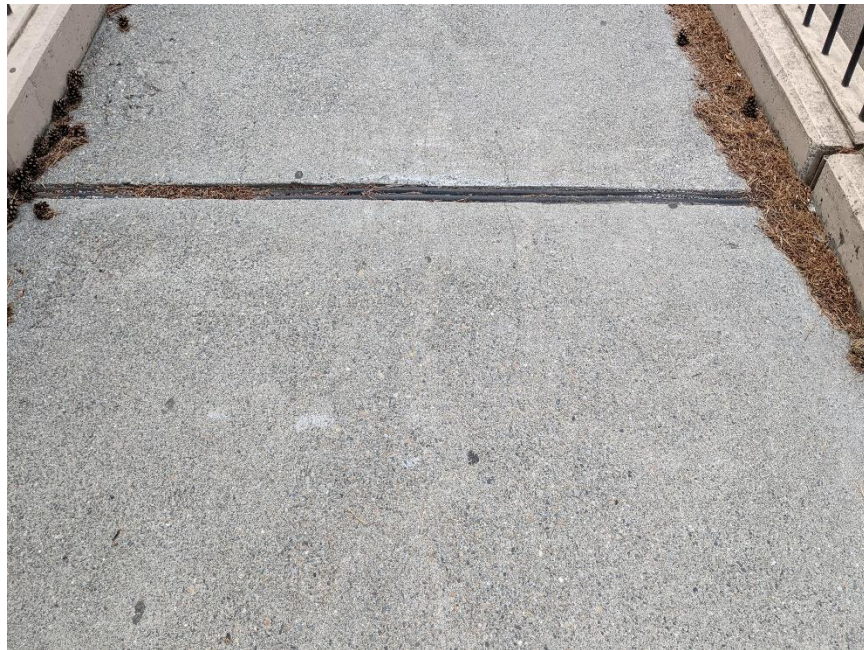
- The majority of the joint material had deteriorated and had lack of adhesion with the adjacent concrete surfaces. (See Photos 83 and 84)
- The joint exhibits minor amounts of debris impaction along the top edge. (See Photos 83 and 84)
- From the corrosion and deterioration of the elements below the joints, it is evident that the joints leak and are no longer sealed.

Photo 84: Typical Expansion Joint, Looking South

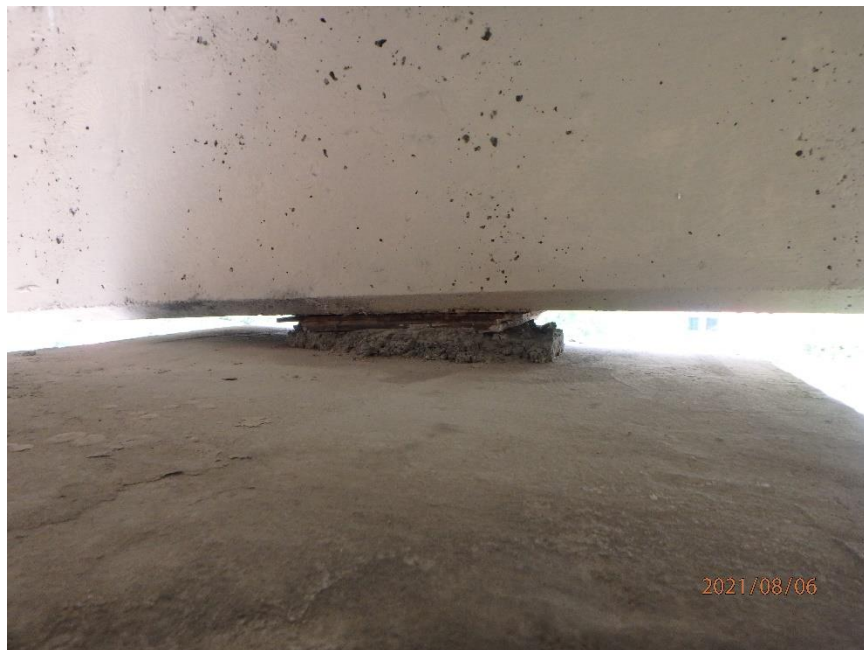
- The bearings between the girders and pier cap at the east and west sides had 1/8-in. to 1/4-in. pack rust in the steel plates. (See Photos 97 and 98)

Photo 98: West Bearing at Pier 2B Cap, Looking Southwest
