Garfield High School
Landscape Renovation Proposal
Autumn 2001

EHUF 480: Selection and Management of Landscape Plants
Mitchell Almaguer-Bay, Barbara Barnes, Jennifer Carlson, Jesse Craven, Cynthia Durfee,
April Mulcahy, Rachel Ramos, Zheng Yin [and Jean Gauthier]

Center for Urban Horticulture/Sustainable Community Landscapes
University of Washington

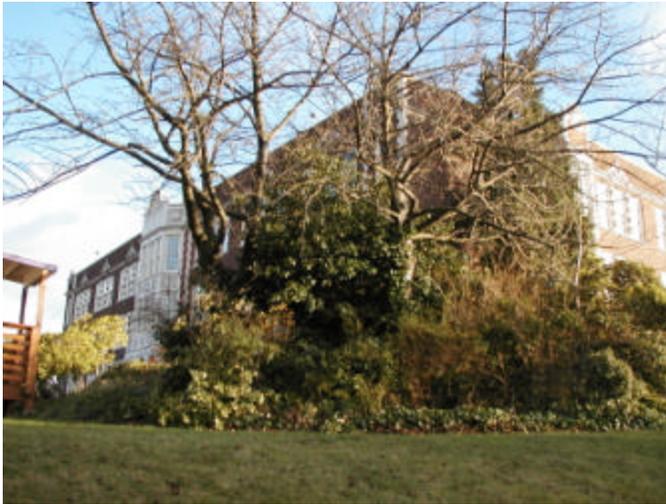
Figure 5: Northwest corner of the site

Overview. The majority of the site is covered with turf or English Ivy (*Hedera helix*). The existing tree species include a Port Orford-cedar (*Chamaecyparis lawsoniana*), two mature cherry trees (*Prunus* spp.), and a young sweet gum (*Liquidambar styraciflua*). Shrubs growing under and around the mature cherry trees include one rhododendron, sword fern

(*Polystichum munitum*), *Viburnum tinus*, Portuguese laurel (*Prunus lusitanica*), *Spiraea* spp., and *Forsythia x intermedia*. Two barberries (*Berberis thumbergii*) are located next to the stairs. There is one *Daphne laureola* and another *Spiraea* spp. next to the building. Besides ivy, weeds present on site include clematis, horsetail, blackberry and dandelion; these are lesser concerns.

Unfortunately, *H. helix* is growing abundantly at Garfield High School. At the time of the site analysis, the ivy was flowering and setting fruit. We recommend removing all *H. helix* from this site to create an environmentally sound landscape and to reduce rodent problems.
